# Building Performance Evaluation and Sustainability Assessment

## Rye Public Library

Rye, New Hampshire

June 2009

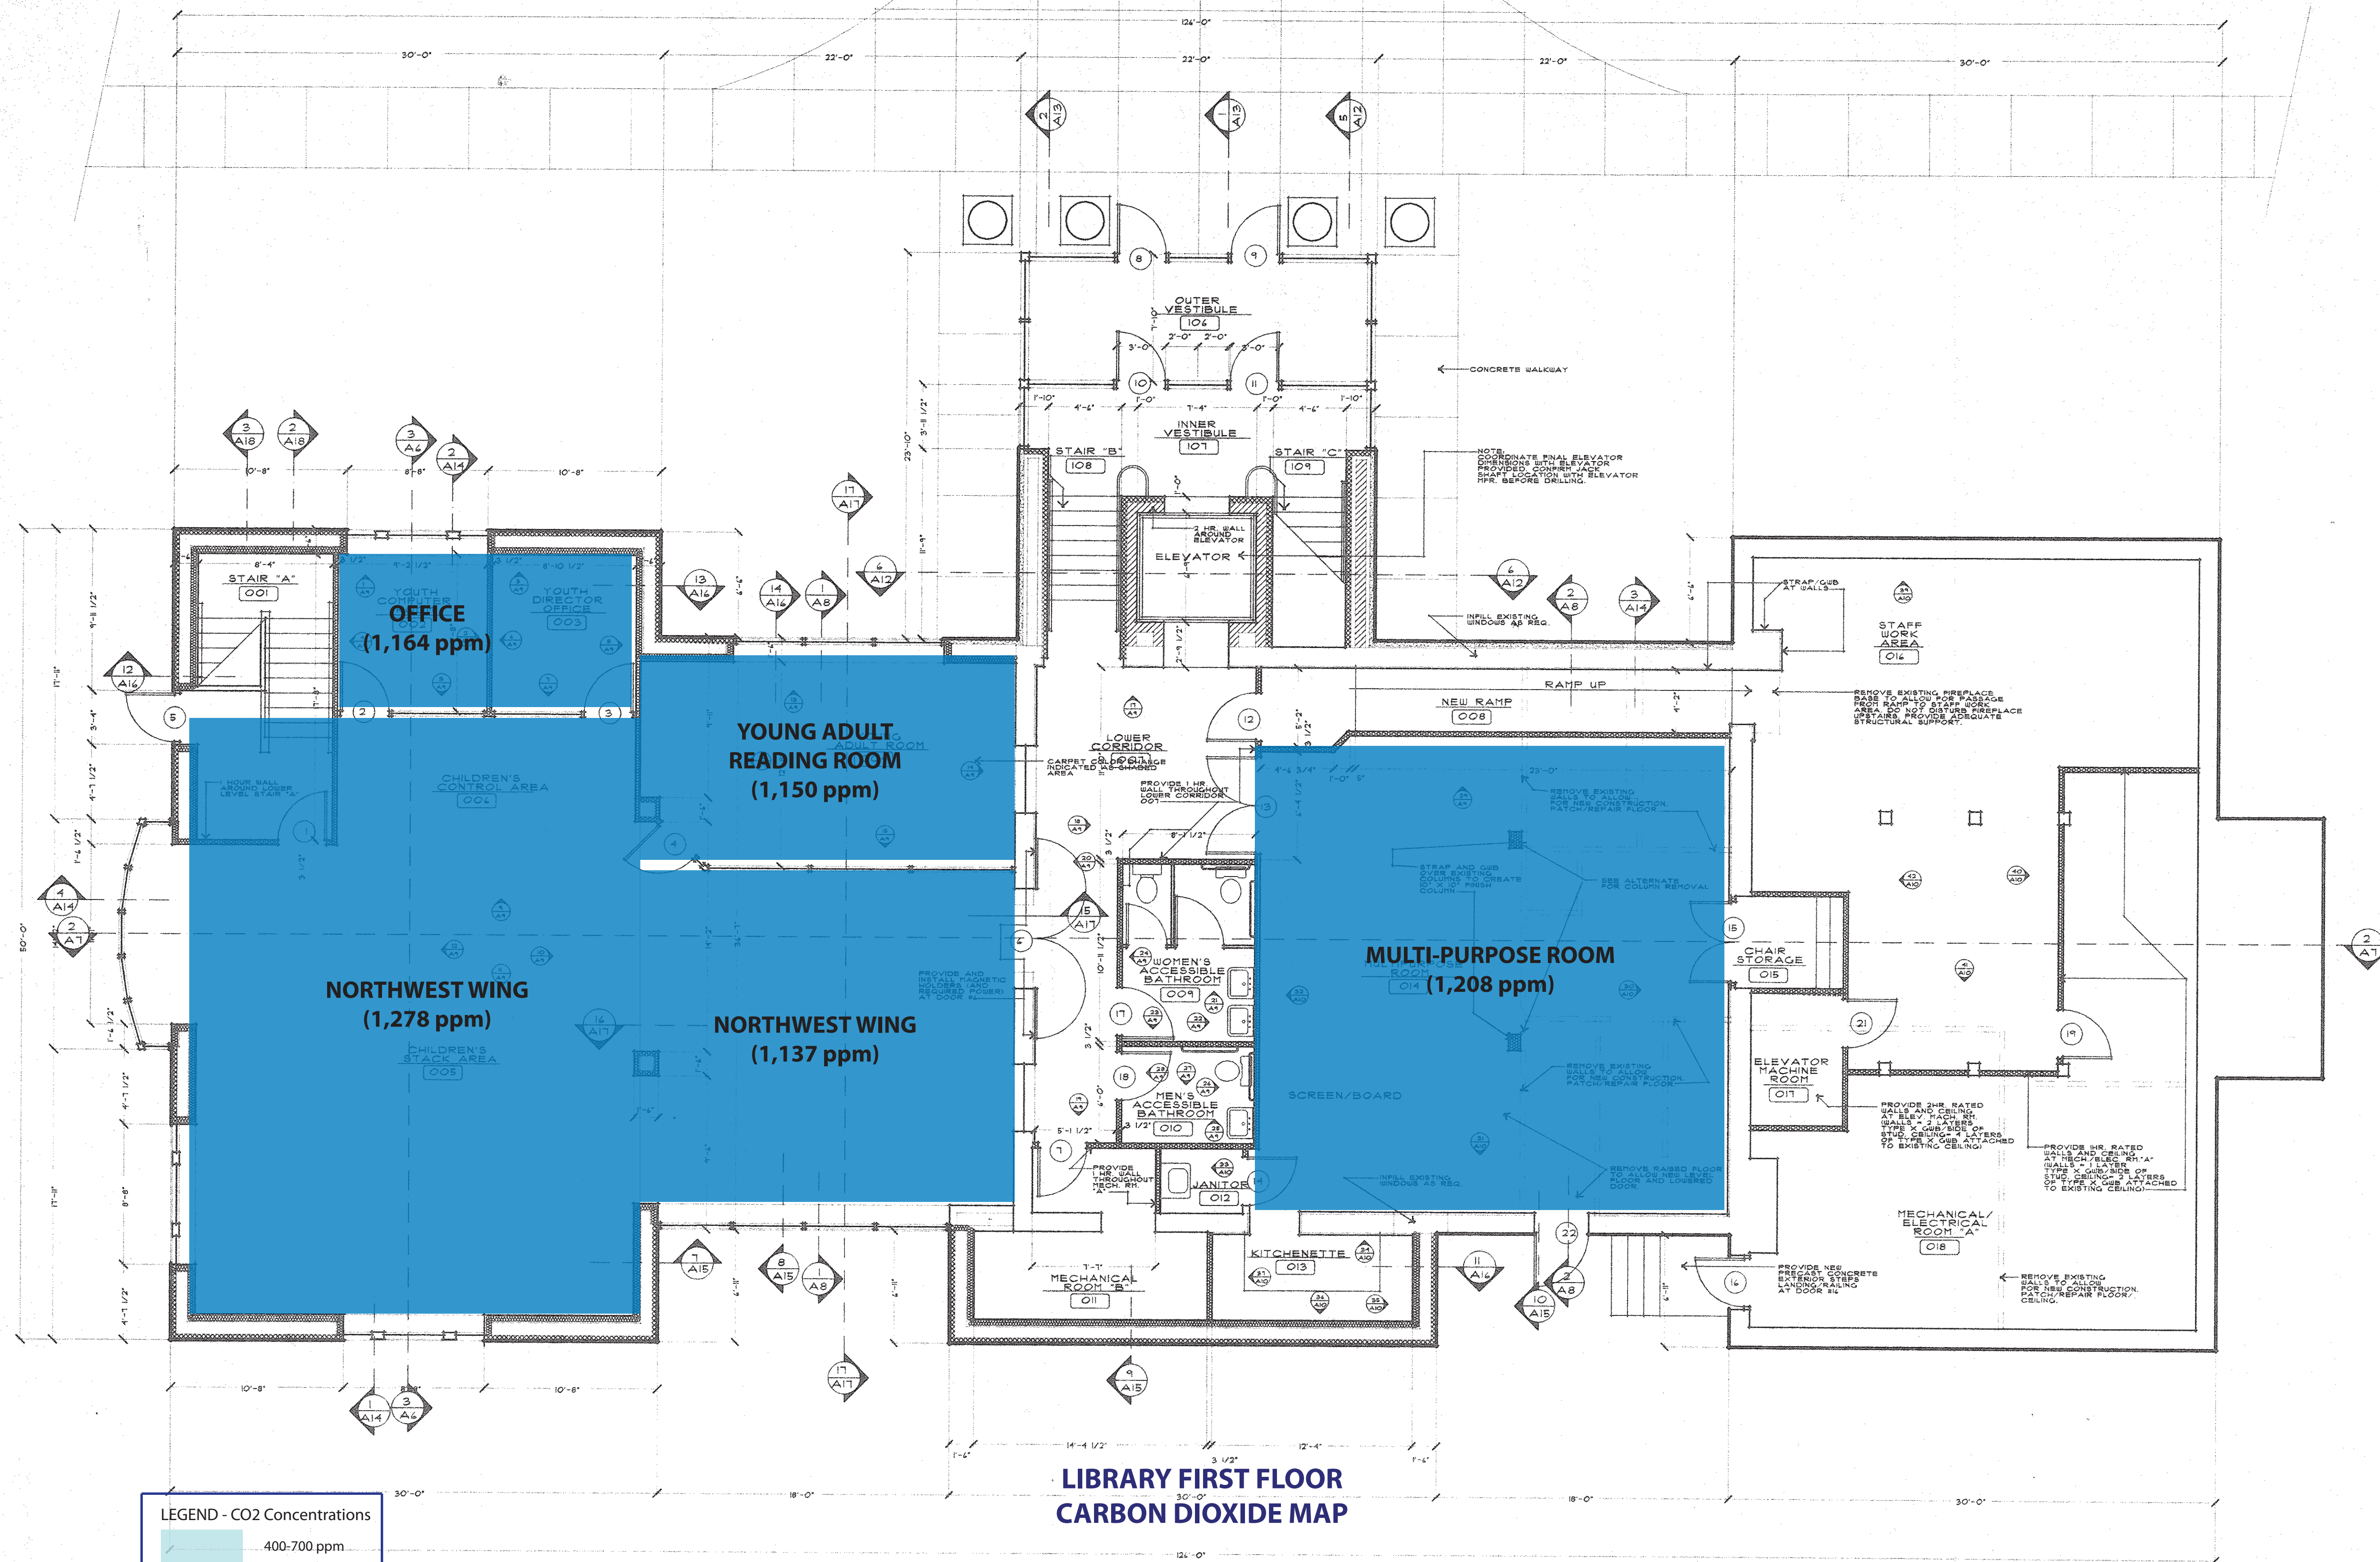
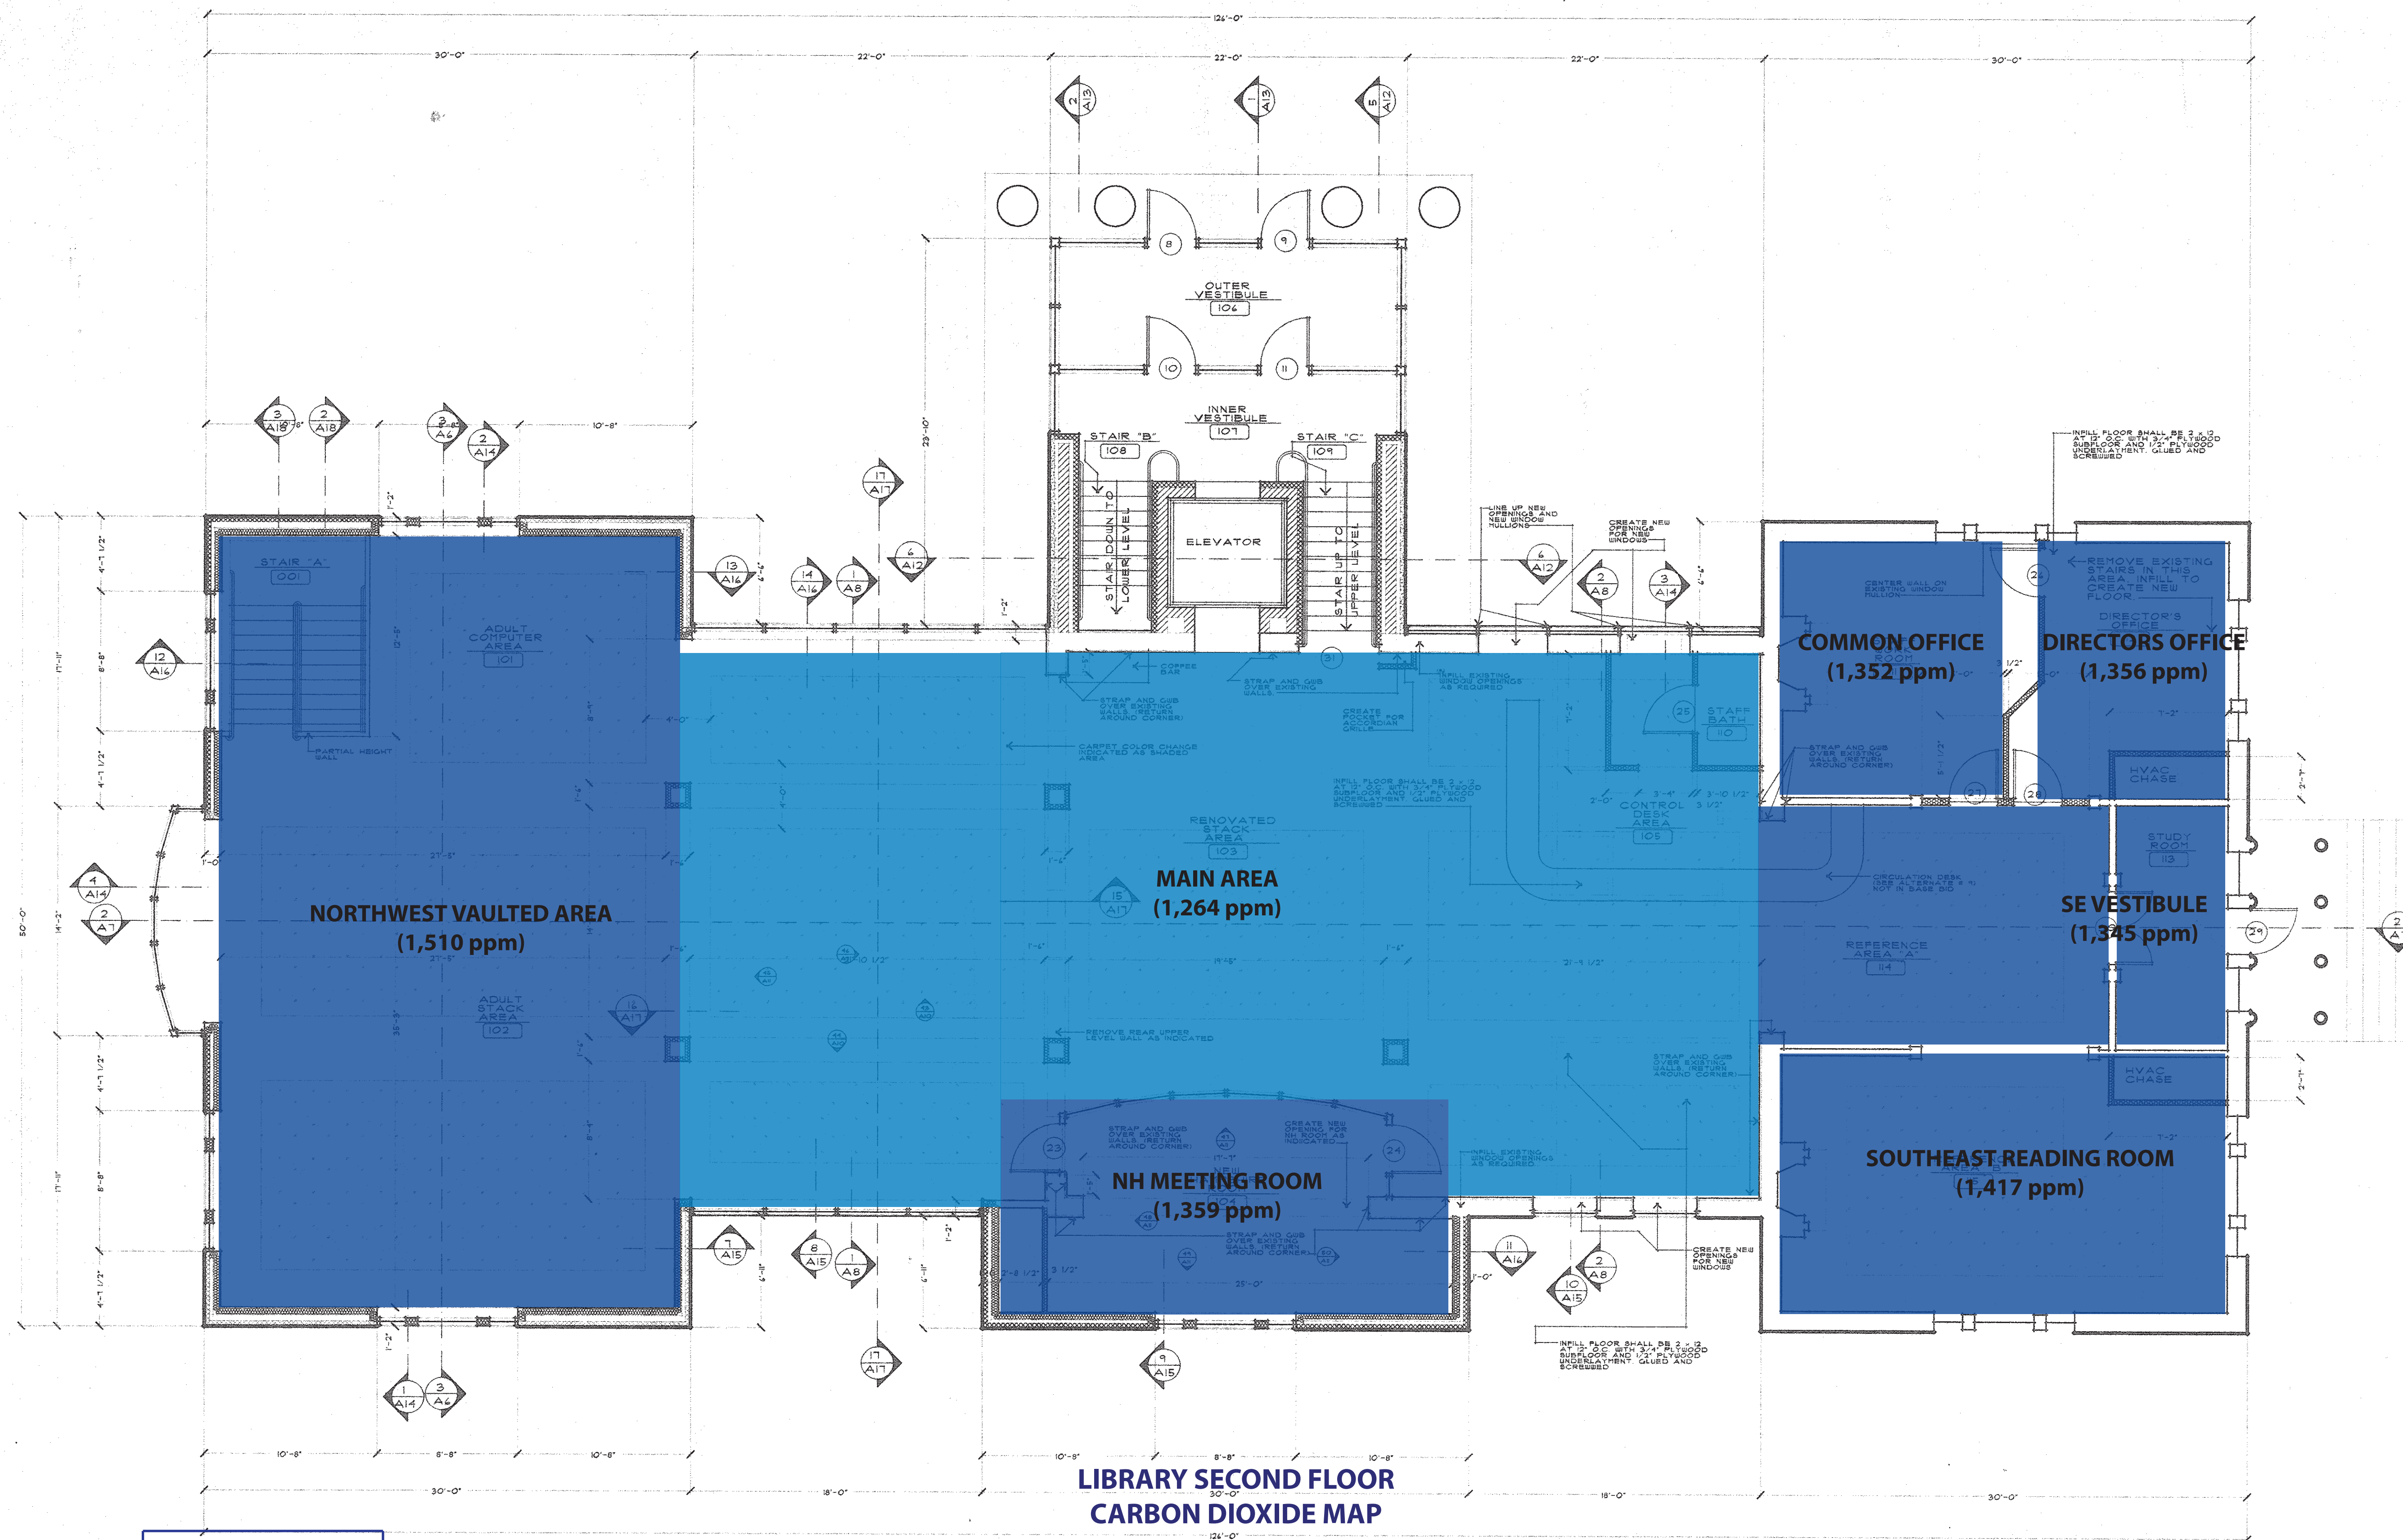
**FIGURE 3**

Based on the measured carbon dioxide (CO<sup>2</sup>) concentrations in the library, the existing ventilation is inadequate for the building. The EPA recommended threshold for CO<sup>2</sup> is 1,000 parts per million (ppm) and of thirteen measurements throughout the lower and upper level occupied areas the concentration ranged from 1,137 ppm to 1,510 ppm with an average concentration of 1,296 ppm (Exhibits C and D). Based on these results, design of a new ventilation system is recommended – this should be considered as part of a new HVAC system design 🚩.

**Carbon Dioxide Data Map**

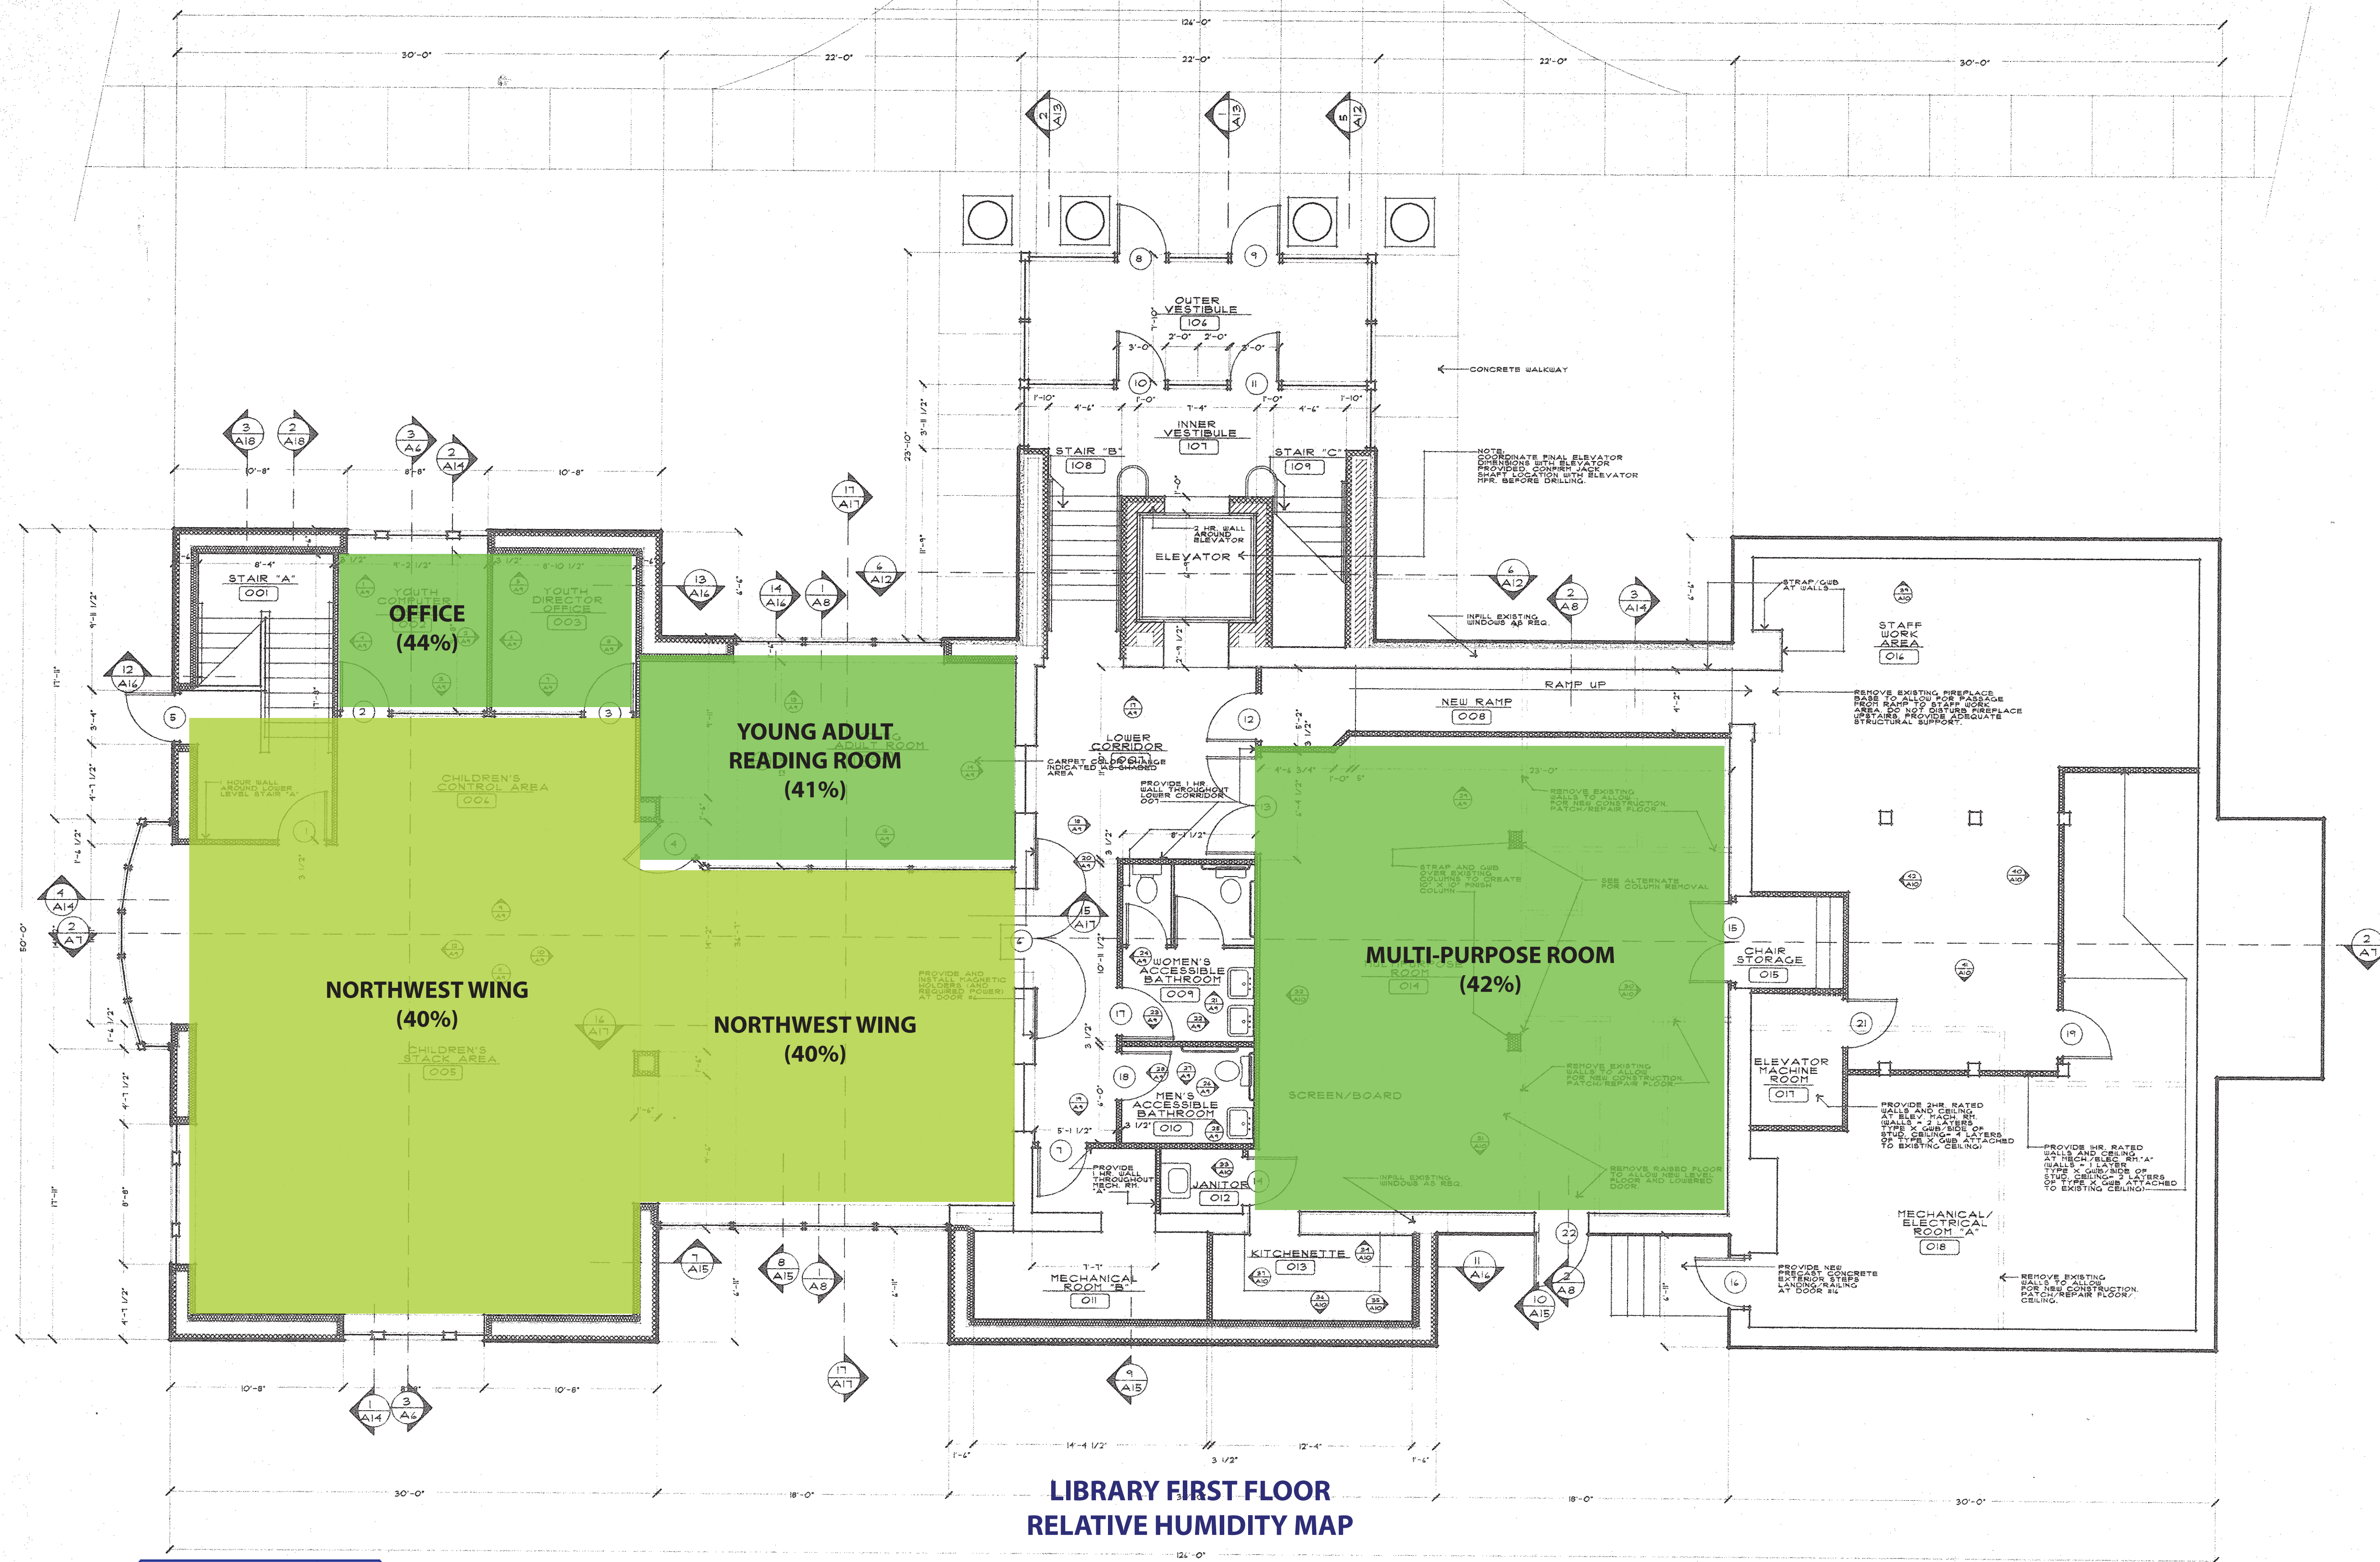
**FIGURE 4**

Measured relative humidity (RH) levels in the library indicate that humidity is within the recommended range per ASHRAE (25% to 60%). Recorded levels in the conditioned spaces of the library varied from 40% to 44% with an average level of 42% (Figure 4 and Exhibit E). It should be noted that the humidity measurements represent a single-point in time and that humidity will change based on meteorological conditions, building loading, and HVAC system operation. RH levels should be routinely measured and following any HVAC system modifications or improvements, ideally during peak heating and cooling periods 🔺. Proper humidity control is critical in libraries where historical documents may be stored and to ensure occupant comfort.

**Relative Humidity Data Map**

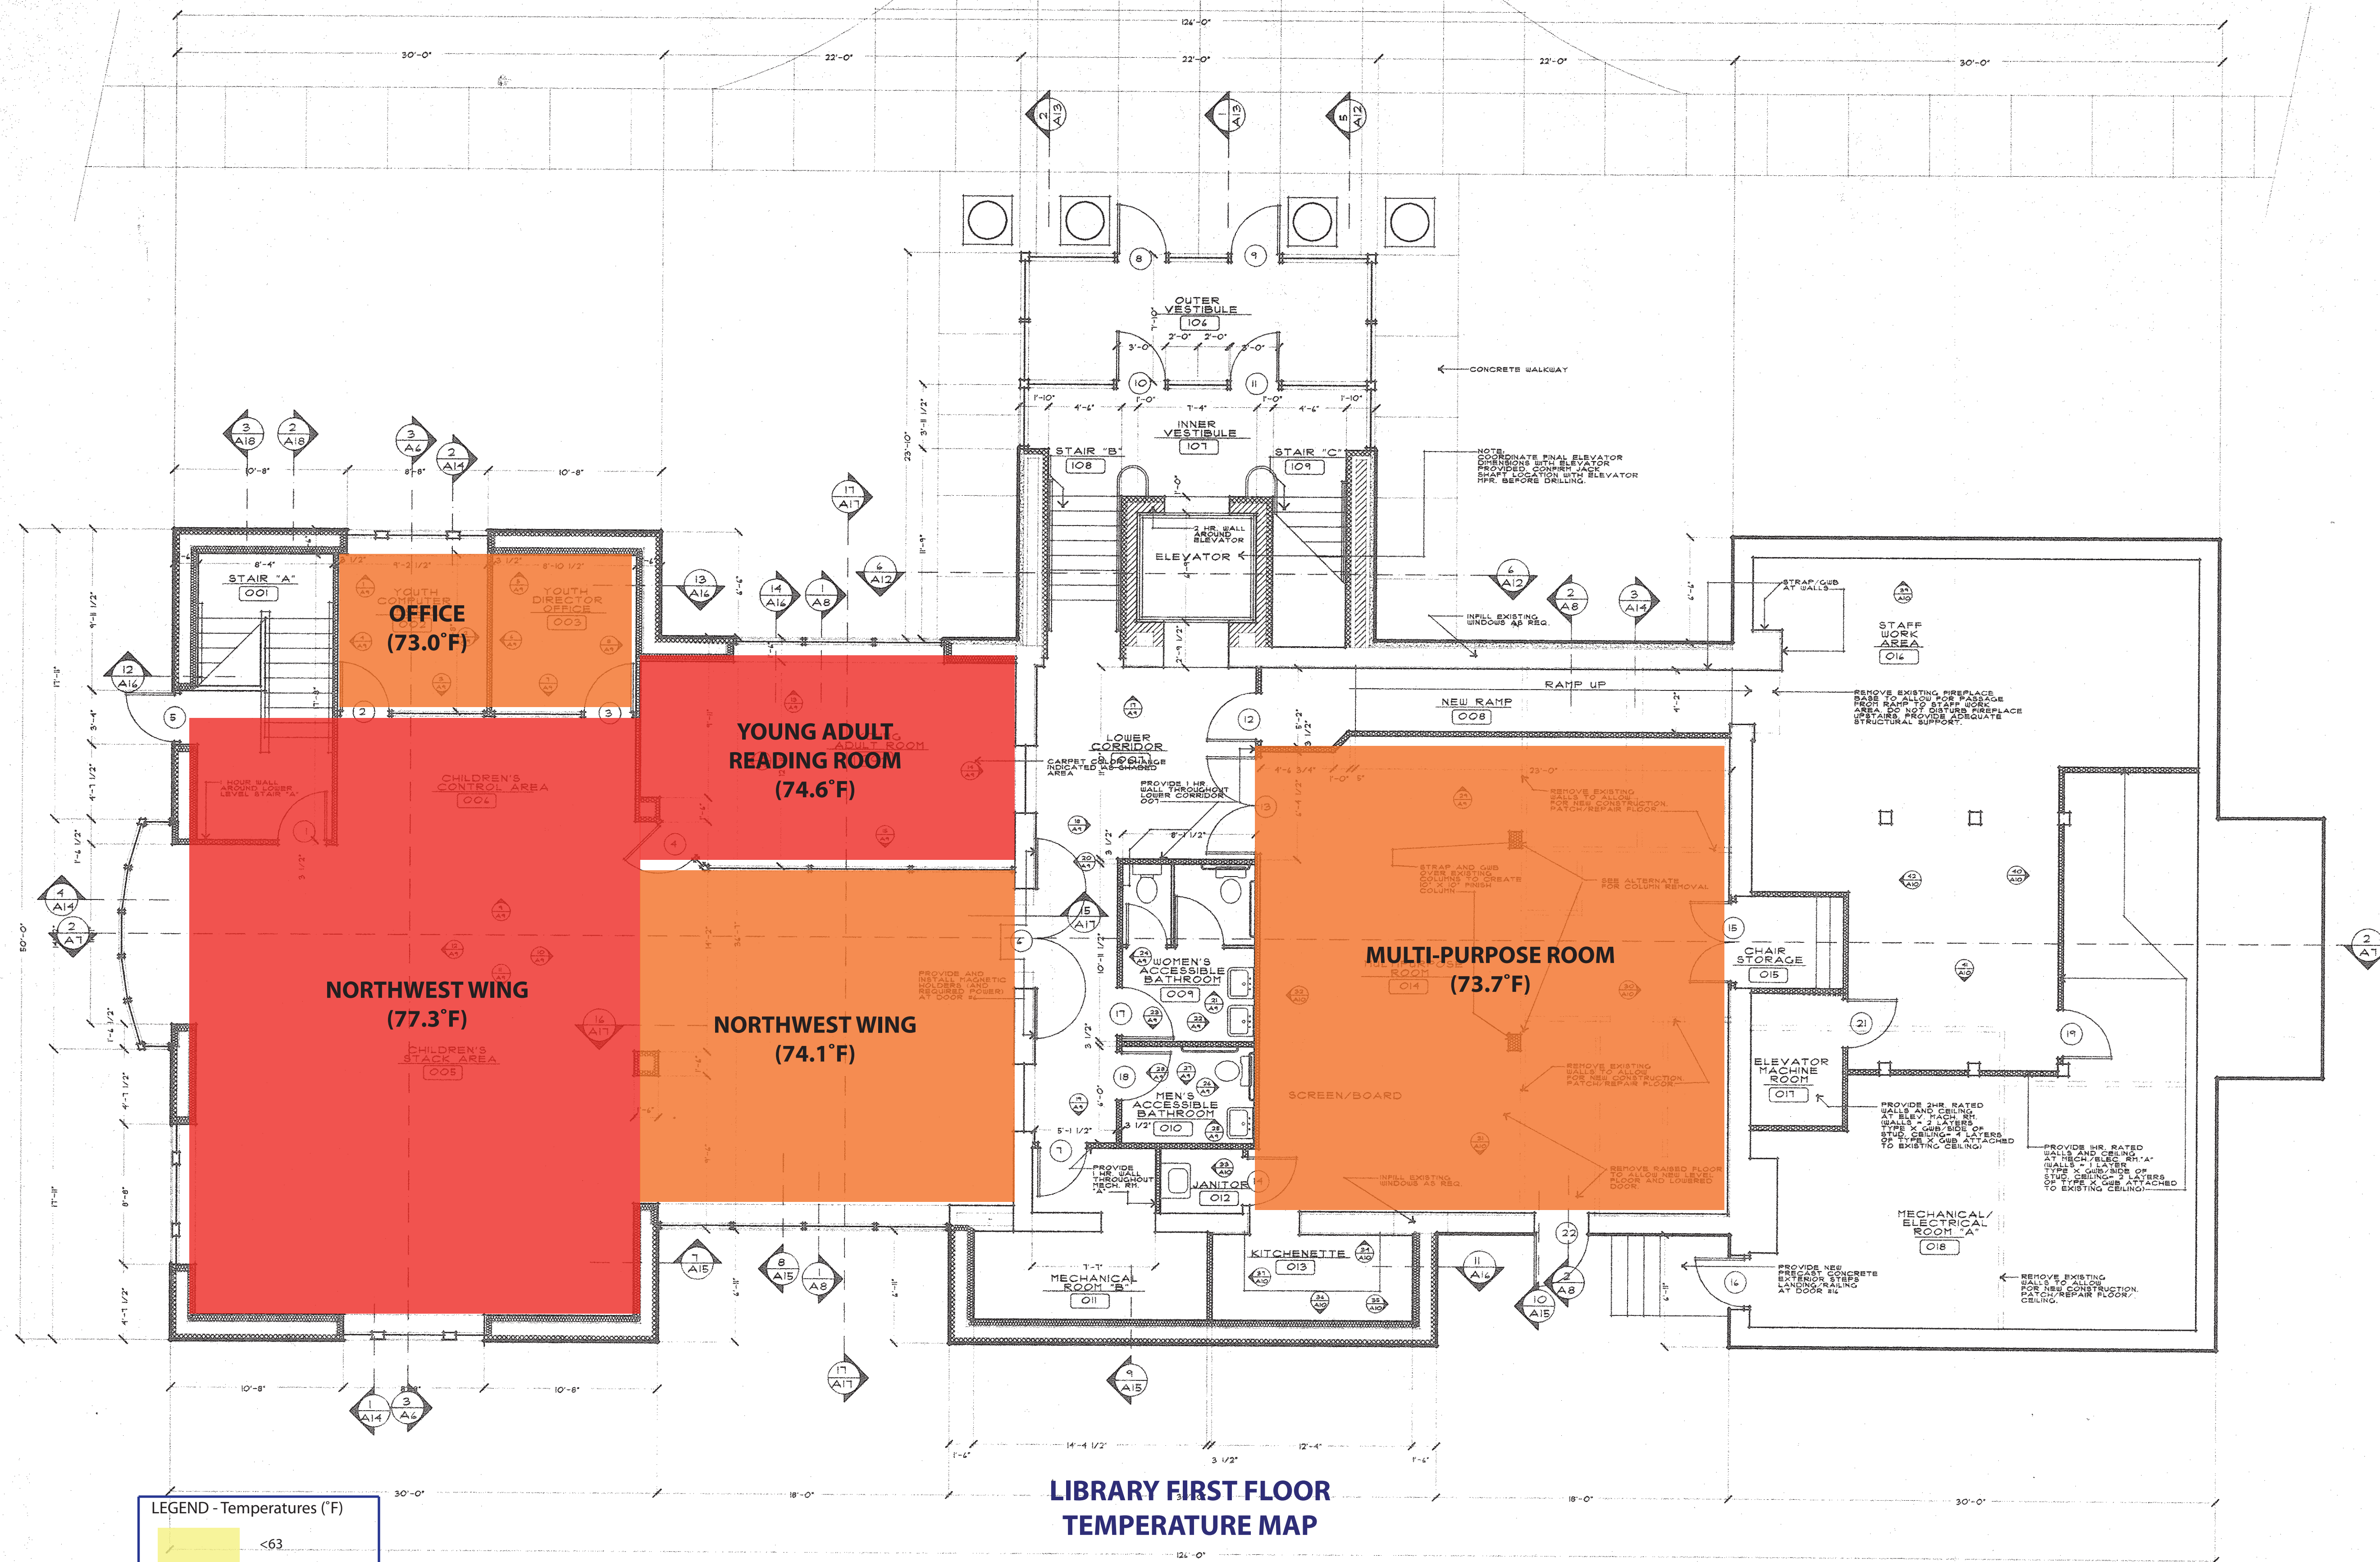
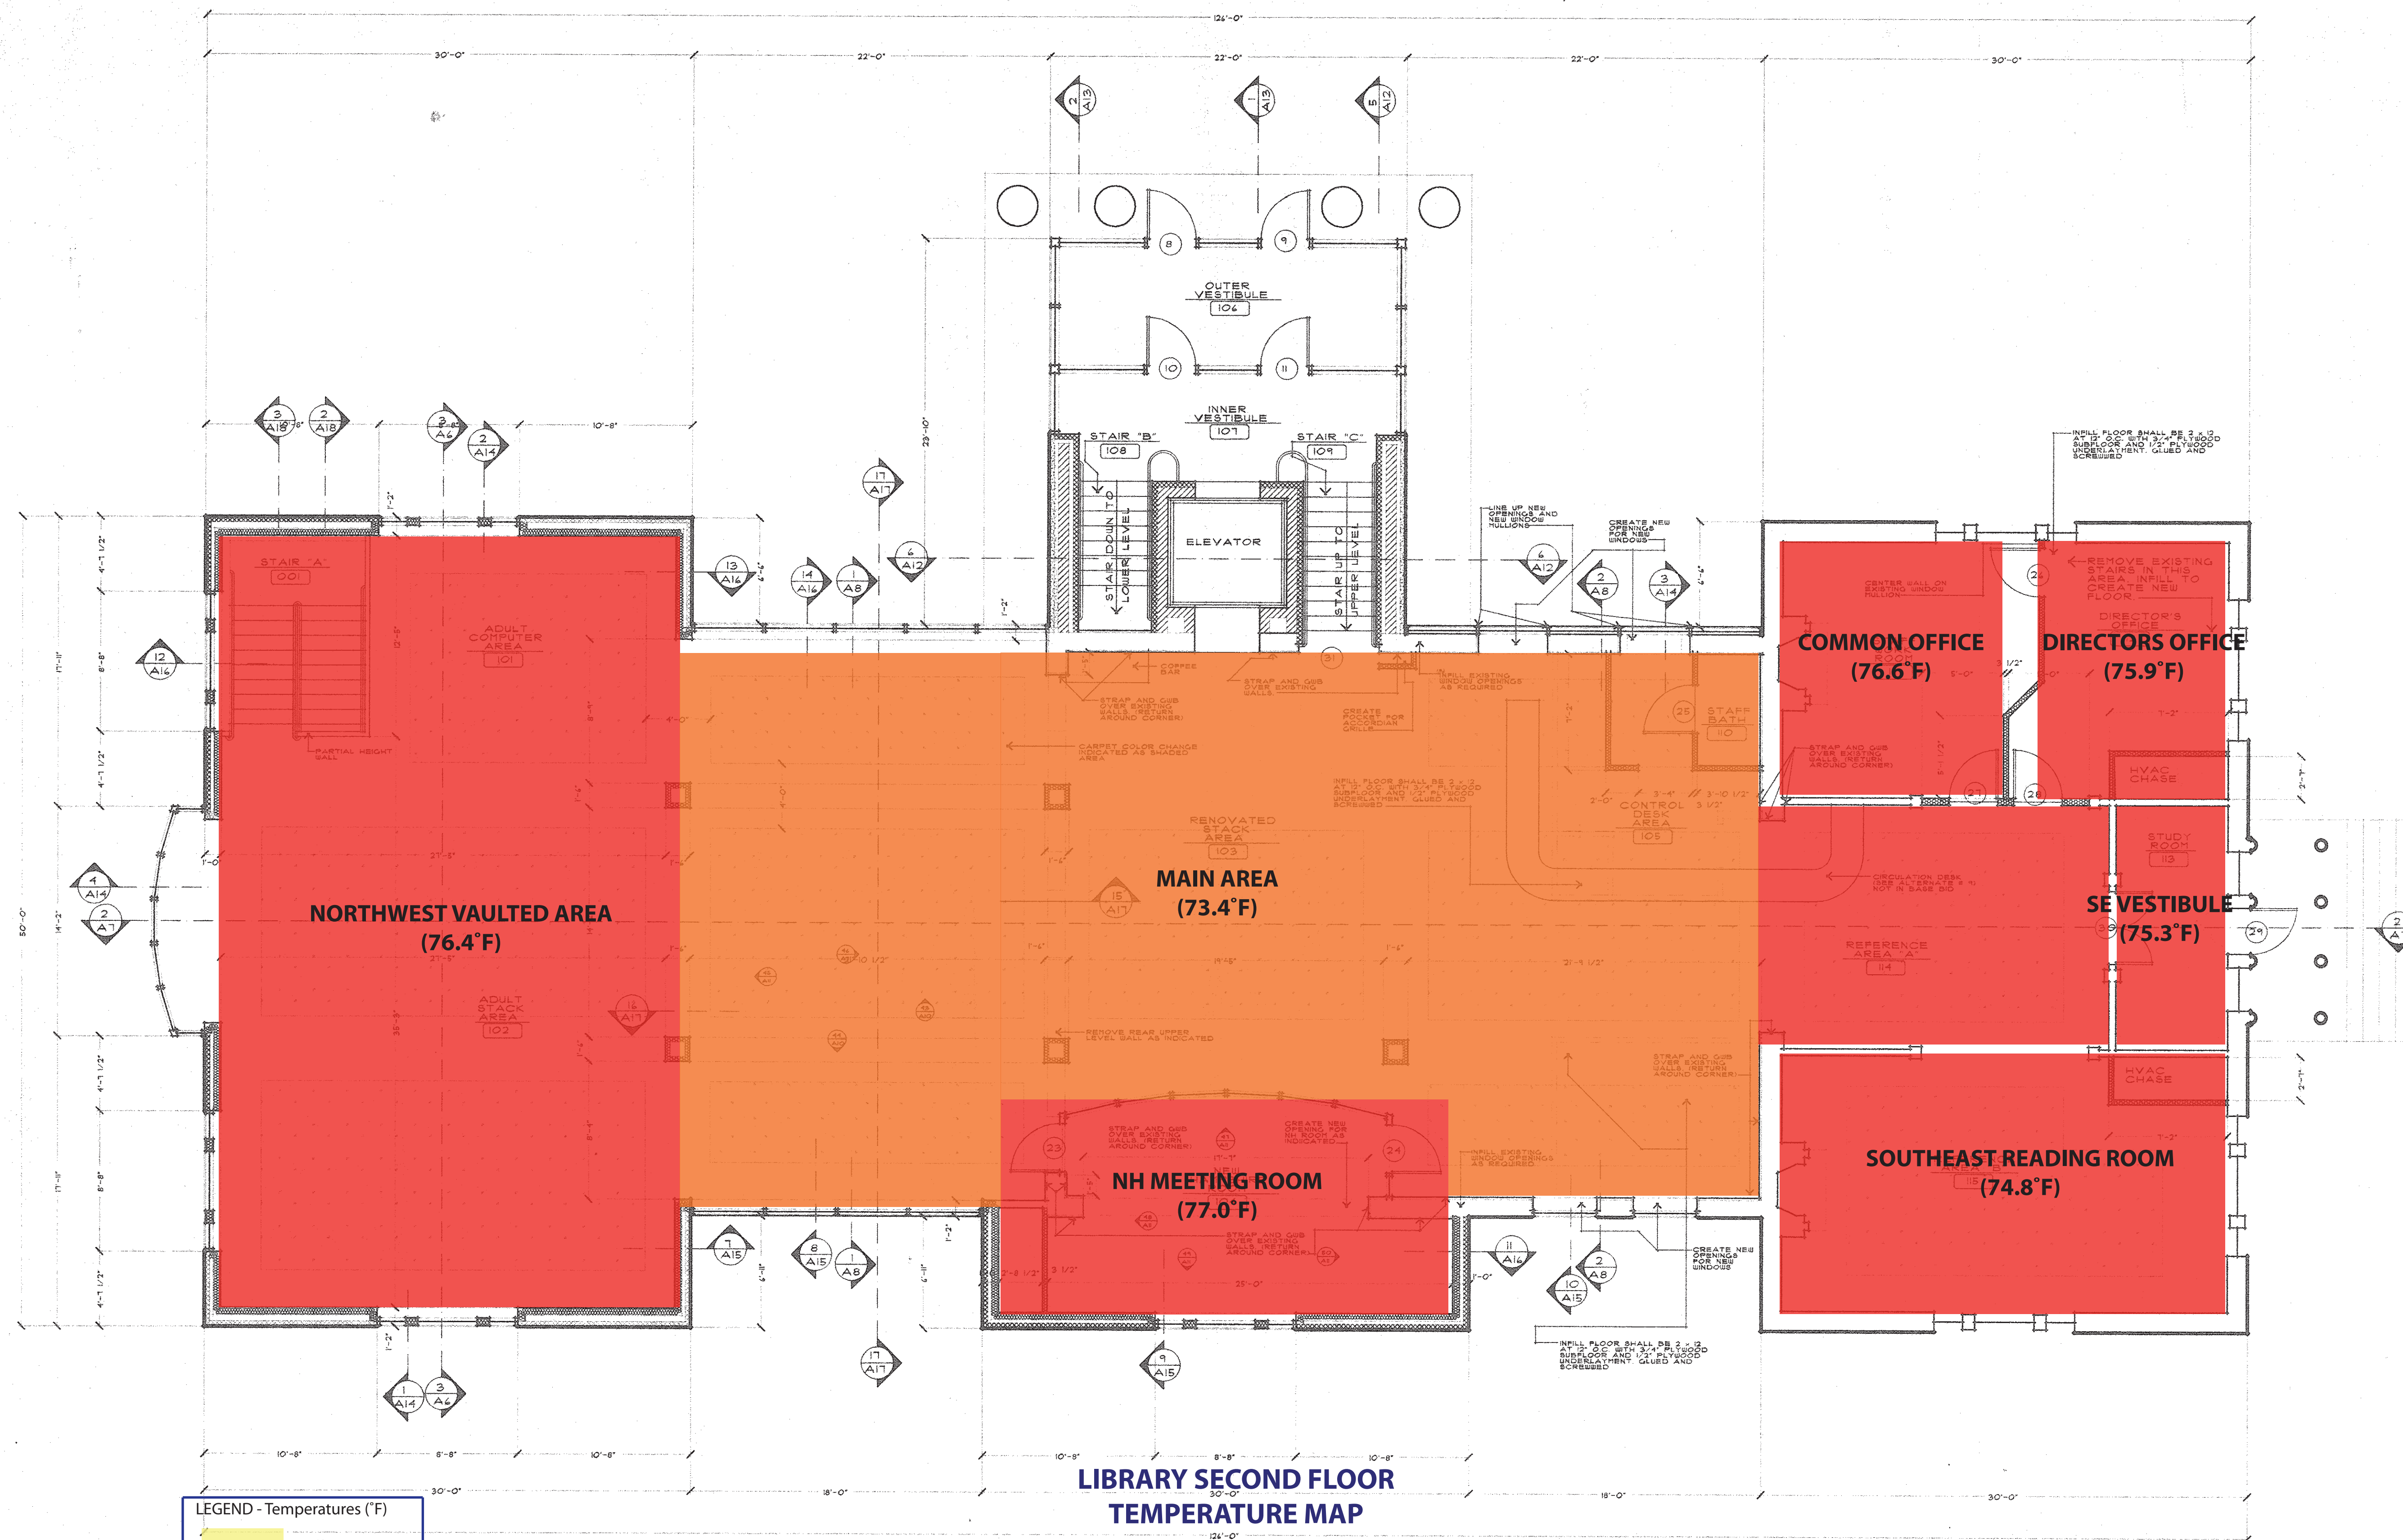
**FIGURE 5**  
**Temperature Data Map**

Recorded temperatures in the conditioned areas of the library ranged from 73°F to 77°F with an average reading of 75°F. It is noted that the temperatures are elevated due increased thermostat settings on the previous night to provide a better assessment of the system operation and envelope performance. The deviation in temperature suggests that heating distribution throughout the conditioned spaces is not balanced. This is partly a result of the inoperable furnace unit supplying the lower northwest wing.

Target Temperature Range = 67 - 70
