Building Performance Evaluation and Sustainability Assessment

Rye Town Hall

Rye, New Hampshire

June 2009

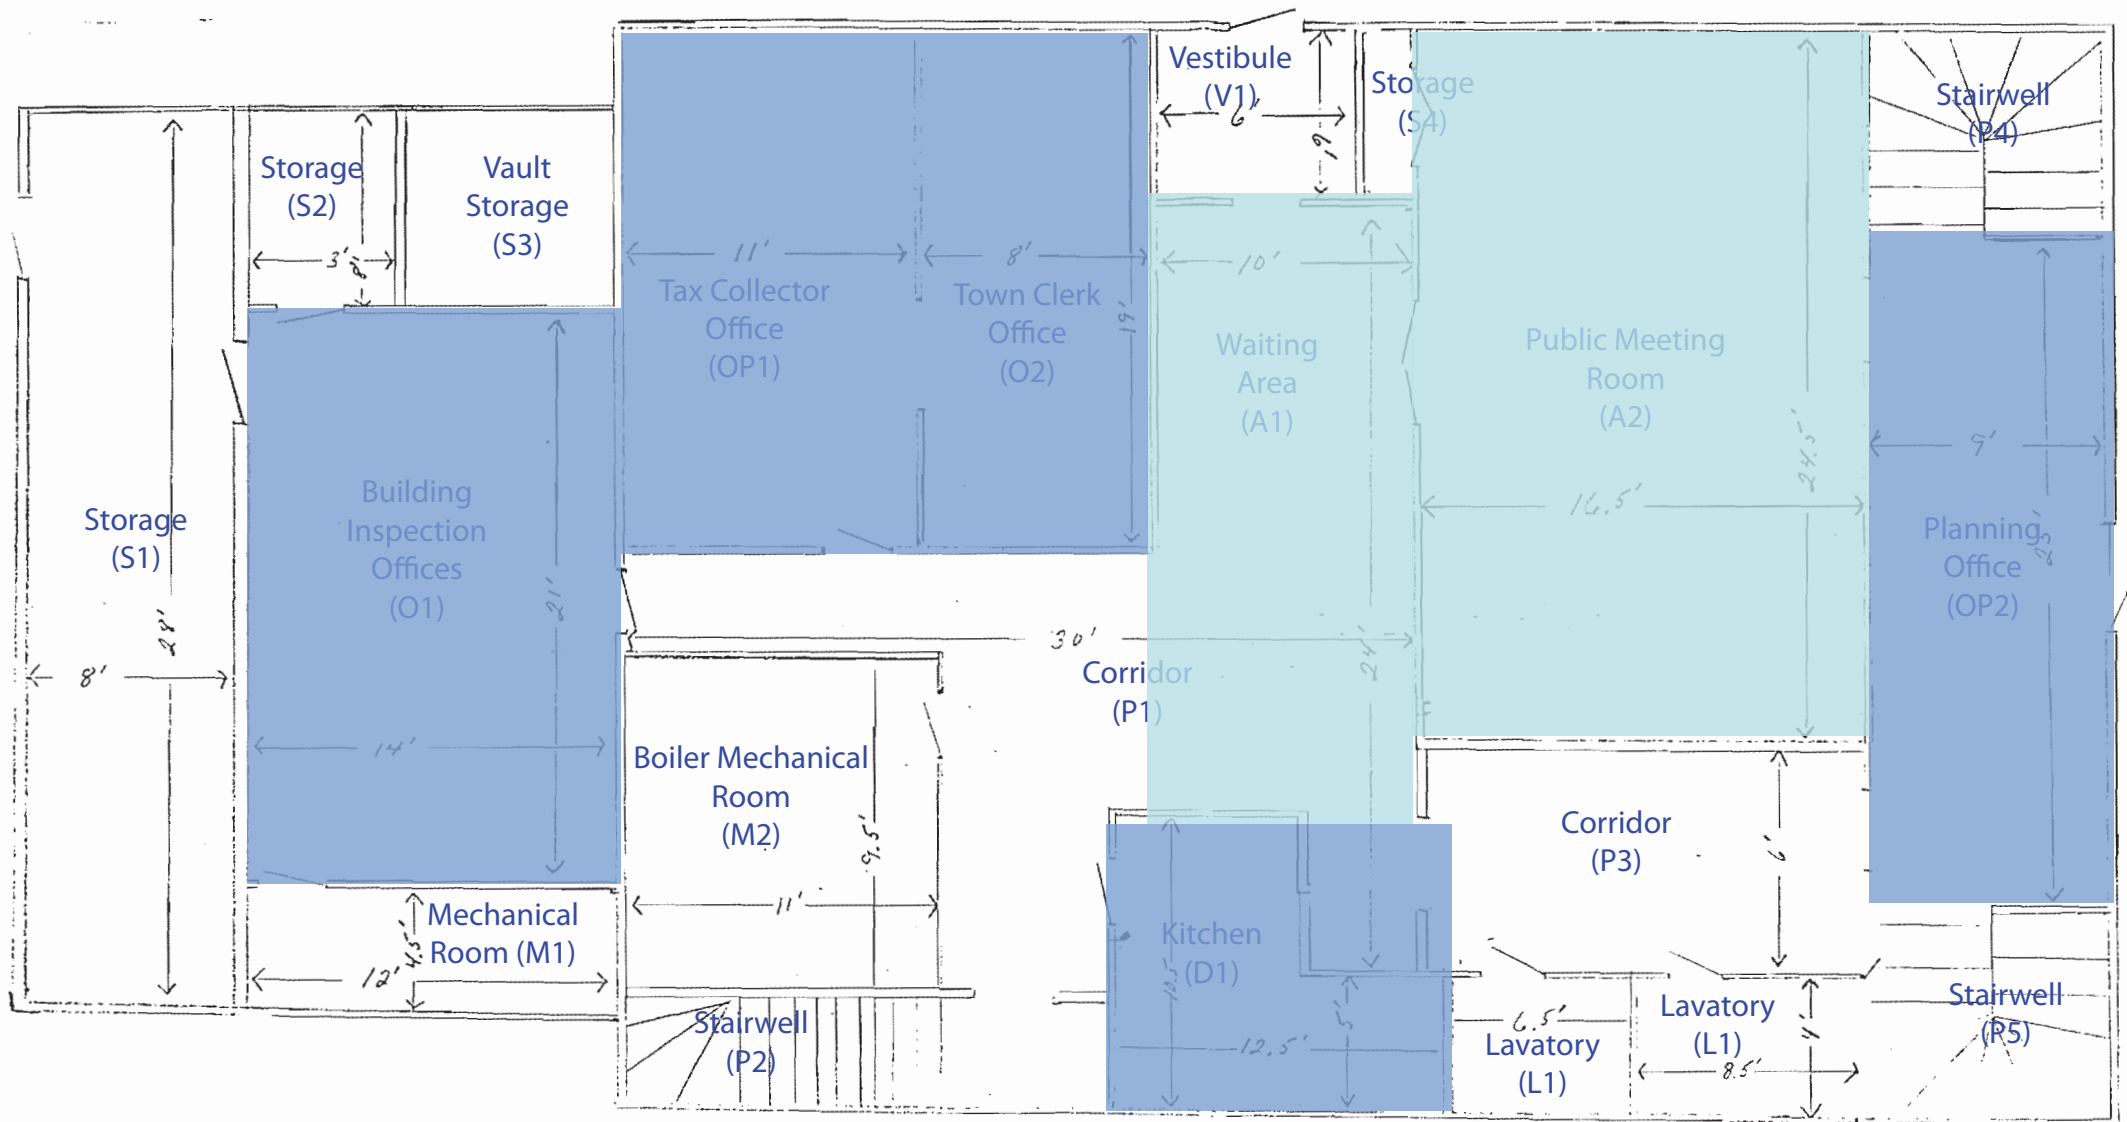
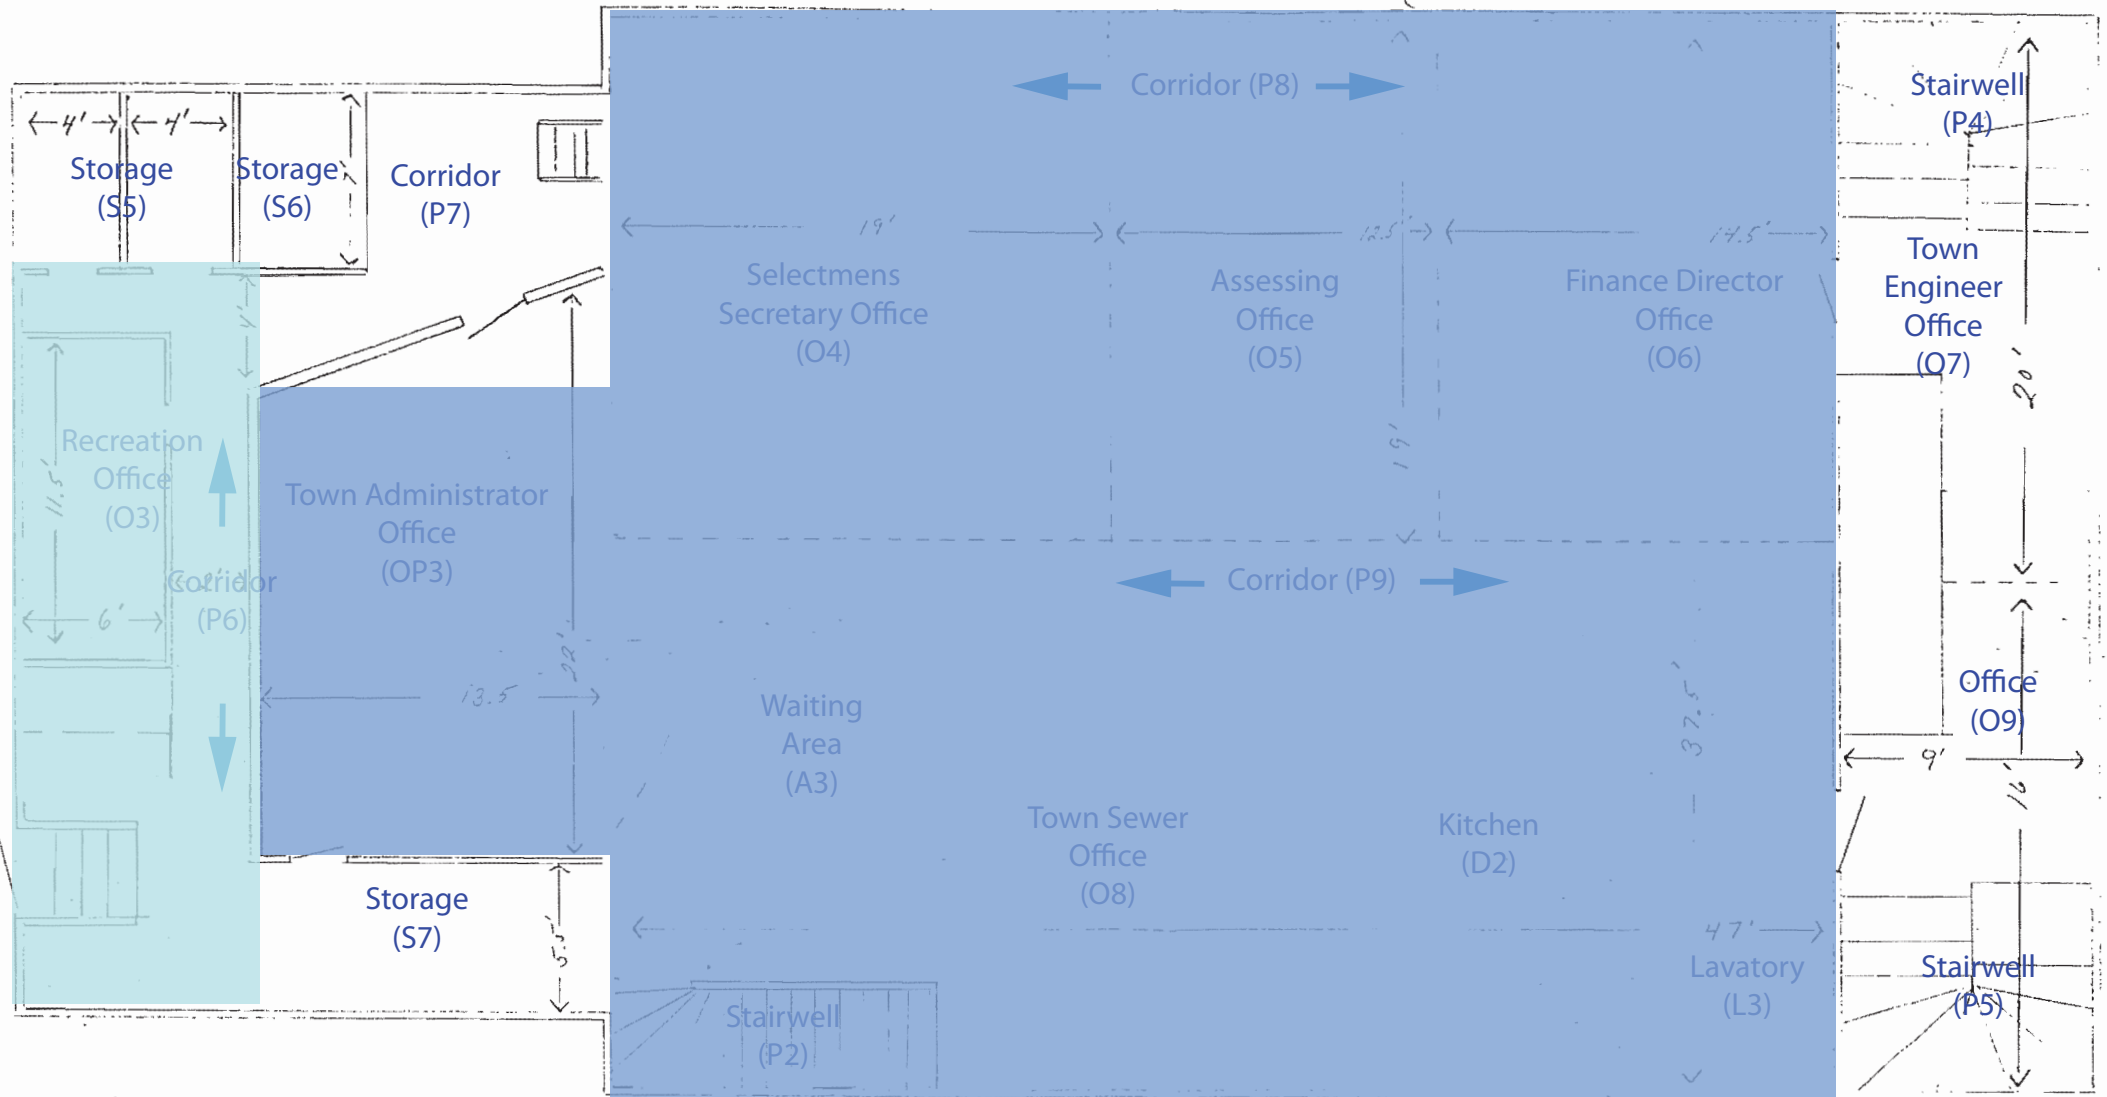
Carbon Dioxide Data Maps

On June 3rd, carbon dioxide (CO₂) concentrations were measured in the Town Hall conditioned spaces. The EPA recommended threshold for CO₂ is 1,000 parts per million (ppm) and of thirteen measurements throughout the lower and upper level occupied areas, concentrations ranged from 525 ppm to 973 ppm with an average concentration of 764 ppm (Exhibits C and D). The elevated concentrations were measured at the vaulted ceiling in the second floor open office. Based on these results, design of a new ventilation system is recommended – this should be considered as part of a new HVAC system design. It is noted that the data represents a single point in time and concentrations will vary based on atmospheric conditions, HVAC system operation, and occupant loading. Ideally, several measurements will be taken during peak heating and cooling periods.

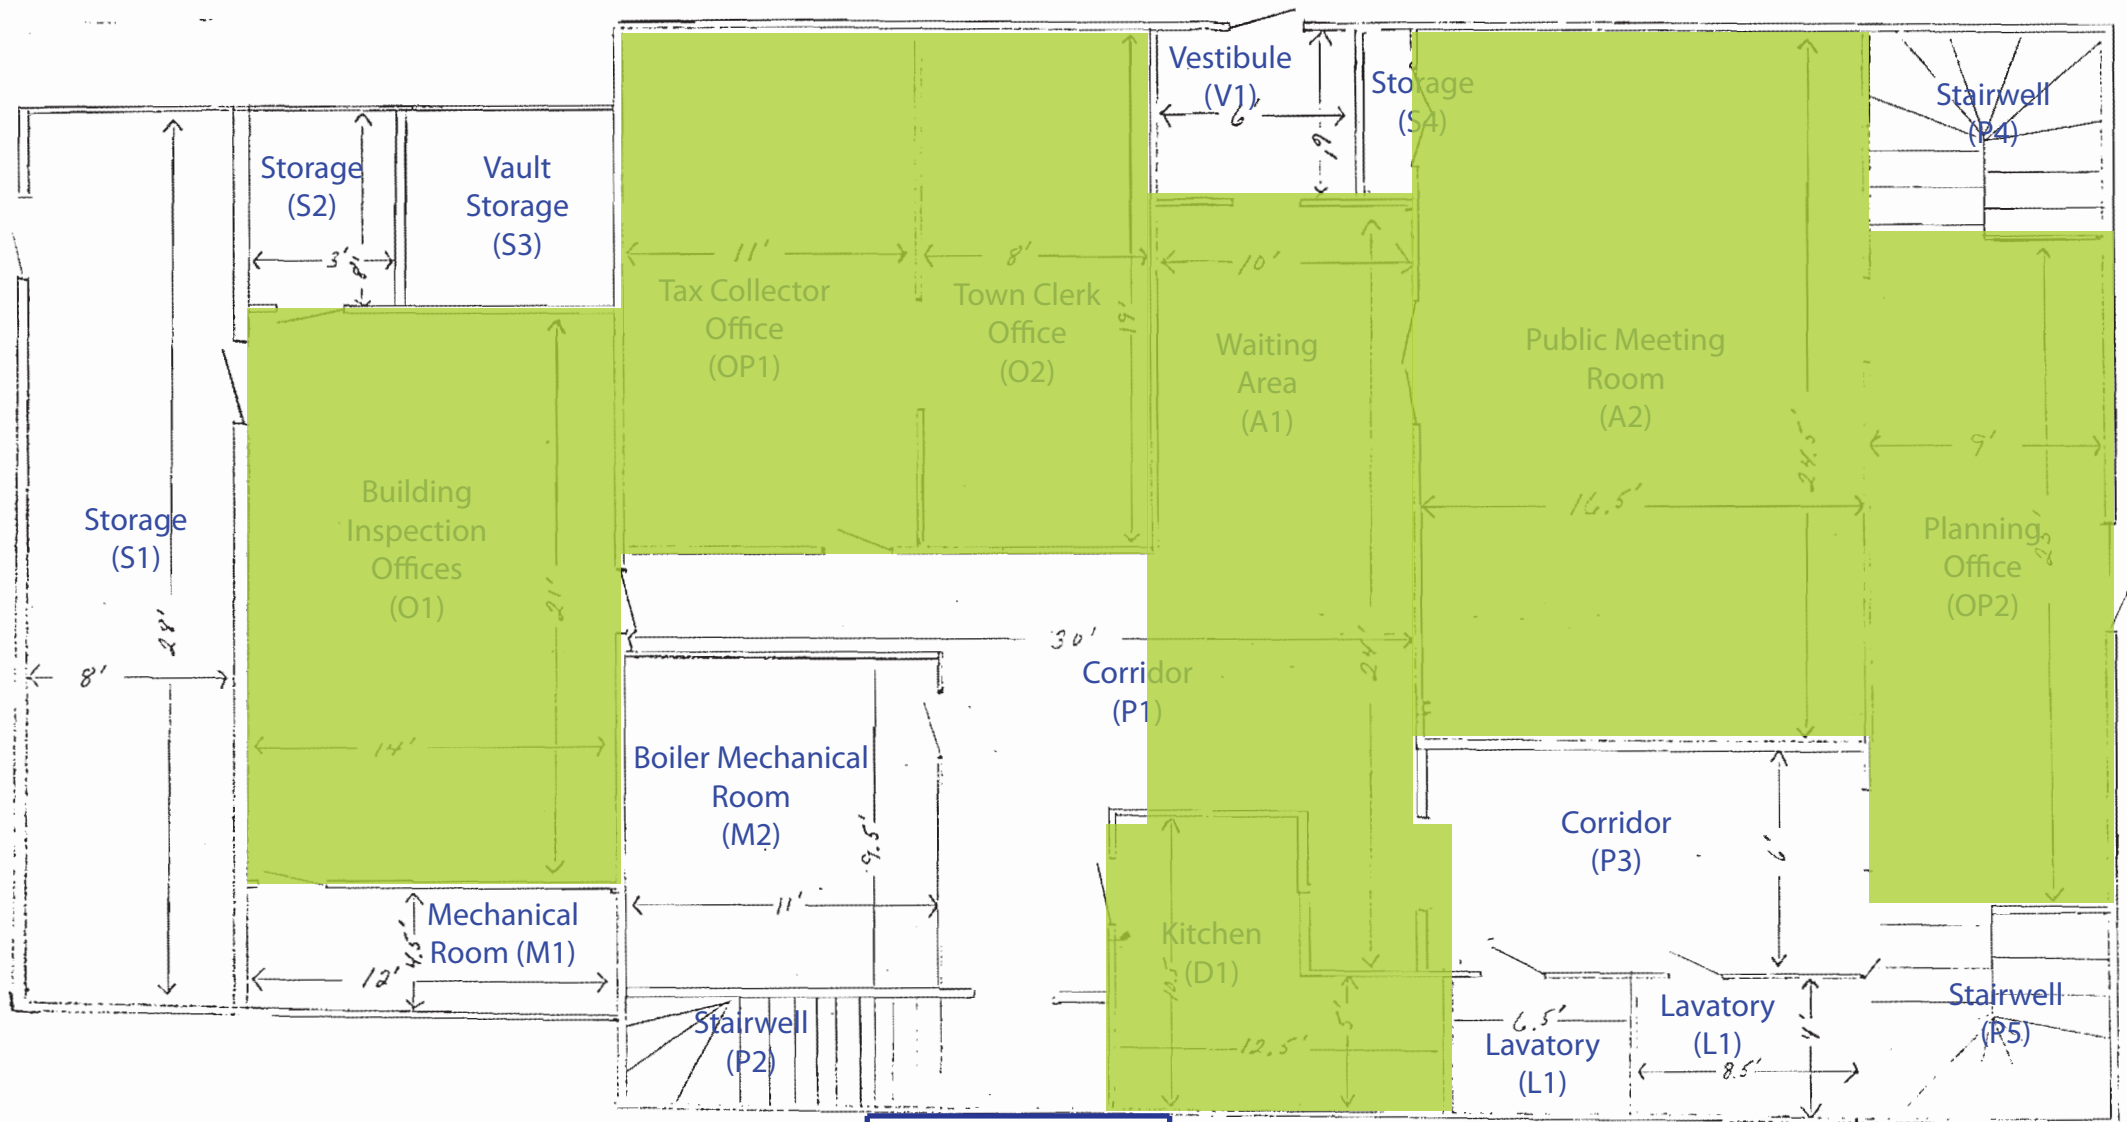
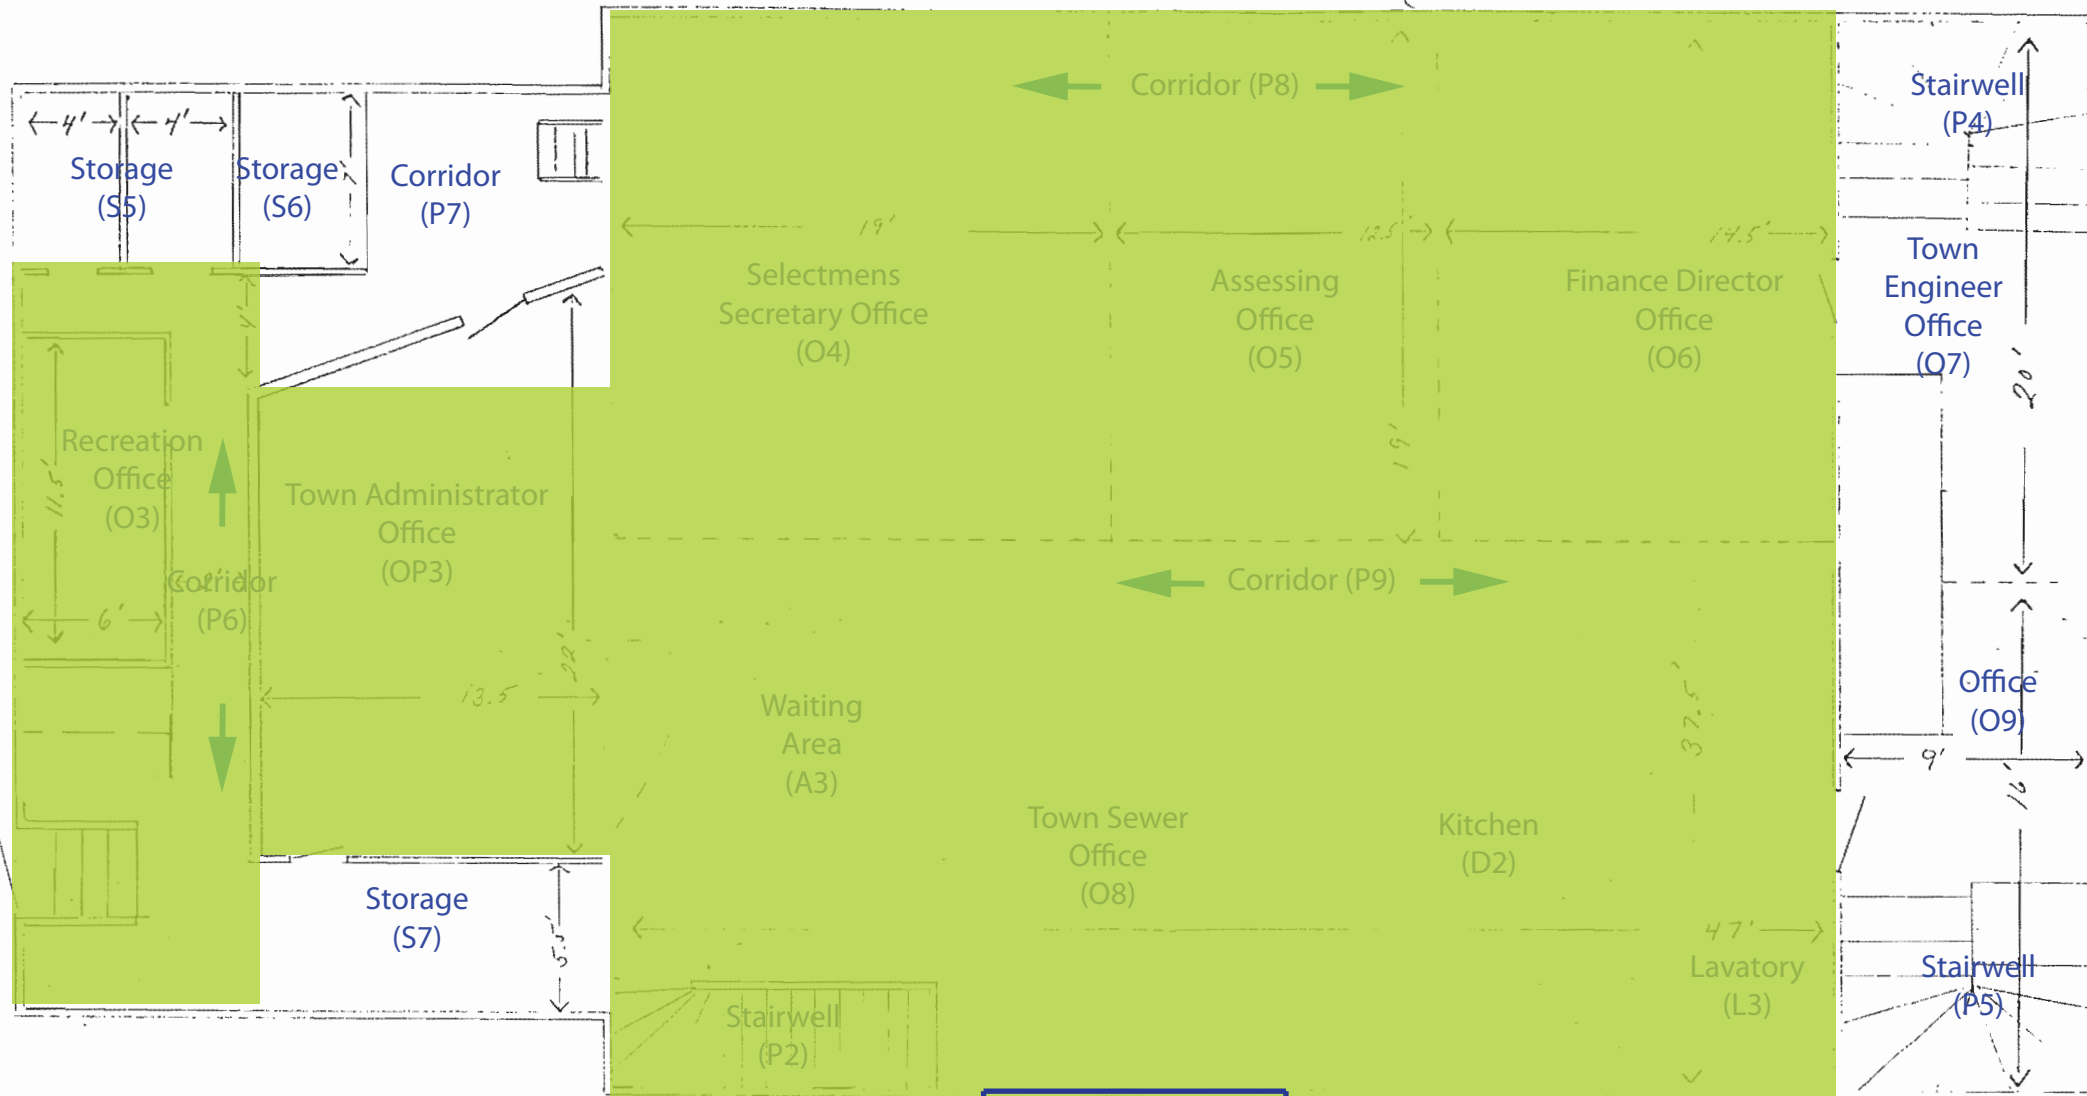
Relative Humidity Data Maps

Measured relative humidity (RH) levels in the Town Hall indicate that humidity is within the recommended range per ASHRAE (25% to 60%). On June 3rd the ambient humidity was 60% and the recorded levels in the conditioned spaces of the Town Hall varied from 30% to 40% with an average value of 36% (Figure 4 and Exhibit E). It should be noted that the humidity measurements represent a single-point in time and that humidity will change based on meteorological conditions, building loading, and HVAC system operation. RH levels should be routinely measured and following any HVAC system modifications or improvements, ideally during peak heating and cooling periods.

Proper humidity control is important in older buildings to prevent moisture accumulation and to ensure occupant comfort. Currently there are no humidification systems in the Town Hall. It is recommended that a humidification system be integrated into the design of a new heating and cooling system for the building.

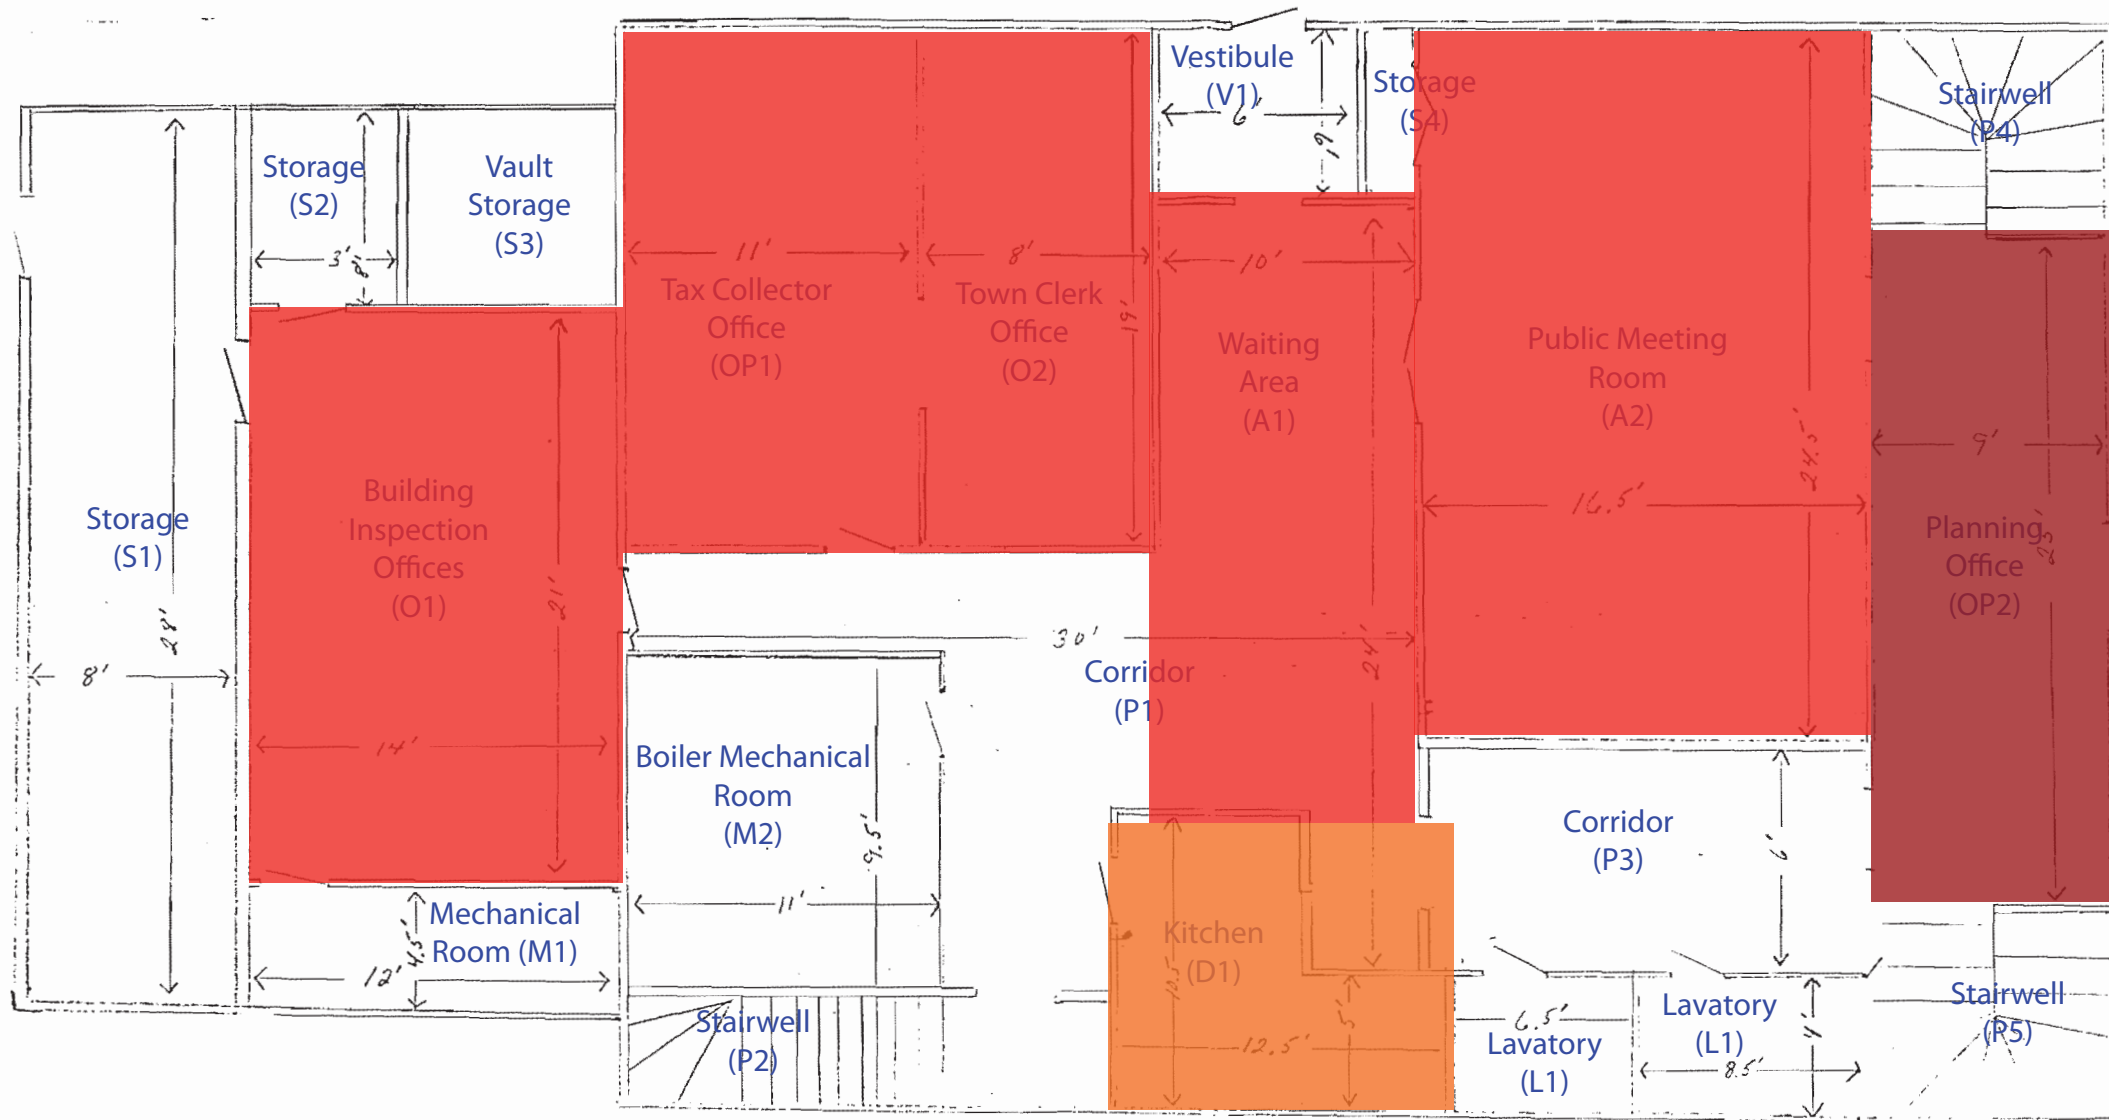
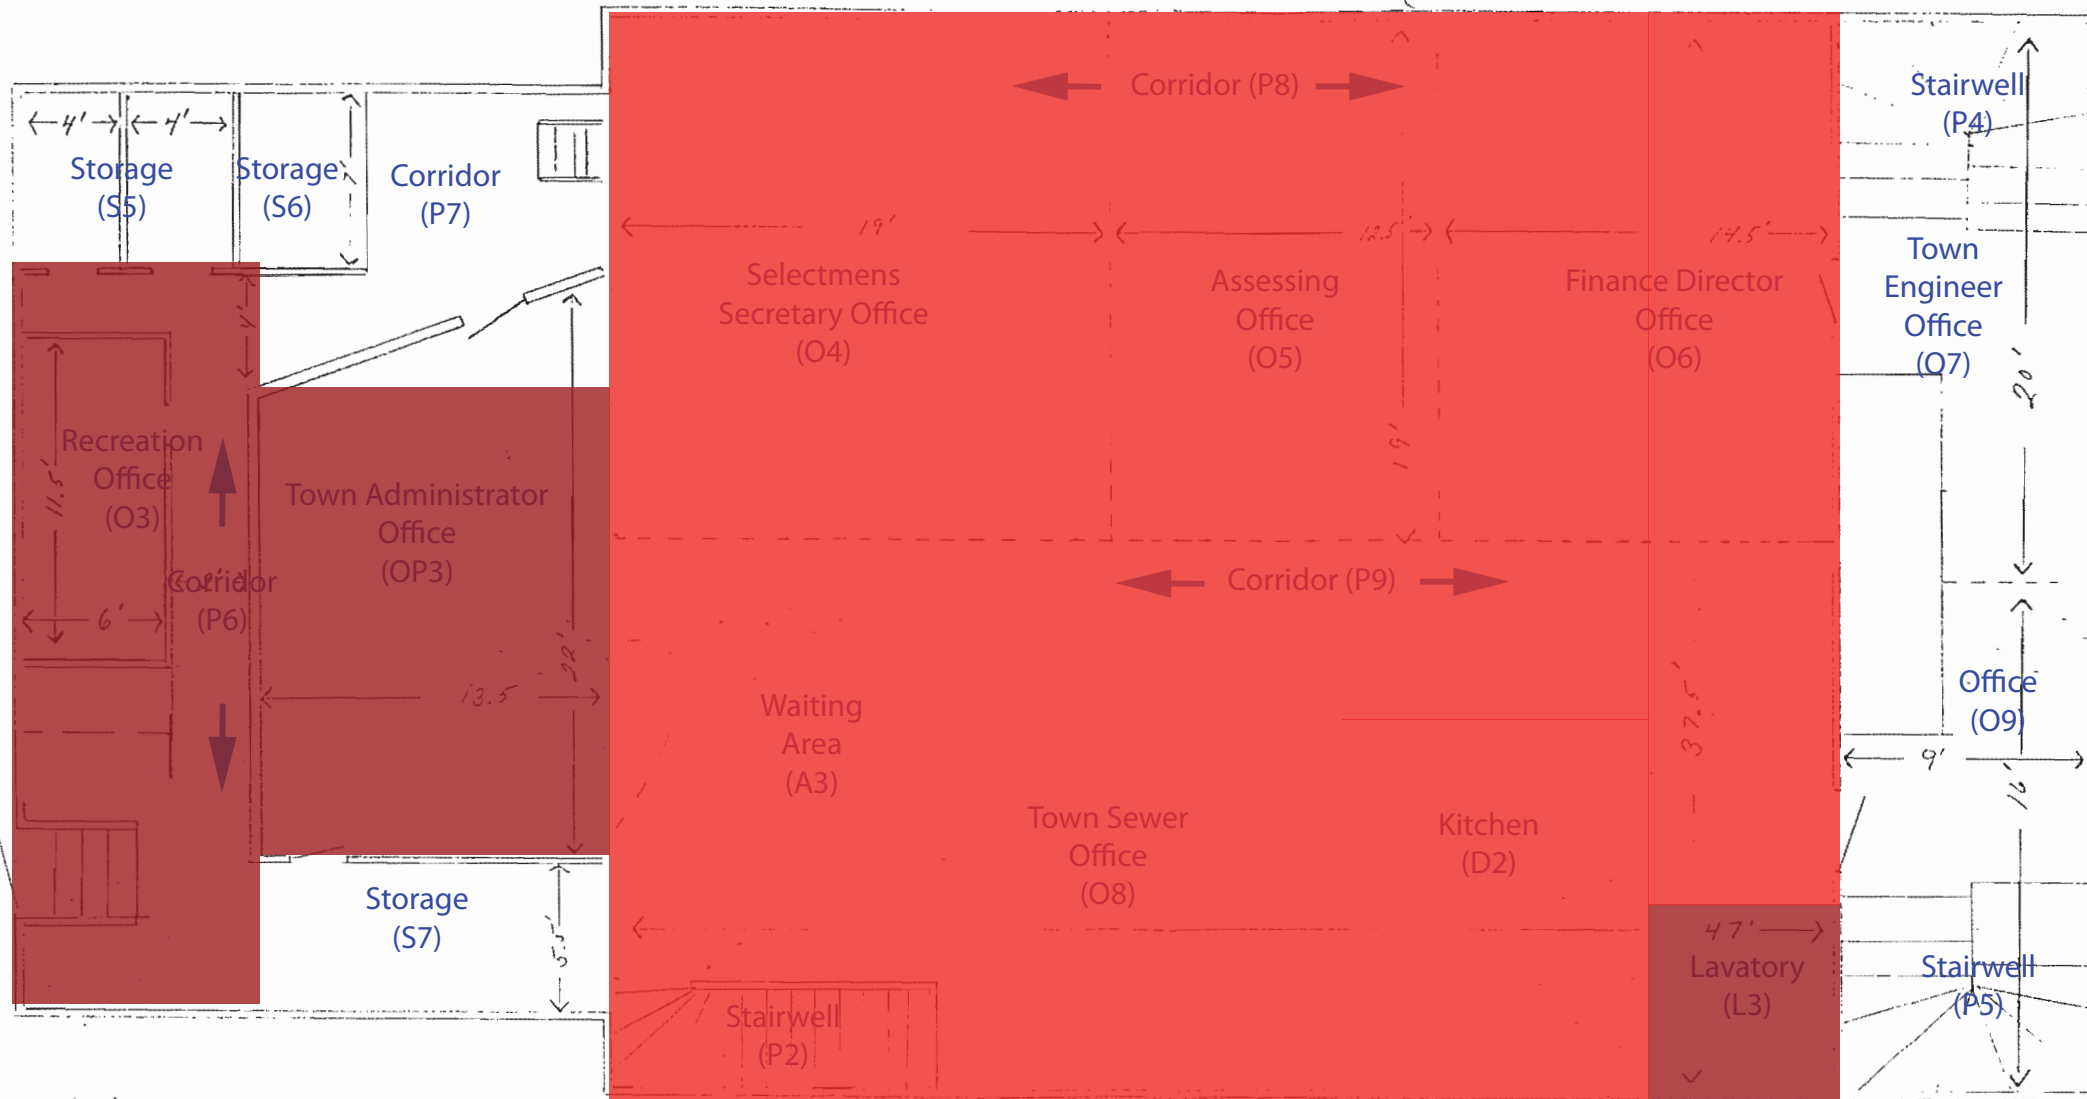
FIGURE 6
Temperature Data Maps

On June 3rd, 2009, a temperature survey of the Town Hall conditioned spaces was completed. Ambient conditions included an outdoor temperature of 65°F, relative humidity of 60%, and clear skies. The overnight low temperature was approximately 52°F and the heating system did operate during the overnight hours. All recorded temperatures in the conditioned areas of the Town Hall exceeded recommended setpoint temperatures (67-69°F) and ranged from 73°F to 82°F with an average reading of 77°F. Highest temperatures were recorded in the second floor recreation office, Town Administrator Office, and the first floor Planning Office. The lowest temperatures were recorded in the first floor offices east of the meeting room. The deviation in temperature suggests that heating distribution throughout the conditioned spaces is not balanced – this is consistent with information provided by occupants throughout the building. Additionally, portable space heating units were observed in some office areas which are indicative of an inefficient heating distribution system.

Because the building wall cavities are not insulated and the air leakage rate is high, a substantial amount of heat is lost through the building envelope thereby diminishing the heating capacity of the system. It is estimated that 20% to 30% of generated heat is lost to unconditioned spaces and through the building envelope.
