Energy Audit, Level 3

9 November, 2011

Prepared For: Town of Rye

Property Address: **10 Central Street
Rye, New Hampshire 03870**

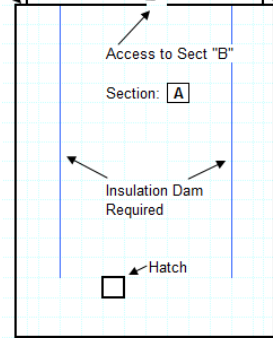
<p>Comments: This attic section is insulated with approximately 12" of blown fiberglass insulation. The ceiling assembly for this section is comprised of a metal ceiling installed over a plaster and lathe ceiling. Currently the old plaster is the primary air barrier and is failing with many gaps and defects observed. It is recommended that the blown fiberglass be removed and a 1" flash spray installed directly over the lathe to create a new air barrier. Once this is accomplished the original blown fiberglass can be re-used and capped with an additional 4" of cellulose insulation to bring the total R value of the assembly to R50+. The perimeter of this attic section slopes down to the walls. An insulation dam would be required approximately 4' inside of the perimeter to allow the flat ceiling area to maintain a full 16" insulation depth. Additional insulation would be required for the sloped sections to ensure the entire sloped section maintains adequate insulation depth. It is also highly recommended that a "catwalk" be built approximately 17" above the level of the lathe and plaster to allow adequate access from the existing hatch to the opposite end of the attic without having to walk through the new insulation. The attic hatch is not insulated. It is recommended that this hatch be rebuilt to include a full height insulation dam, weather-stripped and insulated to R40.</p>

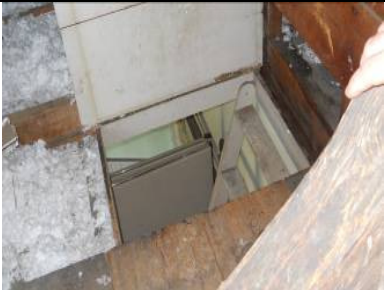
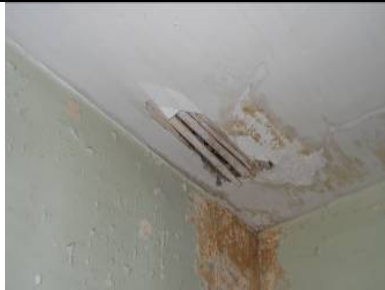
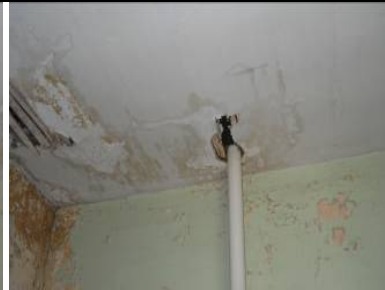
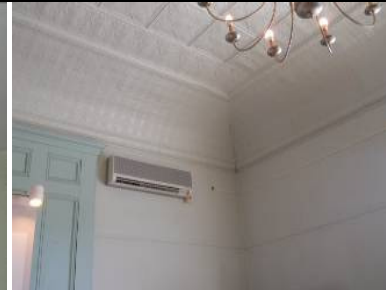
Hatch								Lathe & Plaster Ceiling			
								Metal Ceiling Under			
								Insulation Dam Required

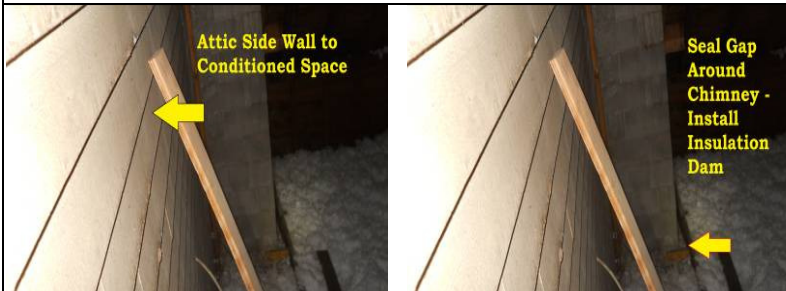
Comments: This attic section is insulated with 12" of blown fiberglass. However the primary air barrier is the tongue and groove wood ceiling. It was assessed via blower door testing that there is excessive air exfiltration through the tongue and groove ceiling assembly and through the fiberglass insulation. The same recommendations are made as was made for Section "A", remove the blown fiberglass to one side of the attic and overspray the attic side of the tongue and groove ceiling with a 1" flash spray of closed cell spray foam to create an adequate air barrier. Once this is accomplished the fiberglass insulation can be re-installed and capped with 4" of cellulose insulation to bring the entire assembly to R50. There is a chimney located in the Northwest corner. Any gap between the chimney and the framing should be sealed with code approved methods and an insulation dam built around the chimney to maintain code required free air space requirements around the chimney. The West wall of this attic is a wall to conditioned space. This wall is not insulated. It is recommended that cellulose insulation be dense packed into this wall assembly from that attic side. It may be possible to insulate this wall assembly from the associated open top plates. 2" XPS rigid insulation can then be installed over the assembly to add R10 continuous insulation. All seams of the rigid insulation should be taped and the perimeter sealed. An alternative to using 2" XPS rigid insulation would be to use 2" of closed cell insulation applied directly to the attic side wall after it is dense packed with cellulose.

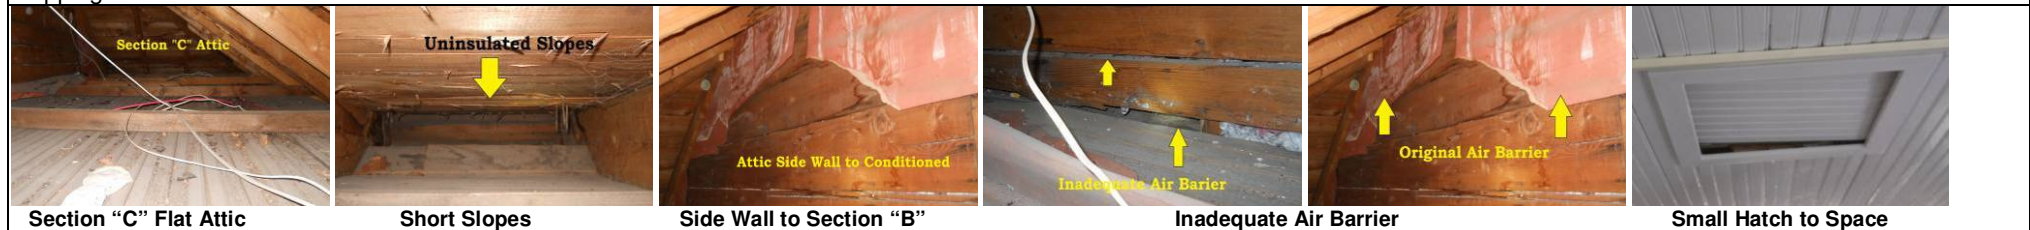
Comments: This attic space was found uninsulated. Occupants report water leaks from this attic section. Interview with workers that utilize this space stated that most of the water leaks seemed to occur during the winter months. It is possible that these leaks are actually the result of condensation from warm interior air condensing in the cold space; however the workers also reported leaks during the recent hurricane. Before any improvements are completed in this space the roof shingles and associated flashing should be inspected by a qualified roofer with appropriate repairs made as necessary. This ceiling assembly is uninsulated tongue and groove wood with short uninsulated slopes around the exterior perimeter. There is an attic side wall on the West side that separates this attic space from the conditioned space of Section "B". Inspection revealed this side attic wall to be mostly uninsulated. Rosin paper installed on this side attic wall was used as the original air barrier. This paper has failed and provides little air barrier value. Both this ceiling and the side attic wall contribute significantly to the overall air leakage of this building in that neither has an appropriate air barrier. The framing of the flat ceiling area is assessed as inadequate to support a worker. This can be corrected by the installation of 2x6 framing between the ceiling rafters and the side wall to create solid support for work to be accomplished. This framing should be installed 15" above the ceiling level so future access can be gained after the insulation is installed. As with the recommendations for the previous attic spaces, it is recommended that an adequate air barrier be established by installing 1" closed cell insulation on the attic side of the flat ceiling area. This would then be capped with 14" of blown cellulose to bring the ceiling to R50. The side attic wall would require a dense packed cellulose blow. Once the cavities are fully insulated than 2" XPS rigid insulation should be installed over the side wall to create an adequate air barrier and to provide a layer of

continuous R10 insulation. All seams should be taped and the perimeter sealed. A 2" application of closed cell insulation could be substituted for the XPS rigid insulation. The small sloped assembly surrounding the exterior perimeter of this space would require a dense packed cellulose blow. Due to the limited cavity depth of these slopes the maximum R-value achievable by dense packing alone would be R20. Consideration should be given to installing 2" polyisocyanurate on the interior sides of the sloped assemblies to be covered by sheetrock. This combination of dense packing the slopes and the additional R13 provided by the continuous insulation would provide R33. The hatch assembly would require full R40 Insulation, weather-stripping and an insulation dam.

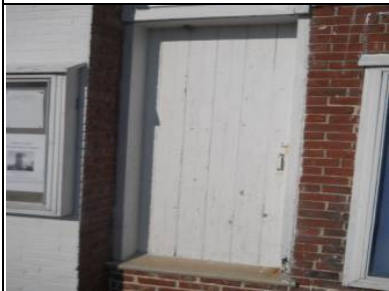
Comments: This section appears to have been an open porch that has been framed in. The framed portions of this section's walls were determined to be insulated via infrared imaging and visual inspection and are assessed at R10.2 for "whole wall" R-value. The Southern closet however has uninsulated masonry walls and a very low R-value and leaky door. The uninsulated brick is assessed an R-value of 1.6 and the door is approximately R1. The East wall of this section has uninsulated brick pillars, and the North wall has uninsulated exposed concrete on the lower half. The foundation wall section of this report provides improvement recommendations that include exterior insulation for the masonry foundations / walls. For this particular section of the building there is an option to put insulation on the interior of the masonry walls instead of the exterior, or both could be accomplished. 2.5" extruded polystyrene protected with a code approved thermal barrier, such as sheetrock, would be appropriate and provide an R13 insulation level. The brick pillars in the East wall and the exposed concrete on the North wall should also be covered with 2.5" rigid foam board with sheetrock. It appears that the exterior door in the South closet is not used and is sealed shut. If this door is not required then it is recommended that this door be fully sealed to create a weather tight barrier then insulated over with rigid insulation and a thermal barrier.

Uninsulated / Leaky Door

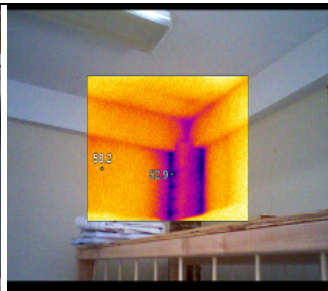
Uninsulated Brick Pillars

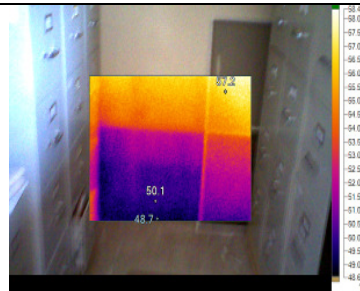
Uninsulated Concrete

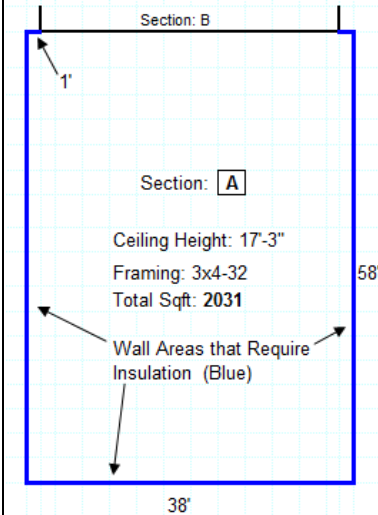
Comments: The Sq-Ft of the wall surface area listed above excludes the surface areas of the windows and is the actual surface area of the wall cavities that require insulation. Infrared imaging and visual inspection from the attic revealed these bays to be void of insulation. Due to the open wall top plates, minor amounts of blown fiberglass have fallen into these bays when the blown fiberglass was installed in the attic. Improvements to these walls will require an exterior cellulose blow. Due to the age of this structure, lead paint abatement procedures would be applicable unless approved RRP testing determines the absence of lead. The interior sheetrock has many unsealed gaps and seams. Interior air sealing should first be accomplished prior to dense packing cellulose to prevent excessive dust and debris from entering the office spaces and to reduce infiltration. Of important note is that there are air ducts in both the North and South Walls. It was not determined during the audit if there is actual ductwork installed in the wall cavity or if the wall cavity itself was panned off and used as the air duct. It is *extremely* important that the follow on insulation contractor first determine if actual air ducts are present in these wall bays prior to blowing insulation into these wall cavities. For either scenario it is highly inefficient to have ductwork inside an exterior wall cavity, and would be significantly worse if the cavity itself was used as the air duct. Even with perfectly tight ductwork (highly doubtful) these specific wall bays can not be properly insulated while the ductwork remains. It is highly recommended that this particular ductwork be re-routed to the interior of the primary air barrier (interior sheetrock).

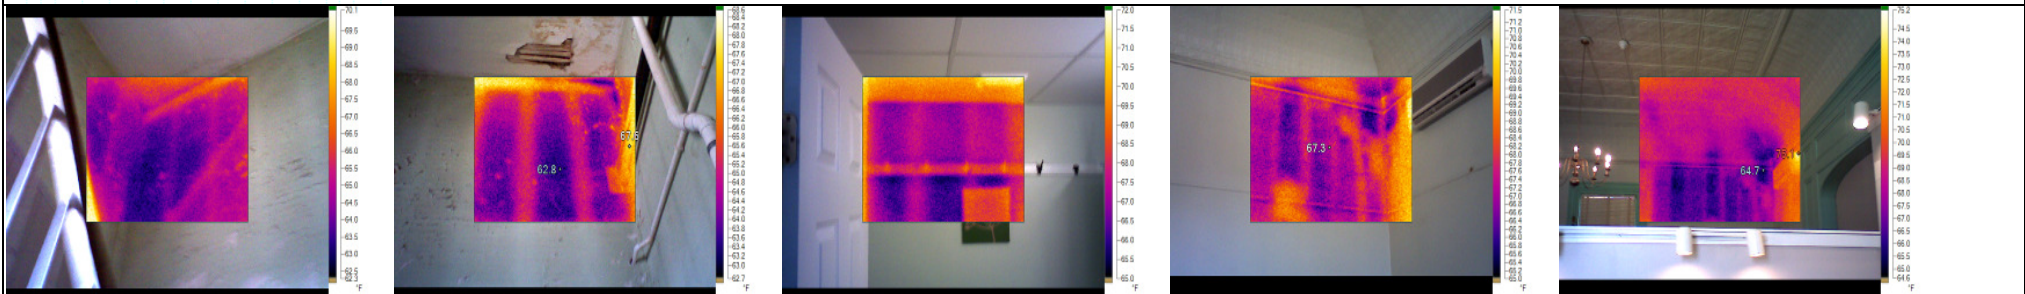
Infrared Images Showing Uninsulated Walls

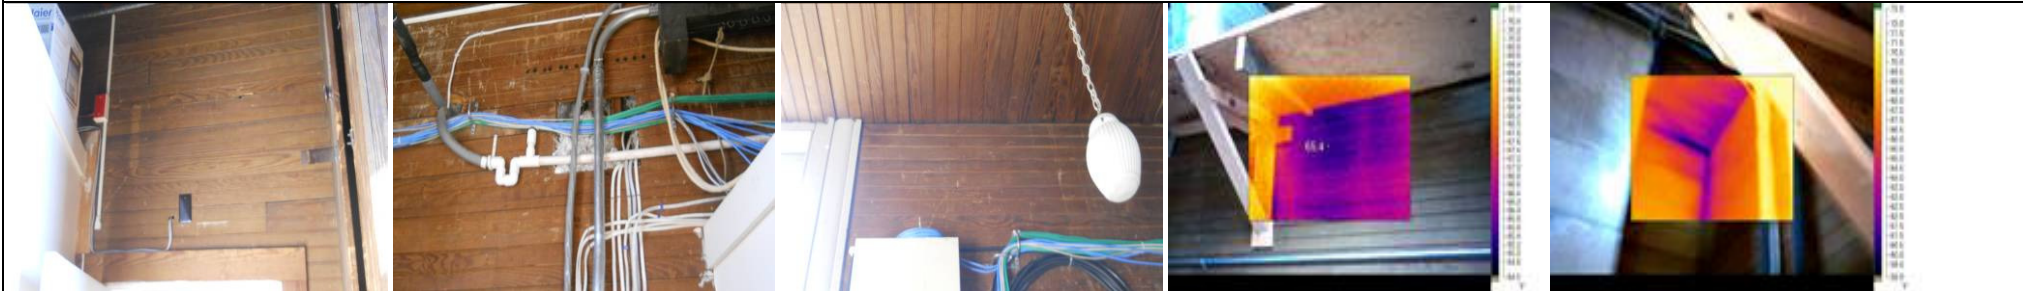
Comments: This section's walls were determined to be uninsulated via infrared inspection. The interior wall surfaces are tongue and groove wood which provides an inadequate air barrier. In addition these walls have many "cut outs" through which wiring had been run. These walls would require and exterior cellulose blow after the holes have been sealed. Lead paint abatement procedures would apply unless the exterior paint tested negative for lead using approved RRP lead testing procedures. The installation of interior 2" extruded polystyrene rigid insulation over the tongue and groove is an additional efficiency upgrade to be considered. This would significantly improve the air barrier reducing infiltration along with providing a layer of continuous R10 insulation. The wall currently is assessed at R5. Dense packing the cavities with cellulose would bring the wall assembly to R14. Dense packing the cavities and adding a layer of R10 interior insulation and sheetrock would bring the assembly to R25 and would provide a superior air barrier. This interior insulation would require a code approved thermal barrier, such as sheetrock. This interior insulation recommendation was not modeled into the energy saving calculations provided previously in this report due to the unlikelihood that this particular improvement would be conducted at this time, but should be considered if funding allows. The square feet provided in the table above are for the opaque wall area exclusive of windows.

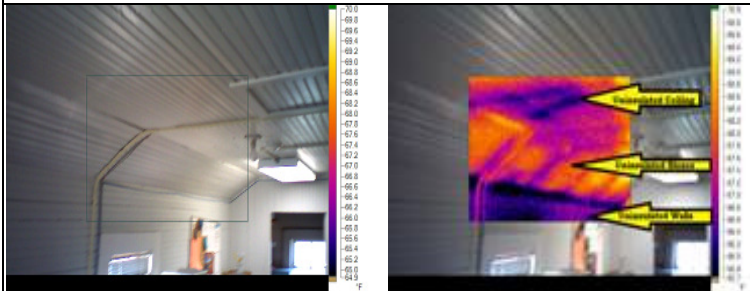
Comments: The same recommendations are made for this section as were made for building section "B". These walls were determined to be uninsulated and the tongue and groove provides a poor air barrier. As seen in the associated sections of this report this entire 2nd floor section of this building has uninsulated assemblies to include walls, the sloped ceiling sections and the flat attic section. The door to exterior is a very low R-value door and would be a candidate for replacement. The square feet provided in the table above are for the opaque wall area exclusive of windows and the door.

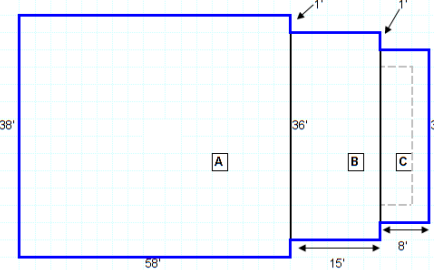
Comments: This building has an uninsulated slab on grade and the lower portions of the foundation walls are uninsulated. Infrared imaging of the foundation wall sections that have finished interiors has lead to the assessment that these foundation walls have no interior insulation. The uninsulated slab on grade along with the uninsulated foundation walls are a significant source of energy losses for this structure. It is recommended that these walls be improved with an Exterior Insulation Finishing System (EIFS) that provides a minimum of R10 with higher R-values preferred. To obtain maximum benefits, and to provide the slab perimeter insulation, it is recommended that the exterior insulation extend 2' below ground level if funding allows. This would require excavation around the perimeter. The below grade exterior rigid should extend down the below grade foundation wall and then horizontal for an additional 2'. If a full 2' depth is not practical due to limitations of funding, then the above grade portion, with as much below grade installation as feasible, is still recommended. One company that specialized in exterior foundation insulation is Associated Concrete Coatings, of Manchester NH. The exterior brick wall segment associated with the "vault" has a through wall vent that presently is covered by the exterior bulletin board on the South Side. Though this vent is covered by the bulletin board, excessive air leakage was noted through this vent. If it is determined that this vent is not required or needed then this vent should be sealed and insulated over.

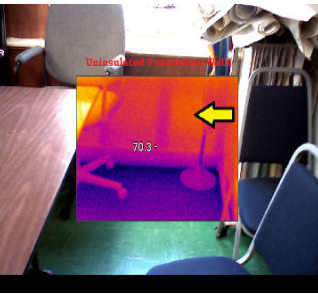
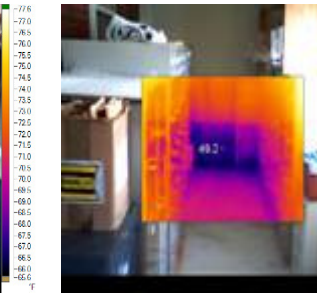
Section A – North & West

IR Image of Lower Foundation

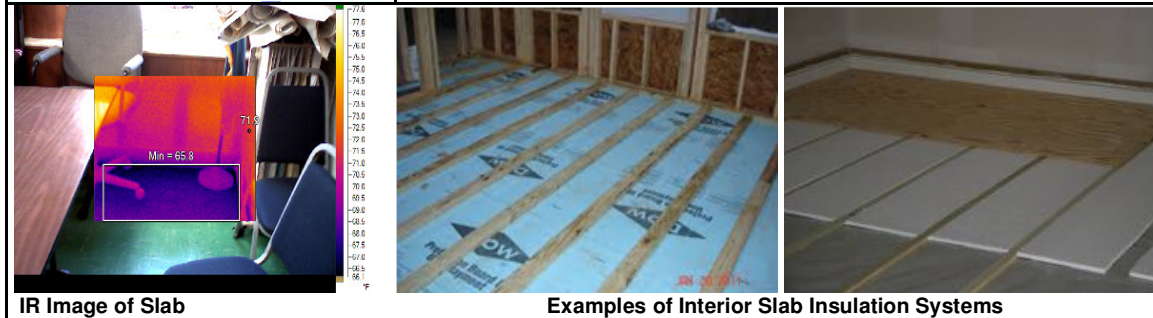
Comments: The recommendations for the slab perimeter improvements were made in the foundation wall section of this report. An additional improvement to the slabs would be to install R10 rigid insulation on the top side of the slab. Normally this type of installation would install the rigid insulation between pressure treated sleepers mechanically fastened to the slab. A new subfloor would be installed over. Other insulation systems rely upon sleepers installed over a continuous layer of rigid insulation. However this would require a specific compressive strength required of the rigid insulation. This improvement was not modeled into the energy savings calculation provided due to the assessment that it would not be accomplished at this time, and that the best section to conduct this improvement, section "C", may be removed during future expansion.

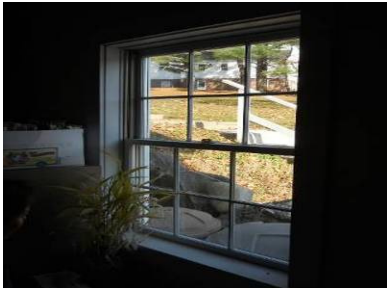
<p>Locations: Throughout Building</p> <p>Assessed U Value: 0.58</p> <p> <input checked="" type="checkbox"/> Single Pane <input type="checkbox"/> Double Pane <input type="checkbox"/> Triple Pane <input checked="" type="checkbox"/> Wood <input type="checkbox"/> Metal <input type="checkbox"/> Vinyl <input type="checkbox"/> < ½ Air Space <input type="checkbox"/> ½ " Air Space <input type="checkbox"/> > ½ " space </p> <p>Low E Coatings: Storm Window: Yes</p>

<p> <input type="checkbox"/> Add Exterior Storm Window <input type="checkbox"/> Add Interior Storm <input type="checkbox"/> Install Weather-Stripping <input type="checkbox"/> Consider Replacement </p> <p>Comments: Building has significant glazing area. The majority of the windows were single pane wood with storm windows and were assessed as fairly tight. Occupants report that the large 2nd floor windows are very difficult to operate and do not have a counterweight system. New recoil style counter weights systems area available. It is recommended that client consult a contractor that specializes in historic windows to install a counterbalance system to allow windows to be used for ventilation. With these windows operable natural ventilation could be used to a greater extend reducing air conditioning loads.</p>

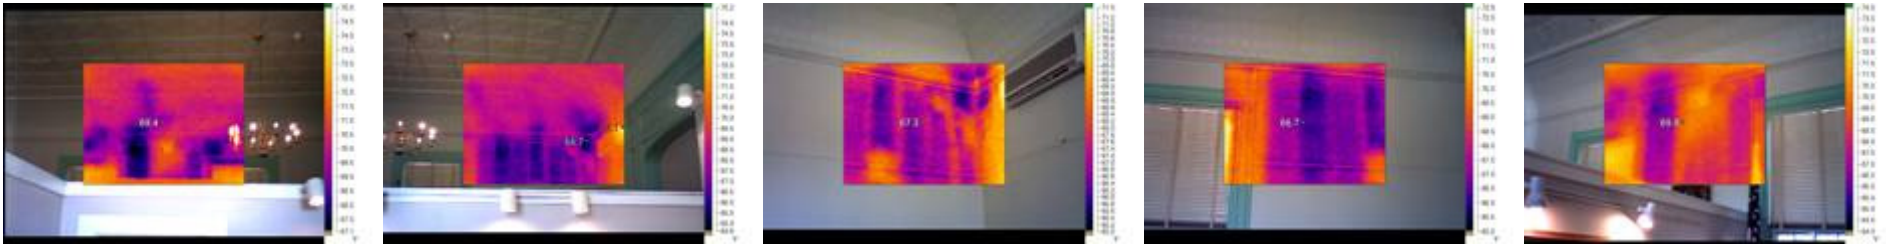
2nd Floor Walls

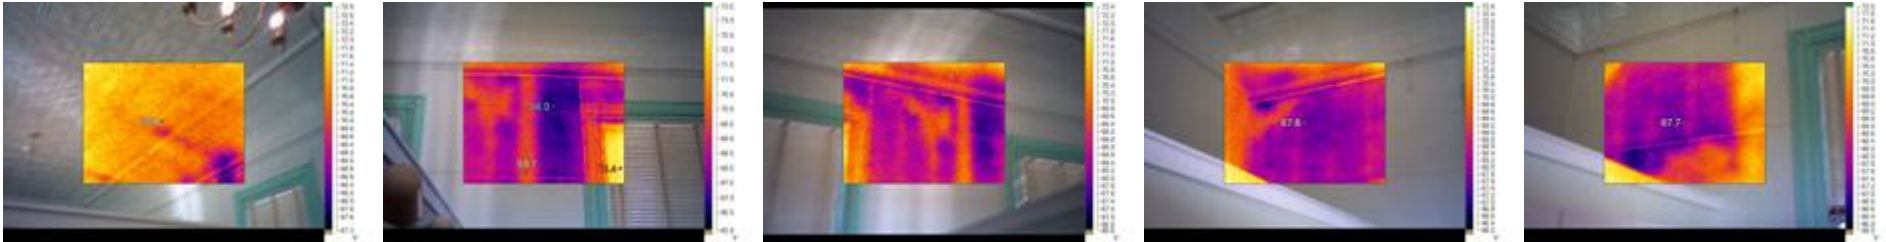
2nd Floor Walls

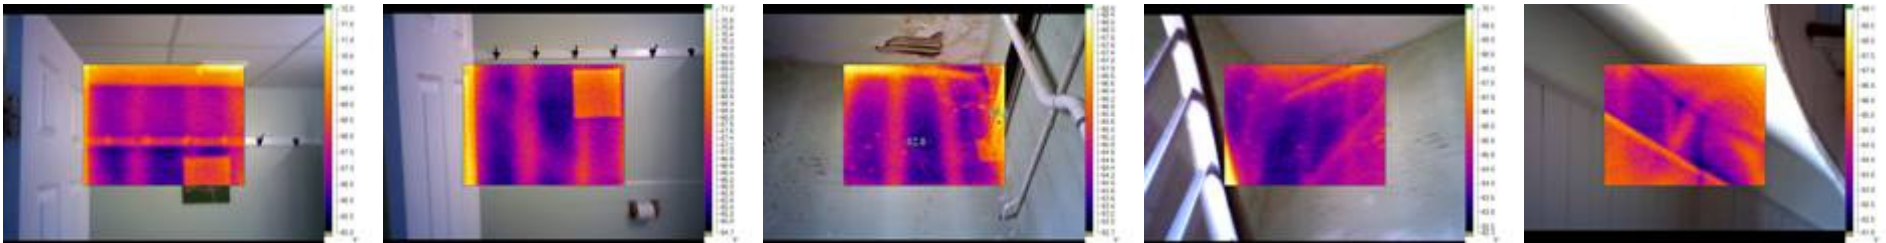
2nd Floor Walls

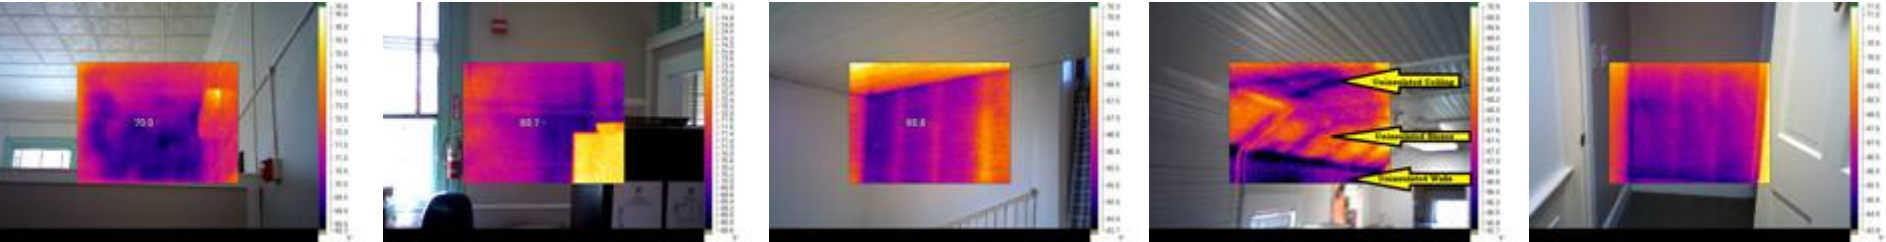
2nd Floor – Section “C”

Uninsulated Foundation / Walls

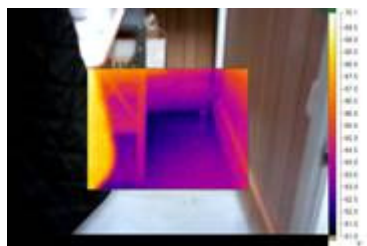
1st Floor Section "A"

Uninsulated Slab

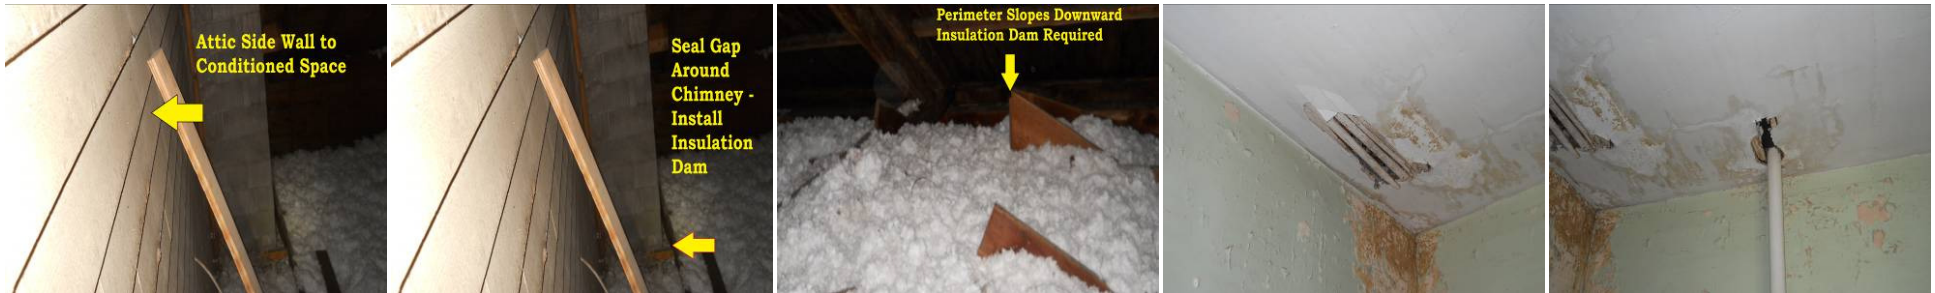
Wall Between Conditioned Space and Attic

Defective Air Barrier

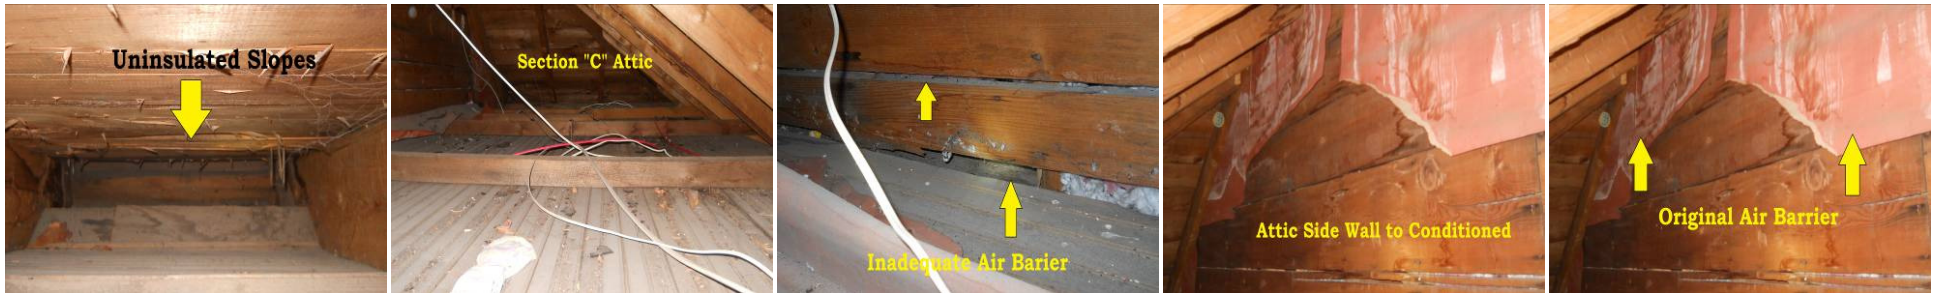
Section "C" Attic

Defective Air Barrier

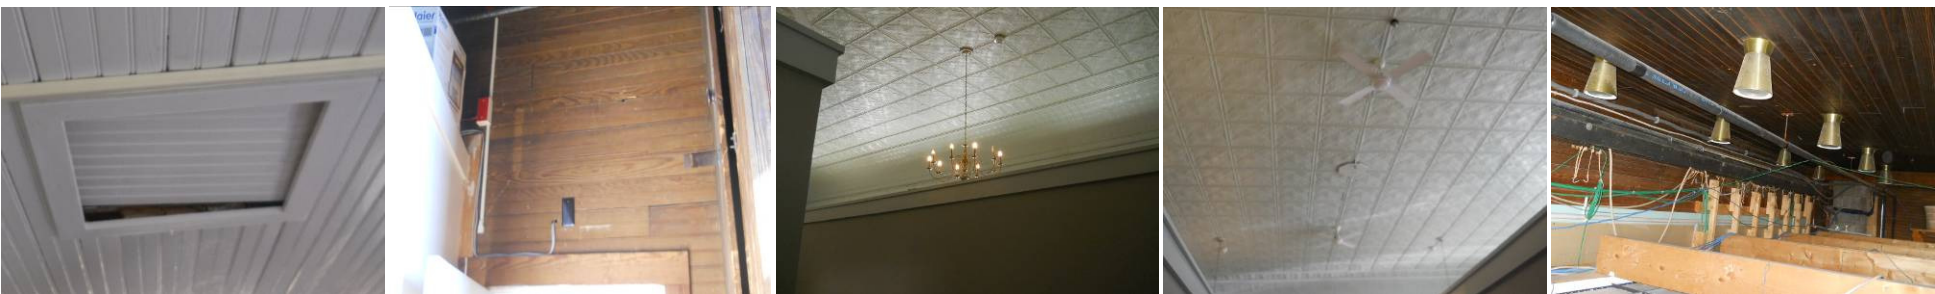
Uninsulated Hatch - Section "C"

Inadequate Air Barrier / Holes in Air Barrier

Metal Ceiling

Inadequate Air Barrier

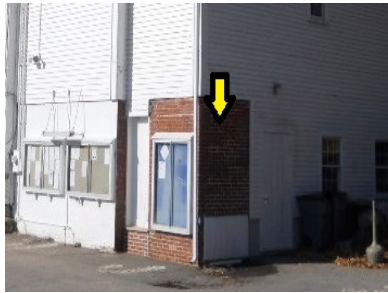
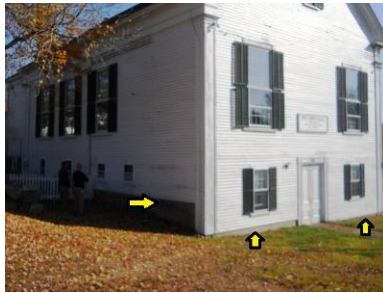
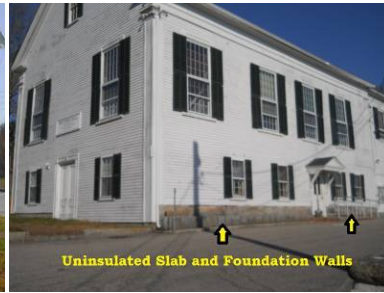
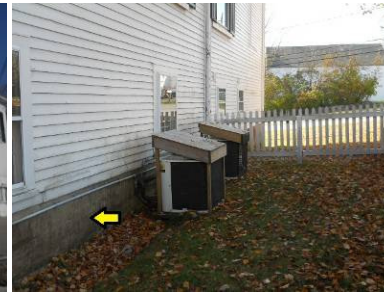
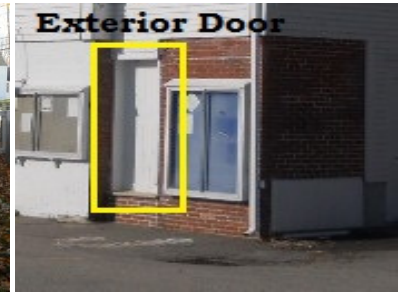
Uninsulated Foundation / Slab

Unused Low R-Value / Leaky Door
