April 7, 2017

RE: Harbor Road Bridge Assessment
NHDOT Bridge No. 135/075
Hoyle, Tanner Project No. 923701

INSPECTION PHOTOGRAPHS

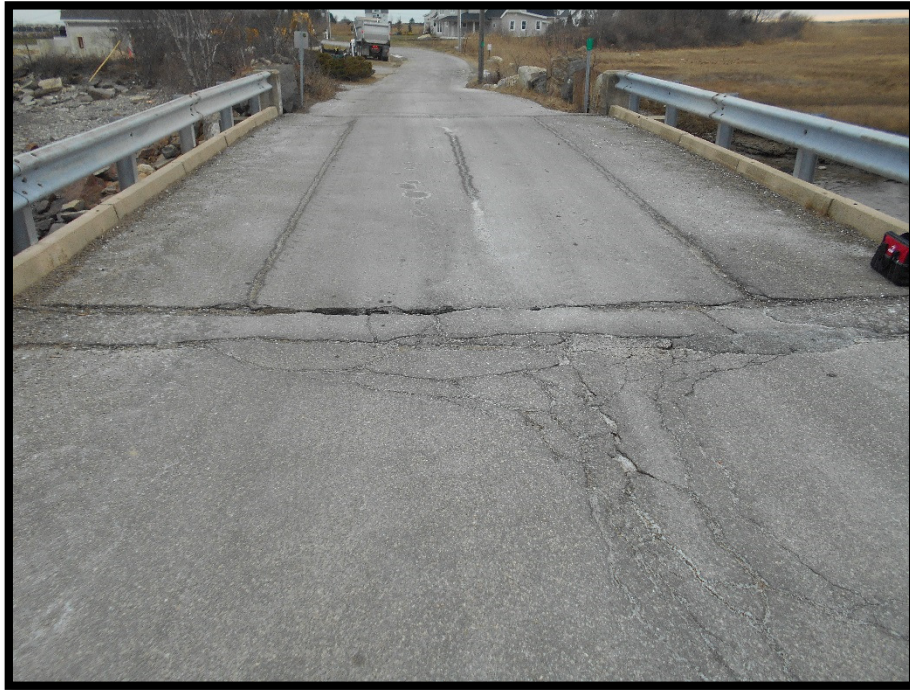
PHOTO NO. 1

- The pavement wearing surface exhibits reflective cracking along the longitudinal joints between adjacent beams.
- The ends of the beams at their interface with the bridge abutments comprise the deck joints, and they exhibit advanced deterioration. There are holes in the pavement up to 4" wide and 36" long along the joints, with signs of significant leaking through the joint.
- The bridge and roadway approach rail are substandard by current design standards. The bolted connections between the steel bridge rail posts and the concrete deck soffit exhibit minor corrosion and are not likely adequate to resist loading from a vehicular impact of any significant force.

West Approach
Looking East

Pavement
Deterioration in
Roadway Approach
and Longitudinal
Cracking at Beam
Joints on Bridge

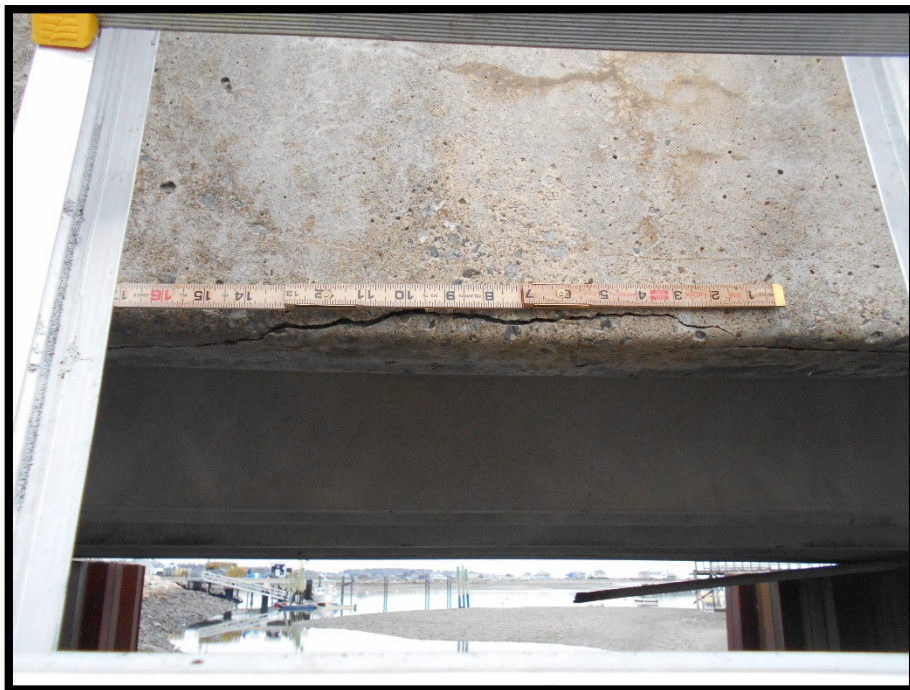
PHOTO NO. 2

- The south stem of Beam 4 exhibits cracking for a length of 61" at midspan.
- The leaking longitudinal beam joints exhibit moderate to major rust staining indicating water migration through, and deterioration of, the joint.

Beam 4 South Stem

Longitudinal
Cracking in Beam
Stem

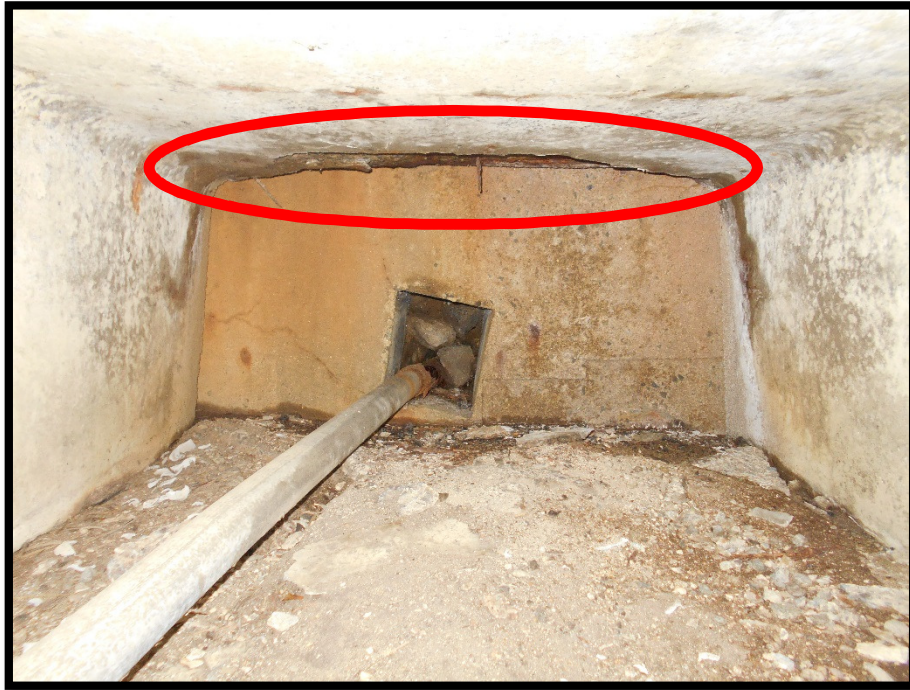
PHOTO NO. 3

- Each of the four beams exhibit spalling of the concrete on the undersides of the flanges at the east and west abutments due to moisture introduced from the leaking deck joints.

Beam 2 at East
Abutment

Typical Top Flange
Spall at Deck Joint
(CIRCLED)

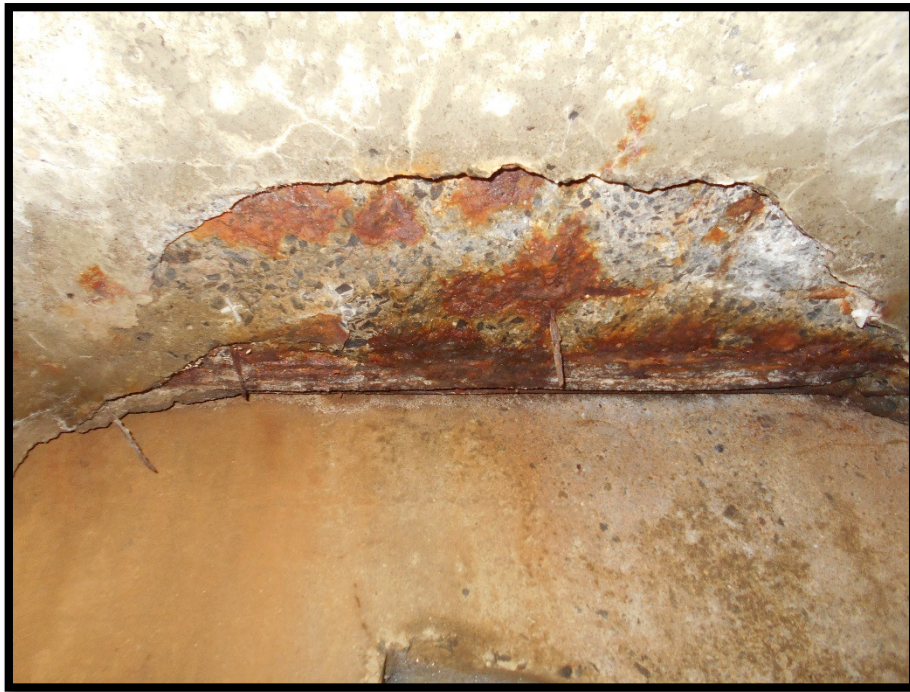
PHOTO NO. 4

Beam 2 at East
Abutment

Typical Top Flange
Spall at Deck Joint

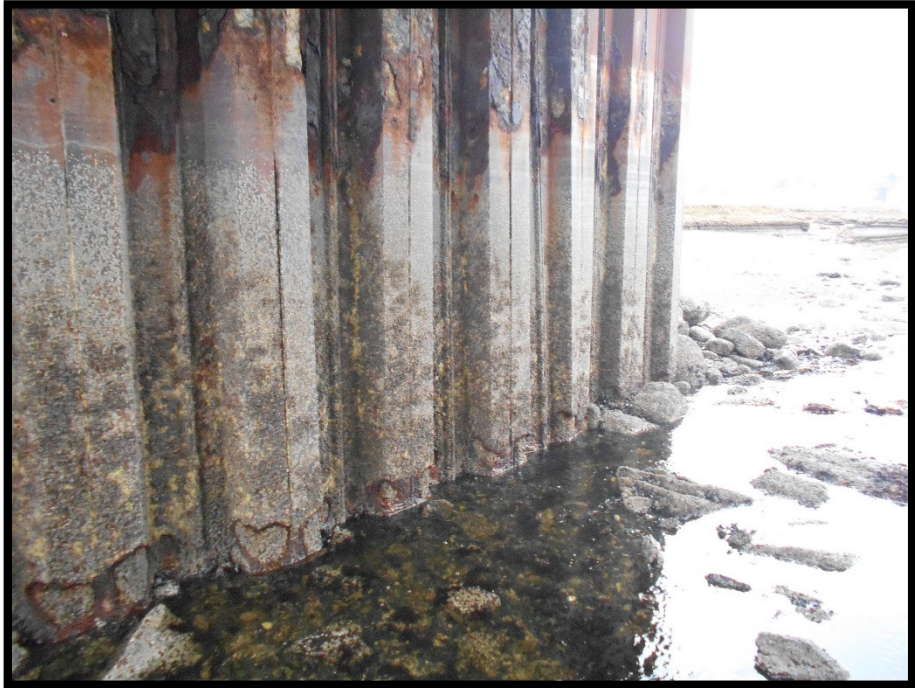
PHOTO NO. 5

- The steel sheeting on the faces of the east and west abutments exhibits advanced section loss with multiple holes at and around the high and low tide water marks.

<u>Location:</u> East Abutment	
<u>Description:</u> Typical Steel Sheet Piling Deterioration	
PHOTO NO. 6

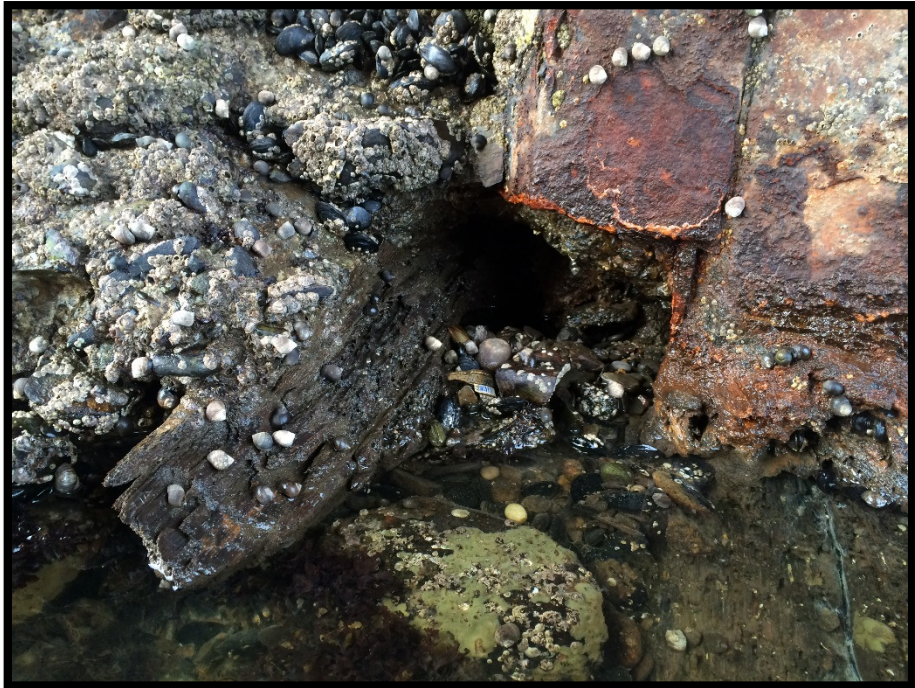
- The west abutment steel sheeting appears to have been installed around timber cribbing members at/near the mudline. This timber cribbing is deteriorating, leaving an unprotected void in the face of the abutment. The extent of penetration of the timber cribbing into the abutment could not be established.

<u>Location:</u> West Abutment	
<u>Description:</u> Deteriorated Timber Cribbing through Abutment

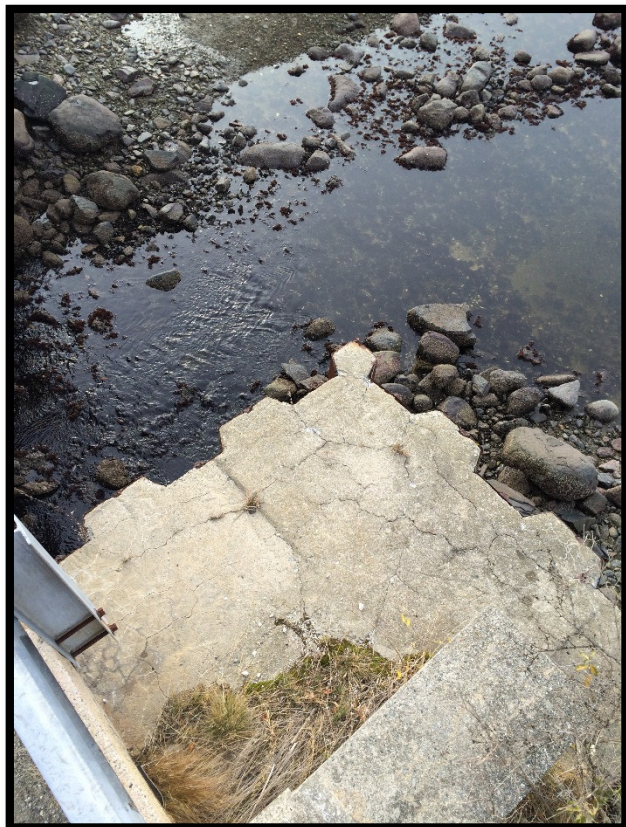
PHOTO NO. 7

- The concrete in the east and west abutment backwalls exhibits random spalling and cracking.

<u>Location:</u> West Abutment	
<u>Description:</u> Typical Abutment Beam Seat Cracking

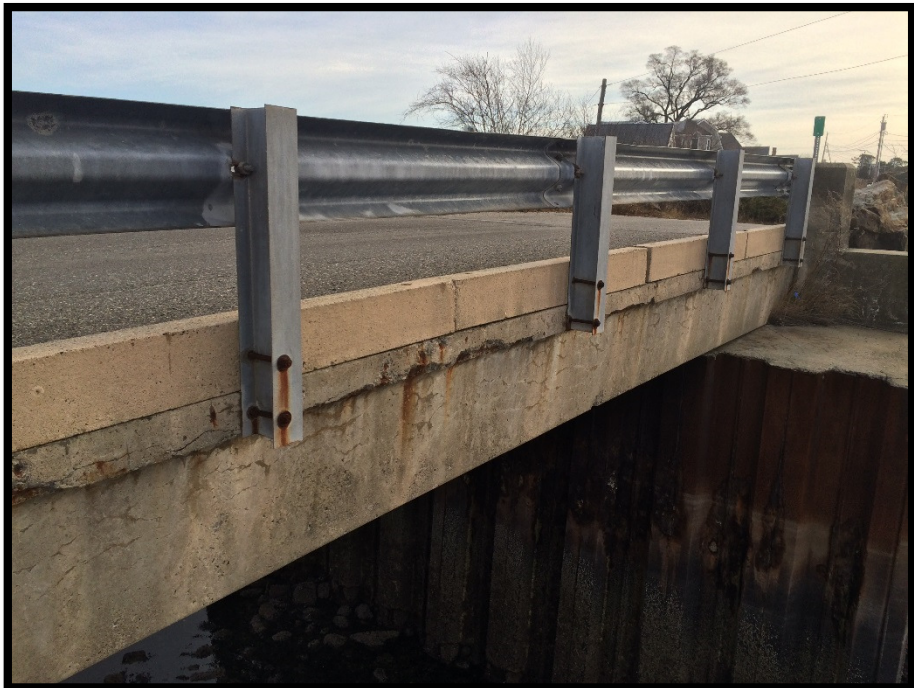
PHOTO NO. 8

<u>Location:</u> Beam 4	
<u>Description:</u> Substandard Bridge Rail and Beam Top Flange Deterioration
