Facility and Space Needs Assessment Rye Recreation Facilities Rye (and New Castle) New Hampshire July 21, 2016 - revised

Norman E. Larson, AIA, LEED AP Christopher P. Williams, Architects

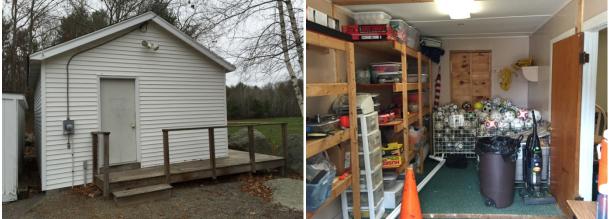
Lighting - utility Mechanical - none Climate - unconditioned Ceilings - painted gyp. Bd. over strapping Walls - painted gyp. Bd. in poor condition (severe localized damage) interior framing of 2x3s Base - none Door - keyed latches from previous layout could trap people in building. NL to verify.. Floor - low pile carpet and sheet vinyl over wood framed floor. Bathrooms - none, no plumbing in building, travel to another building required Egress- single exit is OK. Hardware on doors could create lock-in situation Assessment – Rough condition resulting from heavy use and previous quickly made

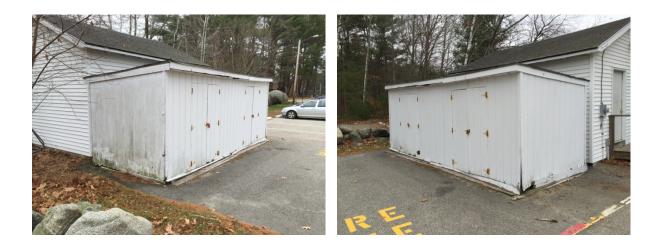
Soccer Storage. (Dedicated facility, Town owned)

Single story wood frame on 2x framing on pavement - T-111 siding in complete failure, asphalt shingle roof No power or plumbing No H/C access

Lighting - none Mechanical - none Climate - unknown Ceilings - unknown Walls - interior unknown Base -Door - 2 sets plywood double doors w/ padlocks Floor – failing Bathrooms - none, no plumbing in building. Egress- single exit is OK. Hardware on doors could create lock-in situation

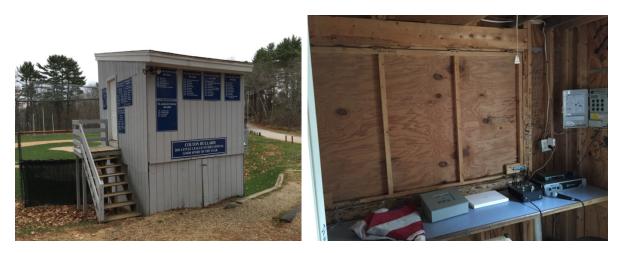
Baseball Announcer's Booth. (Dedicated facility, Town owned)

Two story wood frame on Concrete Block Foundation – T-111 siding in fair condition Underground power from unknown location – exposed wiring w/out conduit No plumbing No H/C access

Assessment – over-used for storage, rough but acceptable structure for intended purpose.

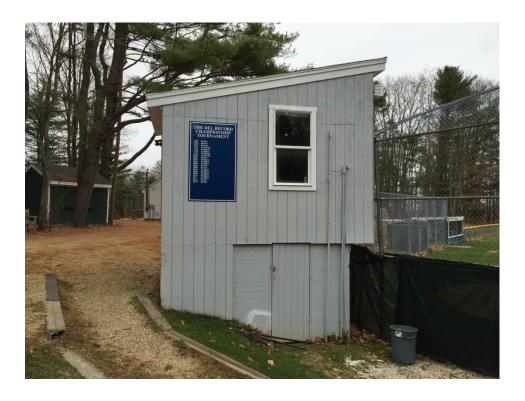
Announcer's Booth Storage. (Dedicated facility, Town owned)

Lower level of Announcer's booth - Concrete Block Foundation – Infill t-111 storage under cantilever failing – asphalt shingle roof in unknown condition No plumbing

Lighting -Mechanical - none Climate – unknown – rodent access evident and ongoing Ceilings - exposed framing Walls – concrete masonry Base - n/a Door – 30" narrow plank wood Floor - presumed concrete at lower level Bathrooms - none Egress- single exit door is OK H/C access: None

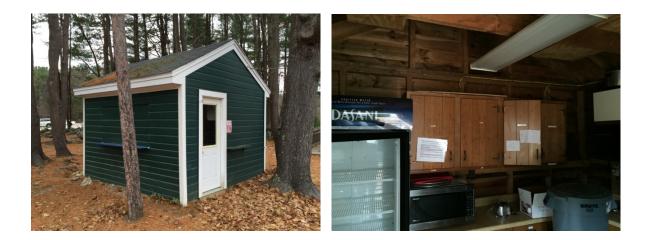
Baseball Snack Shack (Dedicated Facility, Town Owned)

Wood frame with painted novelty siding in fair condition, slab on grade, three-tab shingle roof in fair condition but with significant lichen growth.

Novelty siding and trim near ground is rotted, extended service counter catches rain. Electrical wiring in fair condition - not in conduit

Assessment: Replace damaged siding and trim and repaint. Consider modifying counter or roof to protect from weather

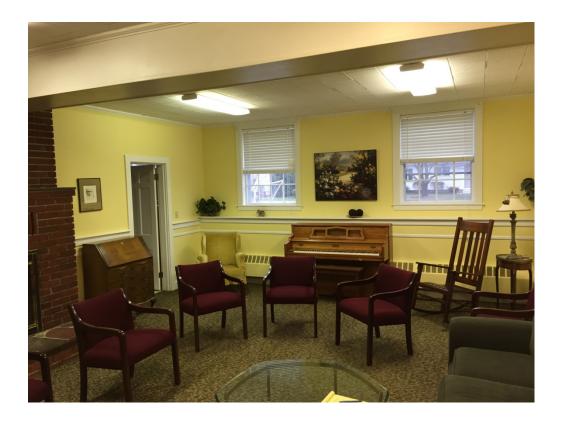
Fire Side Room (Rye Congregational Church, borrowed space)

Wood framed structure on poured concrete foundation "Garden level" space in good condition with movable soft furniture

Assessment: Friendly space with non-accessible restroom. Limit use.

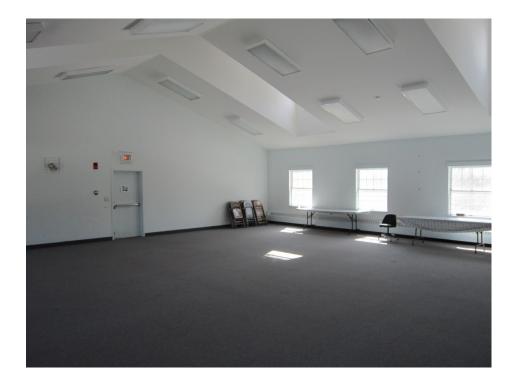
Exercise Room (Rye Congregational Church, borrowed space)

Wood framed construction with long span elements Space is large, clean and dry with basic finishes

Assessment: Do not use while egress corridor is used as store. Limit use thereafter.

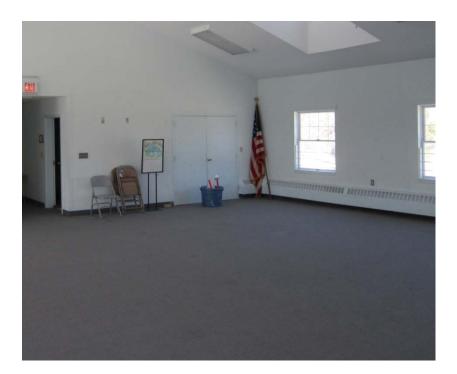
Exercise Storage Room (Rye Congregational Church, borrowed space)

Conditioned, shared storage space with shelve on one wall accessed off the Exercise Room

Assessment: usable (but not securable) shared space

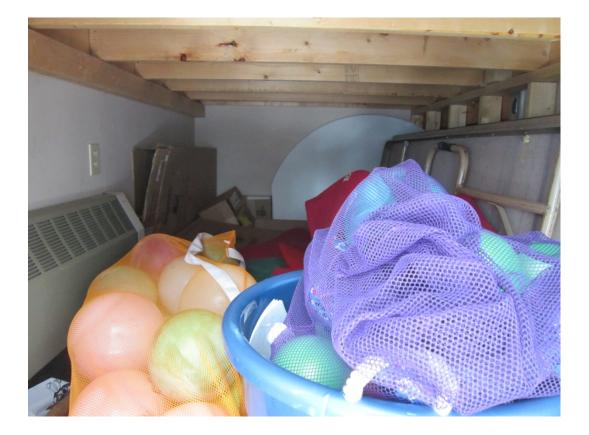
Exercise Low Storage (Rye Congregational Church, borrowed space)

Low space under adjacent stair landing used for storage Conditioned space is cluttered and awkwardly shaped

Assessment: Proper fire rated finishes not provided for storage under egress stairs at this location. Contact F.D. for permission to use or abandon

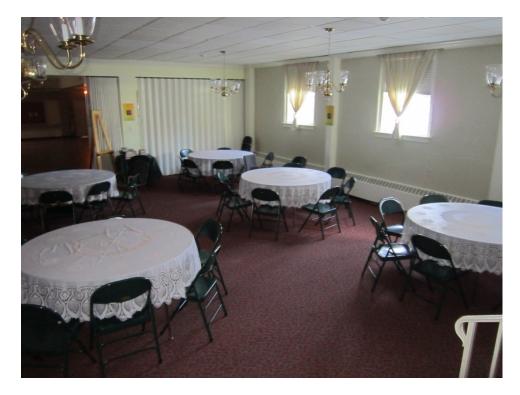
Dining Room (Rye Congregational Church, borrowed space)

Basement space in first masonry addition to historic wood church, opens to large Fellowship Hall adjacent

Assessment: Safe to use with finishes in fair condition.

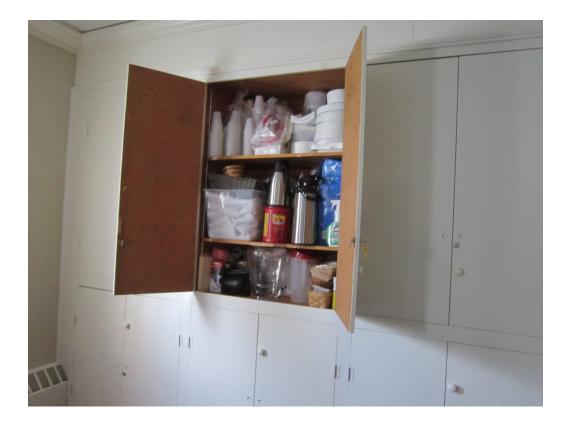
Dining Room Storage (Rye Congregational Church, borrowed space)

Limited space within bank of floor to ceiling cabinets at side of space Painted wood cabinets are lockable and dry

Assessment: Storage space is extremely limited for serving ware and food items.

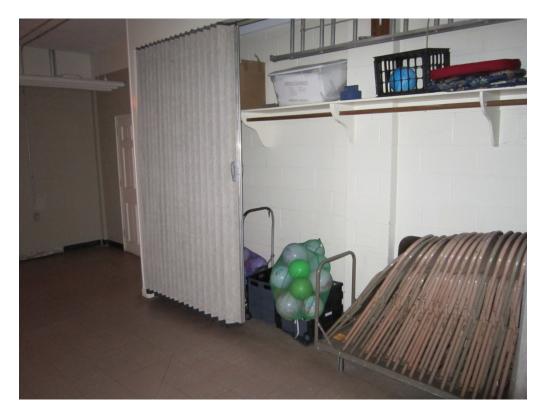
Closet built into original Fellowship Hall space is in similar condition to larger space.

Assessment: Storage is conditioned but unsecured and shared which limits what can be stored safely here.

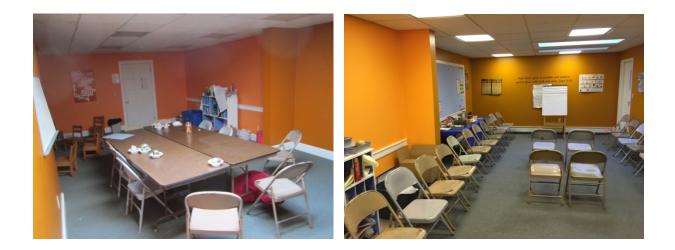
Lighting: lay-in fluorescent Mechanical: baseboard hydronic Climate: Dry, limited natural light Ceilings: lay-in acoustic tile Walls: painted plaster Base: painted plaster Base: painted wood Doors: painted wood with painted 9-lite glass – not fire rated Floor: Carpet Bathrooms: accessible restrooms available down the hall Egress: Corridor has exits in two directions. Glass in door precludes fire rating. HC access: Door is sized for access, but door hardware should be replaced. Door to corridor serving this room is very heavy (hard to operate).

Assessment: Serviceable room hidden away on upper level of church. Minor door hardware changes could eliminate access challenges

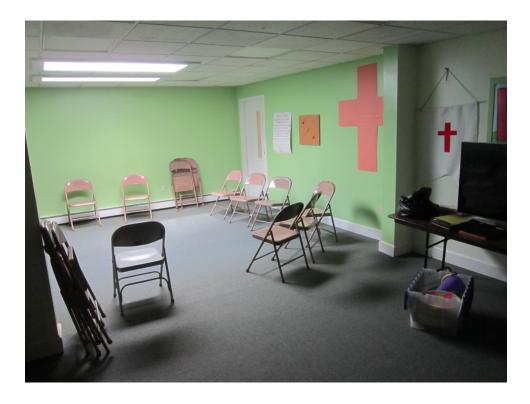
Green Classroom (Rye Congregational Church, borrowed space)

Wood framed classroom with painted finishes and limited daylighting through skylights only (confirm). Classroom is located on upper floor of church past the Orange classroom. This meeting room / classroom is well taken care of and used regularly for church school purposes

Lighting: lay-in fluorescent Mechanical: baseboard hydronic Climate: Dry, limited natural light Ceilings: lay-in acoustic tile Walls: painted plaster Base: painted plaster Base: painted wood Doors: painted wood Floor: Carpet Bathrooms: accessible restrooms available down the hall Egress: Corridor has exits in two directions HC access: Door is sized for access, but door hardware should be replaced. Door to corridor serving this room is very heavy (hard to operate).

Assessment: Serviceable room hidden away on upper level of church. Minor door hardware changes could eliminate access challenges

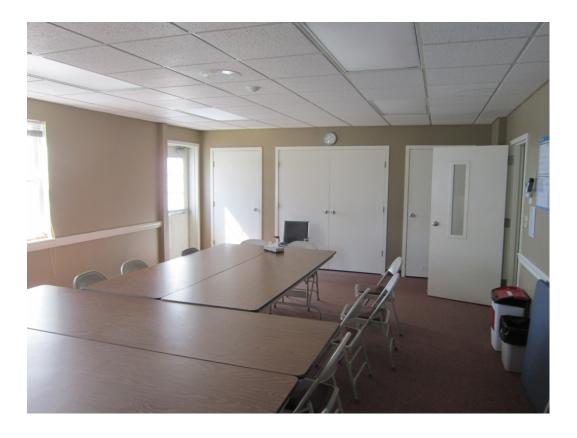
Conference Room (Rye Congregational Church, borrowed space)

Main Level Conference room with folding meeting tables located on main floor. Simple, flexible space in good condition. Extensive storage used by others.

Assessment: Good flexible space in need of hardware replacement to be deemed accessible.

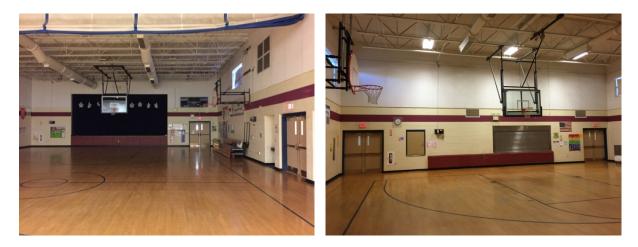
Gymnasium (Rye Elementary School, borrowed space)

Wood floored gymnasium in masonry school building with 3 riser bleachers and dividing curtain to create two separate areas when desired Basketball nets provide for full size court and two separate half size courts. Gym is in good general condition

Lighting: high intensity located at within roof trusses Mechanical: Ducted hot air and air conditioning Climate: dry Ceilings: Exposed metal roof trusses and decking - painted Walls: Painted concrete masonry Base: Rubber Doors: Flush rated wood doors Floor: Wood athletic floor Bathrooms: available nearby Egress: Good – four sets double doors – 2 pair per divided side of gym HC access: At grade access through pairs of double doors, Verify hardware throughout.

Assessment: Good flexible space for basketball and other activities, when available for use. Space is also used as gathering point for RAP program.

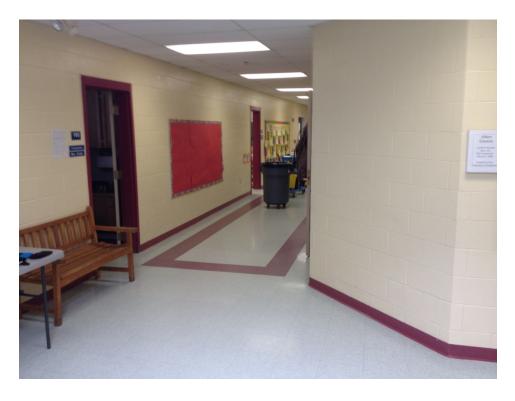
Ski Trip Prep Area (Rye Elementary School, borrowed space)

Niche and portion of hallway near gym for skier check-n in and ski gear storage ahead of planned trips to McKyntyre ski area

Assessment: Not intended as a gathering place, this corner requires setup and takedown time whenever used and should not be used anytime gym is serving as assembly space

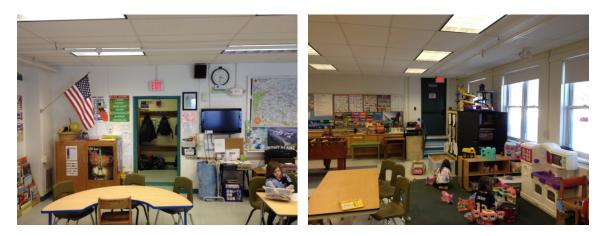
Grades K-2 RAP Space (Rye Elementary School, borrowed space)

Under-used classroom on lower level of school currently available after-school for RAP program. Well maintained space set up with a sink for supporting art projects and a dedicated storage area at the interior

- HC access: Exterior door at stair landing is a step up-from grade. Universal access to lower level classrooms requires entry to school at upper level, long trek to non-compliant stairway, and use of stair-lift that blocks use of stair by others.
- Assessment: Space is generously sized and in good condition, but lacks proper access for those with mobility issues and reasonable access to a restroom. Exploration should be made to resolve these challenges through a new addition or/and an expansion of the interior space to add a bathroom. Use of space relies on school and instructor willingness to leave classroom immediately upon end of school day.

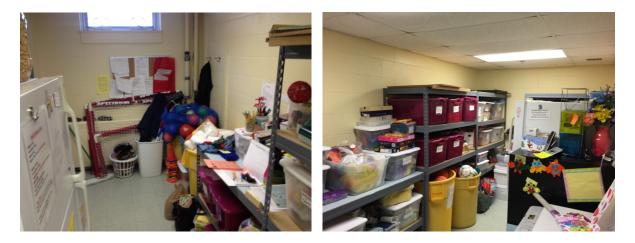
RAP Staff / Storage Room (Rye Elementary School, borrowed space)

Dedicated secure storage on lower level of school currently available for RAP program. Well maintained and conditioned space

Assessment: Space is slightly under-sized and in good condition, but lacks proper access for those with mobility issues and reasonable access to a restroom. Exploration should be made to resolve these challenges through a new addition or/and an expansion of the interior space to add a bathroom. Use of space relies on school and instructor willingness to leave classroom immediately upon end of school day.

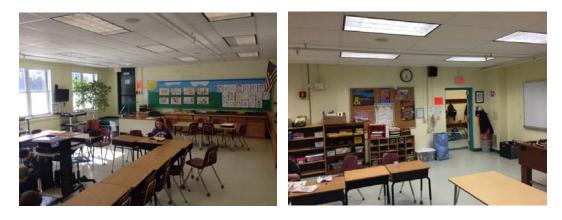
Grades 3-5 RAP Space Classroom (Rye Elementary School, borrowed space)

Under-used classroom on lower level of school currently available after-school for RAP program. Well maintained space set up with a sink for supporting art projects and a dedicated storage area at the interior

- neaded to or back from the bathroom.
- Egress: Good Exit corridor is dead end with nearest exit partially up stairway to upper level. Dedicated exit from classroom is requires three steps up
- HC access: Exterior door at stair landing is a step up-from grade. Universal access to lower level classrooms requires entry to school at upper level, long trek to non-compliant stairway, and use of stair-lift that blocks use of stair by others.
- Assessment: Space is generously sized and in good condition, but lacks proper access for those with mobility issues and reasonable access to a restroom. Exploration should be made to resolve these challenges through a new addition or/and an expansion of the interior space to add a bathroom. Use of space relies on school and instructor willingness to leave classroom immediately upon end of school day.

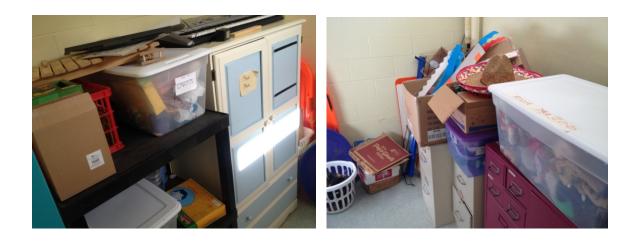
RAP Shared Storage Space (Rye Elementary School, borrowed space)

Shared, secured storage on lower level of school currently available for sharing with RAP program. Well maintained and conditioned space

Assessment: Space is in good condition, but lacks ability to be secured. Exploration should be made to resolve these access challenges through a new addition or/and an expansion of lower level spaces. Use of storage space and classroom relies on school and instructor willingness to leave classroom immediately upon end of school day.

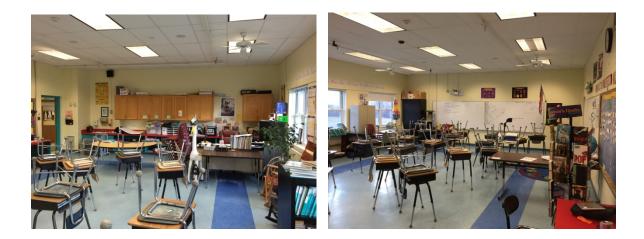
RAP Study Room (Rye Elementary School, borrowed space)

Assessment: Space is generously sized and in good condition. Use of space relies on school and instructor willingness to leave classroom immediately upon end of school day.

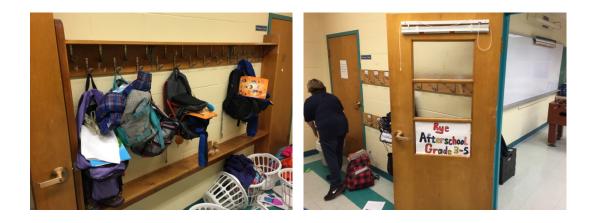
RAP Coat Room - Hallway (Rye Elementary School, borrowed space)

- Bathrooms: gender specific restrooms up the stairs and 150' +/- down the corridor. This requires a dedicated staffer on second floor to take or watch children headed to or back from the bathroom.
- Egress: Good Exit corridor is dead end with nearest exit at stair landing partially up stairway to upper level.
- HC access: Exterior door at stair landing is a step up-from grade. Universal access to lower level classrooms requires entry to school at upper level, long trek to non-compliant stairway, and use of stair-lift that blocks use of stair by others.
- Assessment: Space is under-sized and in good condition, but lacks proper access for those with mobility issues as well as reasonable access to a restroom. Exploration should be made to resolve these challenges through a new addition or/and an expansion of the interior space to add a bathroom.

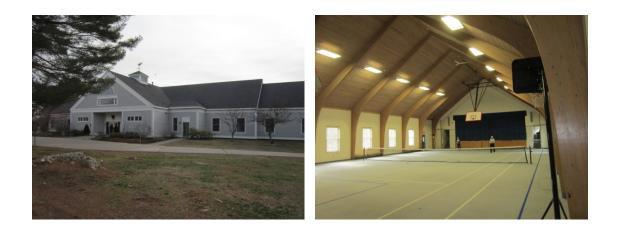
Indoor Tennis Court (New Castle Recreation Building / Library, borrowed space)

Large indoor multi-purpose space framed with Glu-lam frames with wood ceiling and a floor finished with carpet and striped for tennis. Raised stage provided at end of building opposite attached library. Materials are in good condition but floor will wear quickly

Assessment: Single tennis court with unusual short pile carpeted floor finish

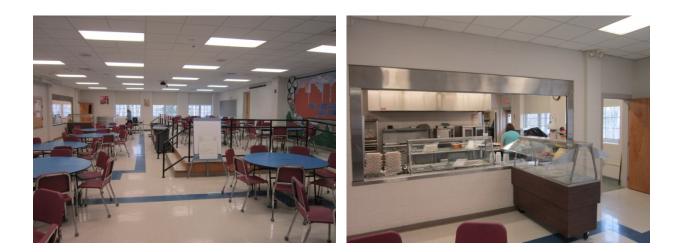
corridor lacks grab bars as found in the men's restroom.

Assessment: Occasional use facility is roomy and bright. Minor repair to women's restroom would make space fully accessible.

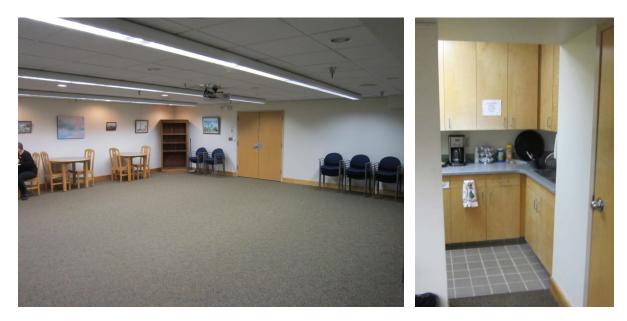
Library Meeting Room (Rye Public Library, borrowed space)

- Flexible meeting space in basement of library provided with a small kitchenette. Below grade space is equipped with ceiling mounted A/V equipment and has no exterior window.
 - Space is showing some early wear related to leaking (equipment?) above suspended ceiling.

Assessment: Flexible meeting space with kitchen provides multiple meeting room uses sought after and space is frequently in use.

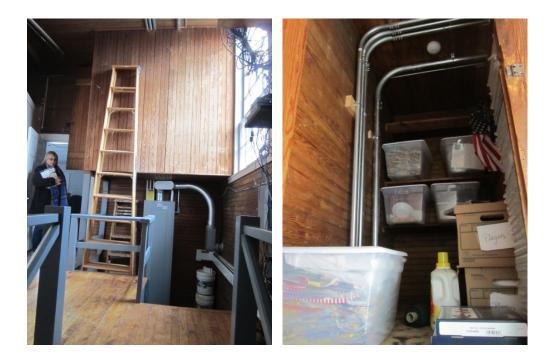
Ladder Access Art Storage (Rye Town Hall, controlled space)

Storage Cabinet/Closet accessed awkwardly by a ladder. Space is located at top of rear stairway in historic wood framed town hall Historic edge and center beaded board cabinet is in fair condition but located terribly for regular access

Lighting: none Mechanical: ambient Climate: dry now with some past water infiltration Ceilings: historic beaded board Walls: historic beaded board Base: none Doors: plank door of beaded board Floor: rough wood Bathrooms: n/a Egress: storage in stairwell is a code violation HC access: none at all

Assessment: This storage space is extremely difficult to access - ABANDON

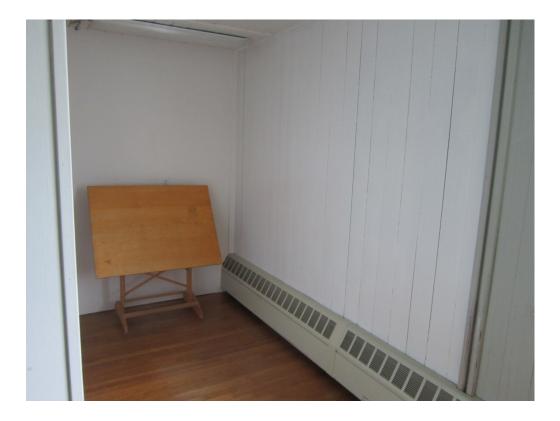
Storage Closet (Rye Town Hall, controlled space)

Lighting: none Mechanical: ambient – highly influenced by air infiltration at historic window. Climate: dry Ceilings: painted historic beaded board Walls: painted historic beaded board Base: none Doors: plank door of beaded board Floor: carpet Bathrooms: n/a Egress: through office space to stairwell or exterior door HC access: access to this area is by stairway only. All stairs are too steep for code.

Lighting: surface mount fluorescent Mechanical: hydronic baseboard Climate: dry Ceilings: historic beaded board Walls: painted historic beaded board / painted plaster Base: none Doors: nine Floor: narrow wood strip Bathrooms: n/a Egress: storage in stairwell is a code violation HC access: none at all

Assessment: This unsecured storage space is extremely difficult to access and dangerous to use for storage- ABANDON

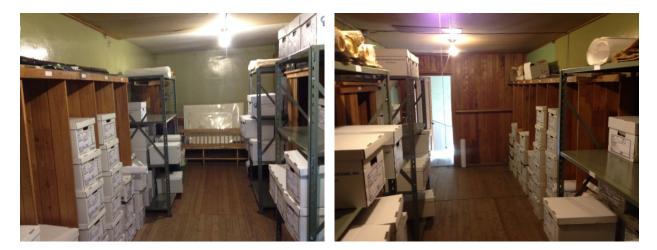
File Archive (Rye Town Hall, controlled space)

Storage Closet located at top of front stairway in historic wood framed town hall Historic edge and center beaded board cabinet is in fair condition but located terribly for regular access

Lighting: ceiling mounted utility incandescent Mechanical: ambient Climate: evidence of moisture movement Ceilings: plaster with augmentation by unfinished gypsum board Walls: historic plaster and historic beaded board with exposed framing Base: none Doors: Historic 4 panel wood Floor: narrow strip wood from two separate installations Bathrooms: n/a Egress: access to room is by single winding stairway HC access: none at all

Assessment: This storage space does not provide adequate protection for contents from either fire or moisture and is difficult to access - Abandon

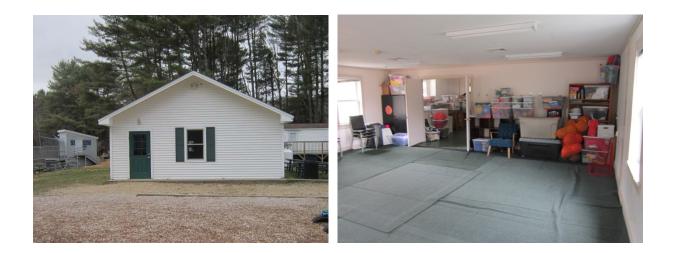
Assessment: Constructed at minimal expense, the building has had some utility but condition and size limit usefulness. Air quality of indoor space is of some concern.

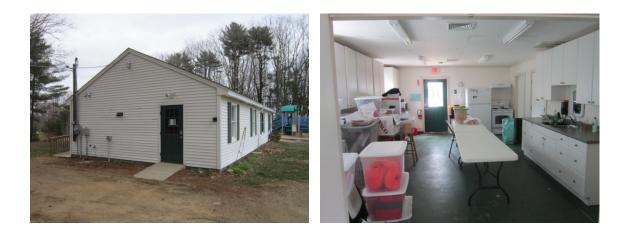
Kitchen/Art Room (Recreation House, controlled space)

Assessment: Lack of storage a primary concern and ceiling finishes should be repaired after determination and repair of cause.

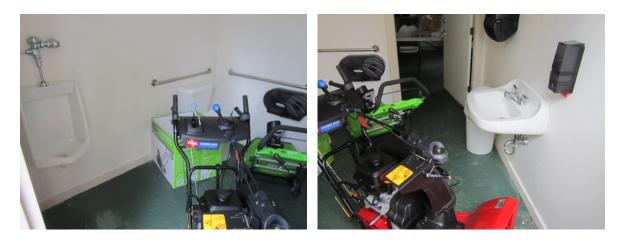
Assessment: Constructed at minimal expense, the building has had some utility but condition and size limit usefulness.

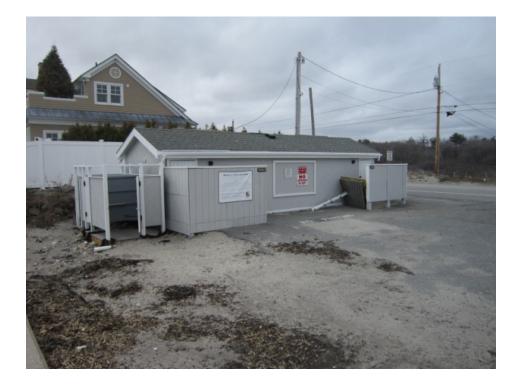
Changing Rooms (Jenness Beach, borrowed space)

Assessment: State of New Hampshire is planning to demolish and replace existing building.
