923.86.01

January 31, 2011

SUBJECT: Town Hall Structural Investigation Services  
Rye, New Hampshire

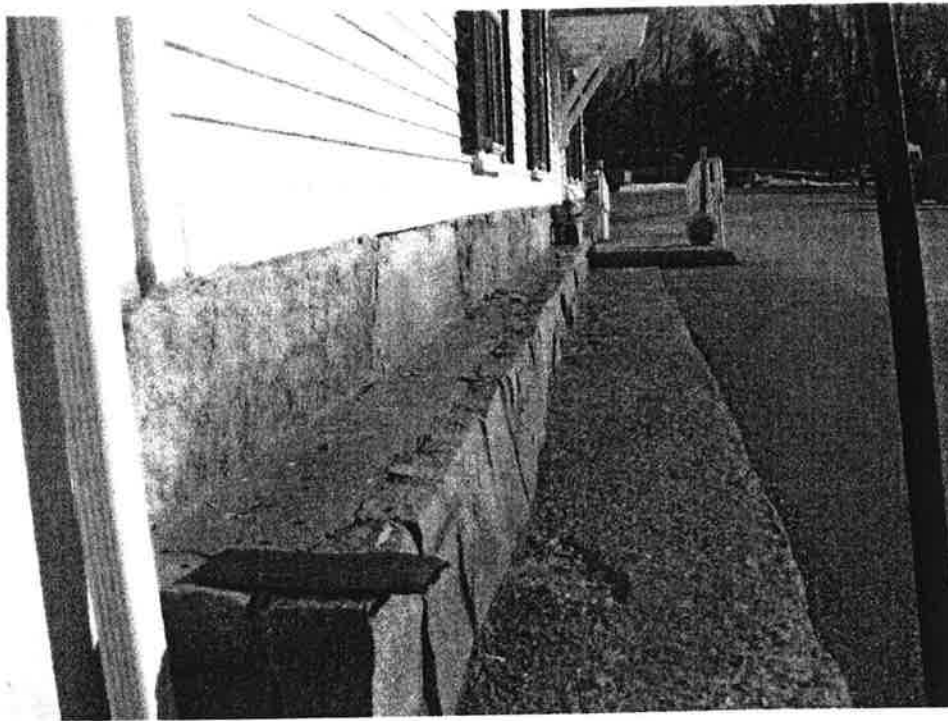
The original building foundation along the south perimeter was identified as a granite stone, brick and mortar perimeter wall that rises approximately twenty inches above a concrete slab on grade (Figure 1). It appears several repairs have been made to the foundation wall on the south side. There are several deteriorated sections where cracked and spalled mortar has created gaps in the foundation wall (Figures 2 and 3).

**Figure 1: South Side Foundation**

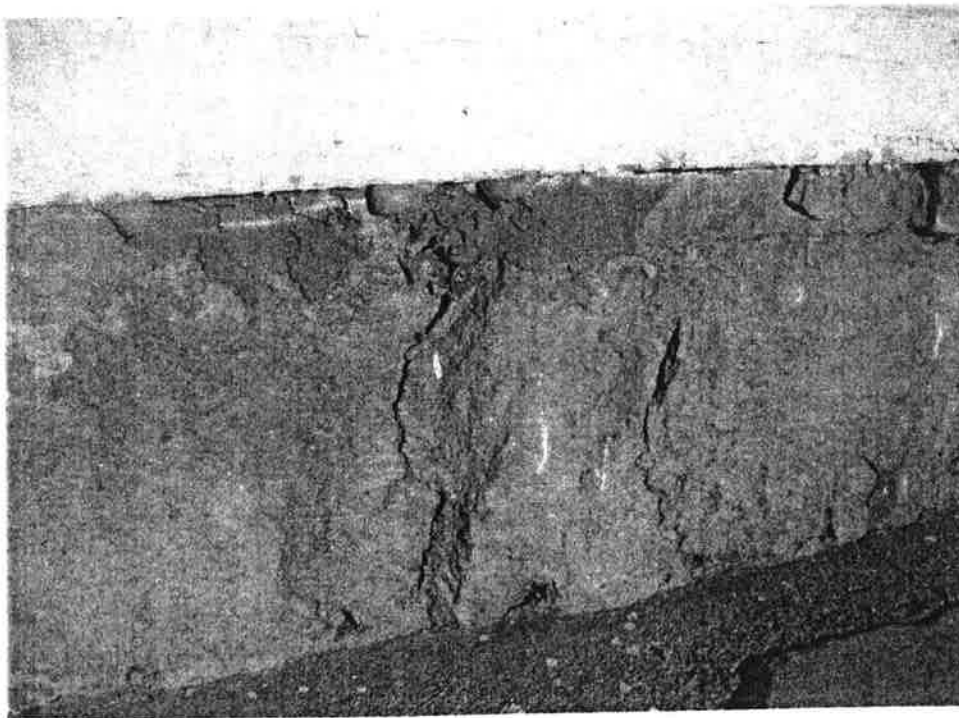
Based on our visual observations of the perimeter foundation walls, we found that the existing foundation walls have only minor cracks and/or deterioration of mortar joints. During our visit, the foundation walls showed no signs of overstress or excessive settlement. Although the top and bottom of the foundation walls were concealed and we could not verify the existing condition of these elements, it is our opinion that the existing foundation is in good condition. We recommend filling in the cracks in the poured concrete sections of the walls with pressure grout. At the granite walls, we recommend that the deteriorated/cracked mortar be removed and new mortar be installed. Both of these recommended repairs are to help prevent future deterioration due to water infiltration.

**Figure 2: Cracks in Granite Foundation – South Side**

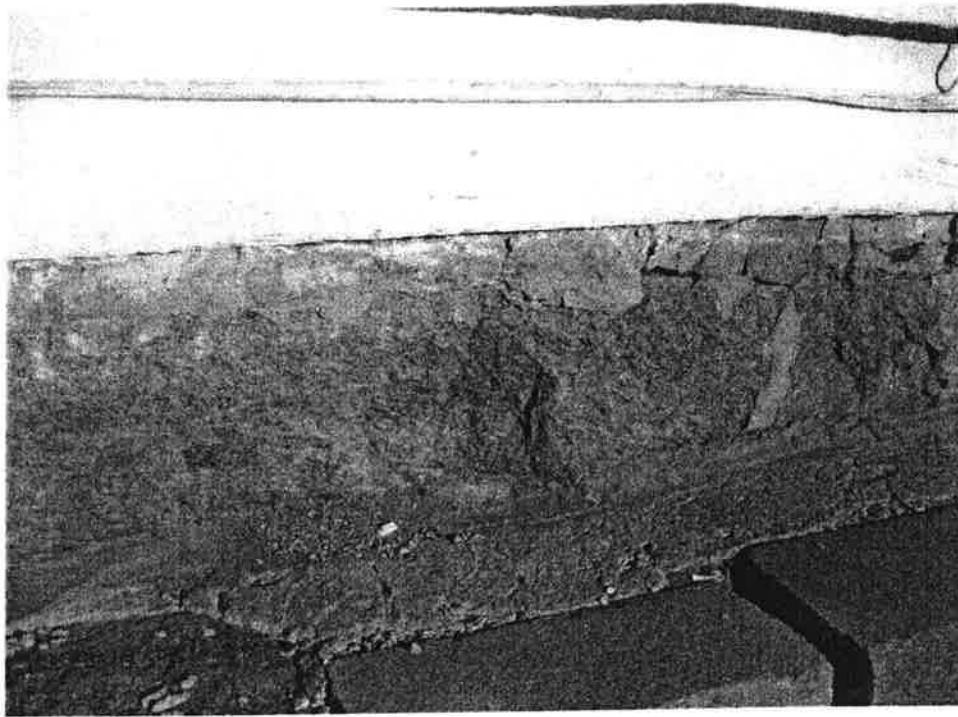
**Figure 3: Cracks in Granite Foundation – South Side**

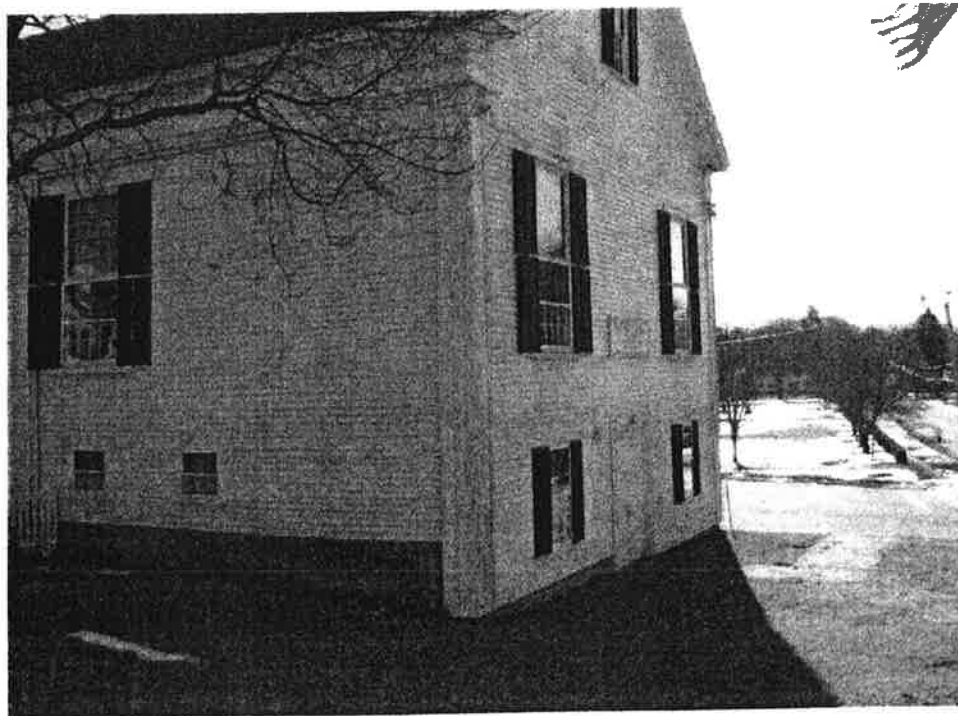
The front (west) and north perimeter foundation walls of the original building consist of a concrete wall extending below grade (Figure 4). We believe at some point these walls replaced the original granite stone foundation. The foundation walls appear to be in good condition. There were a few areas where cracking has occurred (Figures 5 - 7) but there are no signs of settlement.

**Figure 4: North and West Side Foundations**

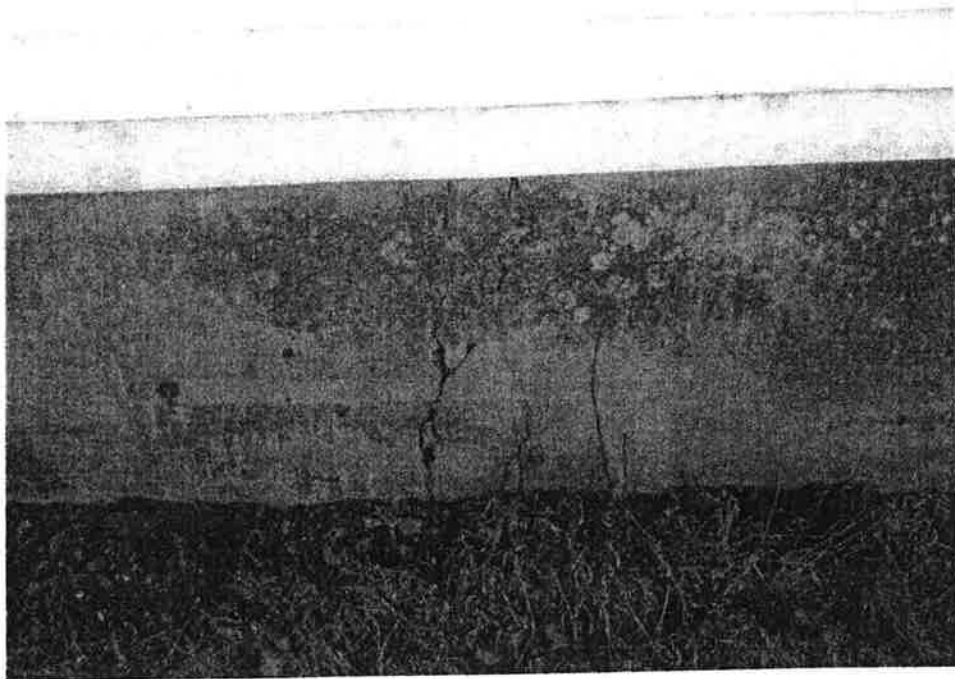
**Figure 5: Cracks in Foundation – North Side**

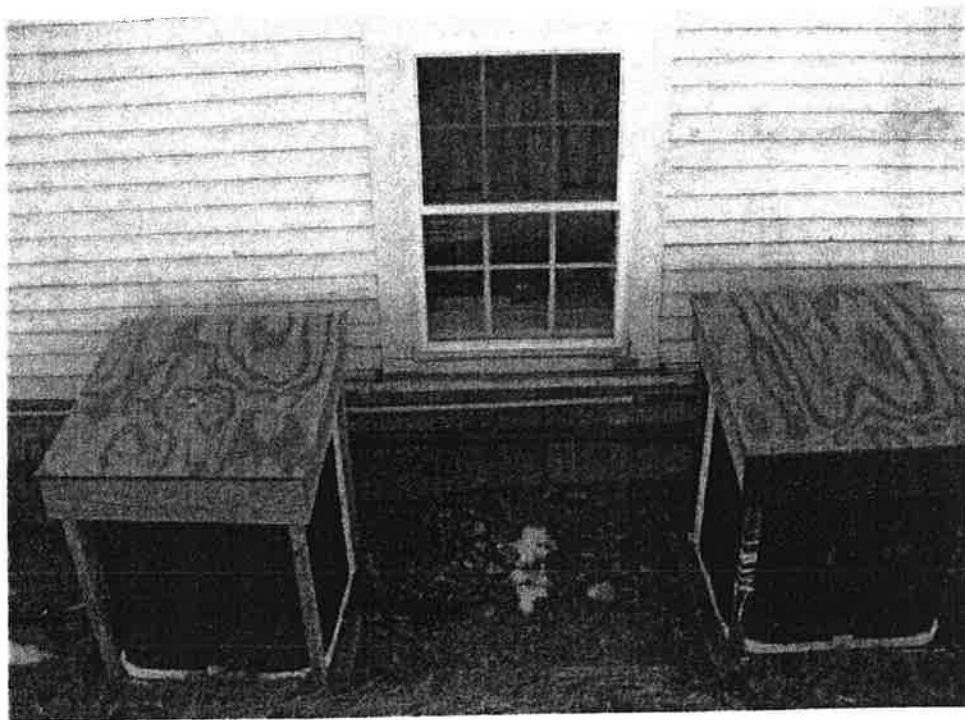
**Figure 6: Cracks in Foundation – North Side**

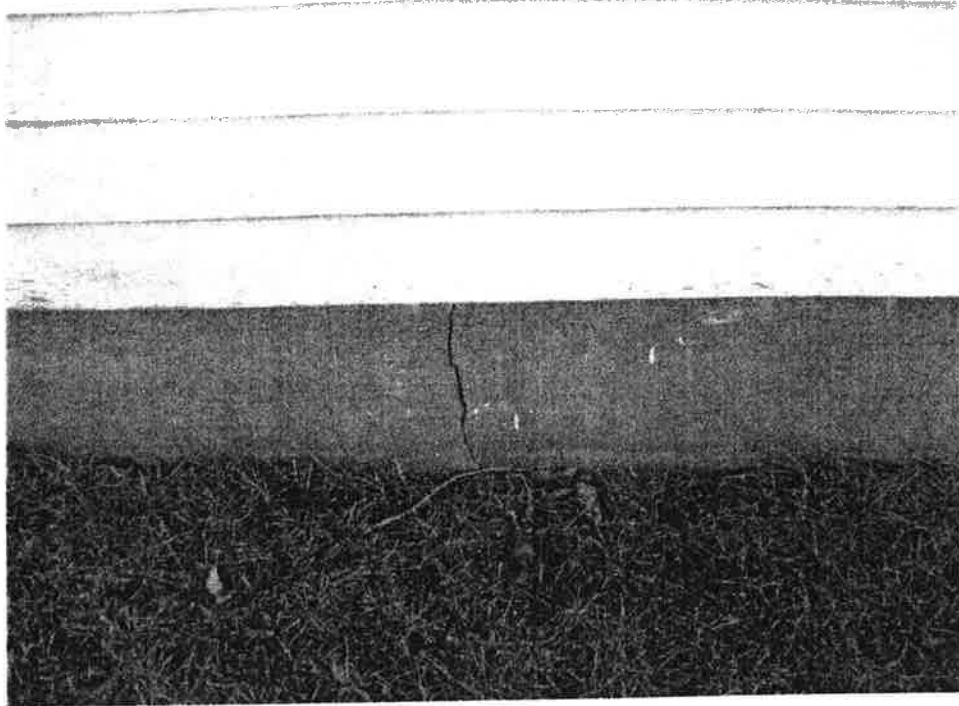
**Figure 7: Cracks in Foundation – West Side**

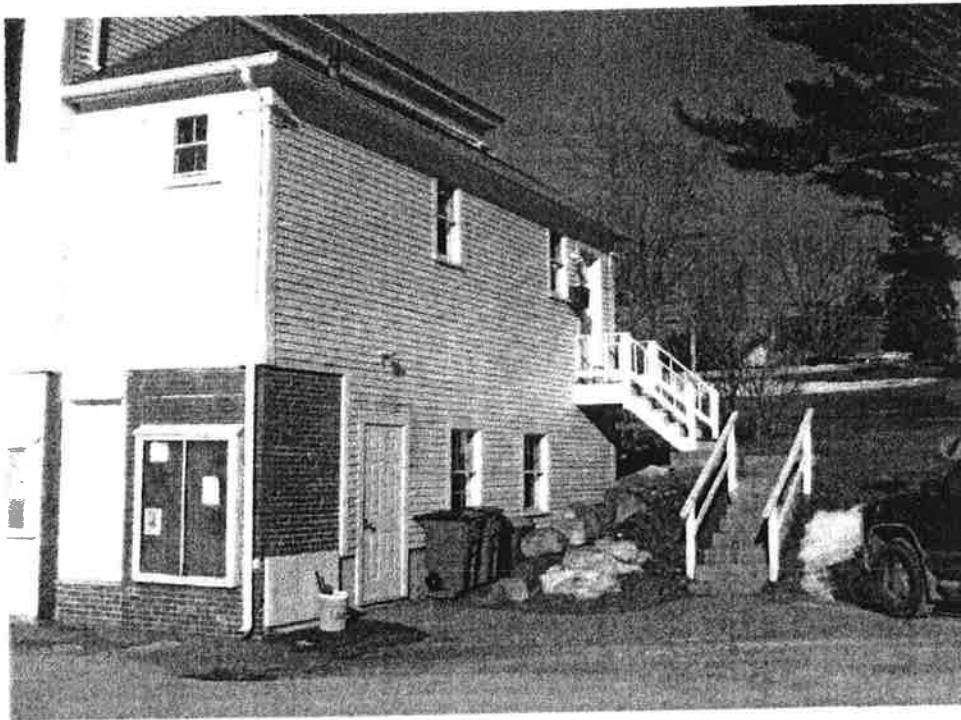
The east perimeter is the foundation under the newest addition. It is comprised of masonry block and brick pillars (Figures 8 and 9).

**Figure 8: East Side Foundation**

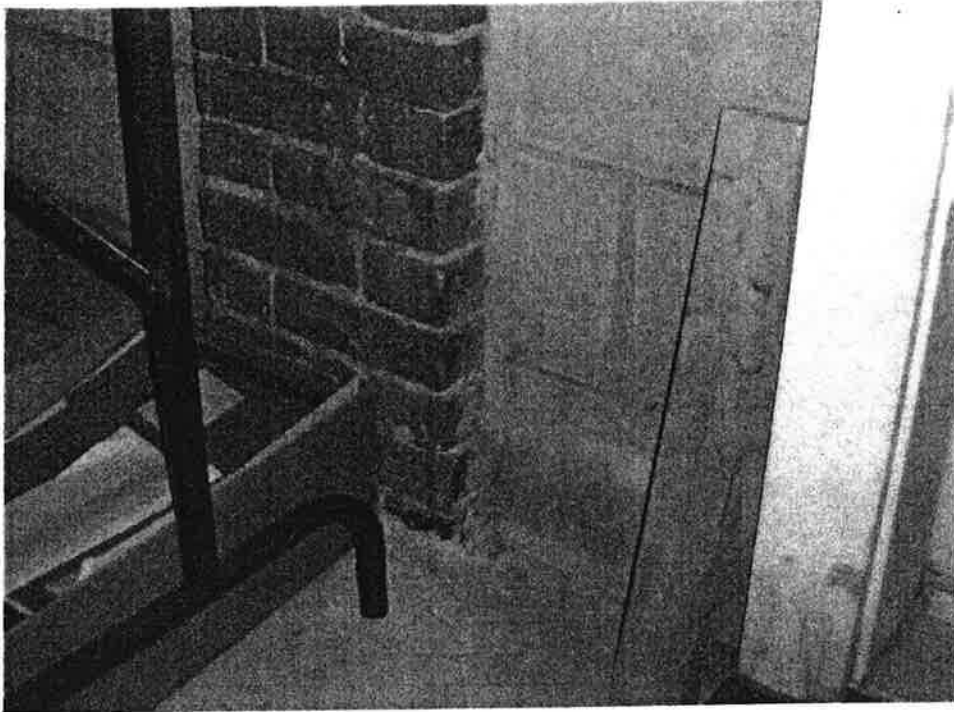
**Figure 9: East Side Foundation**

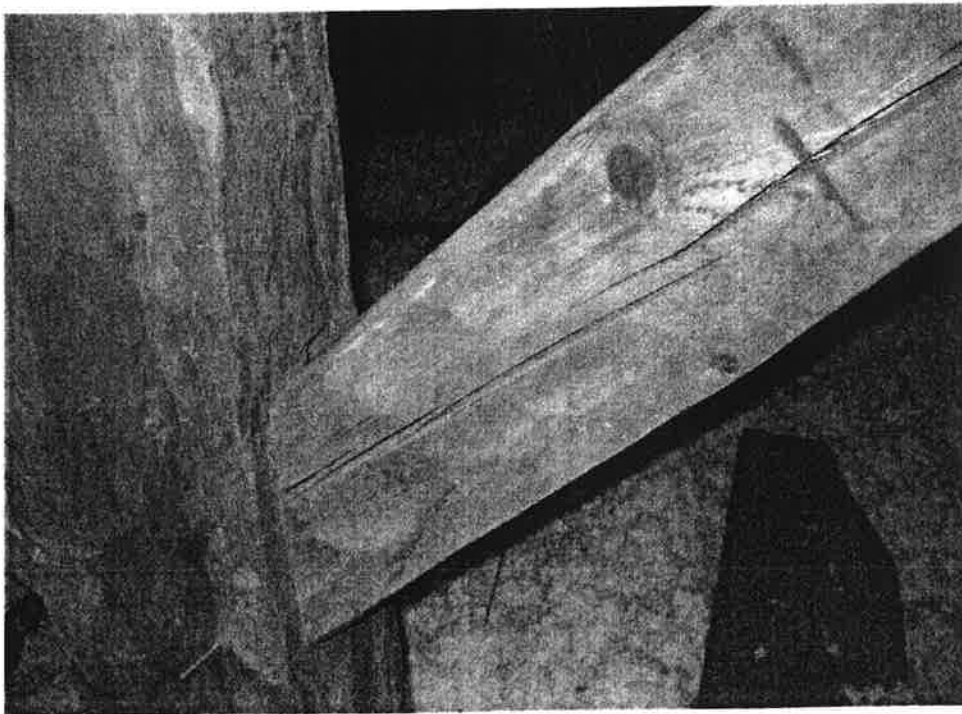
We visually reviewed each frame and its connections for deficiencies. Many of the framing and truss members have checked (Figures 10-12). At the north end of Frame 6, we noted some sawdust on the top of the tie beam, but found no signs of deterioration or distress that would have created it (Figure 13). At the north end of Frame 4, the column

**Figure 10: Checking in Truss Member**

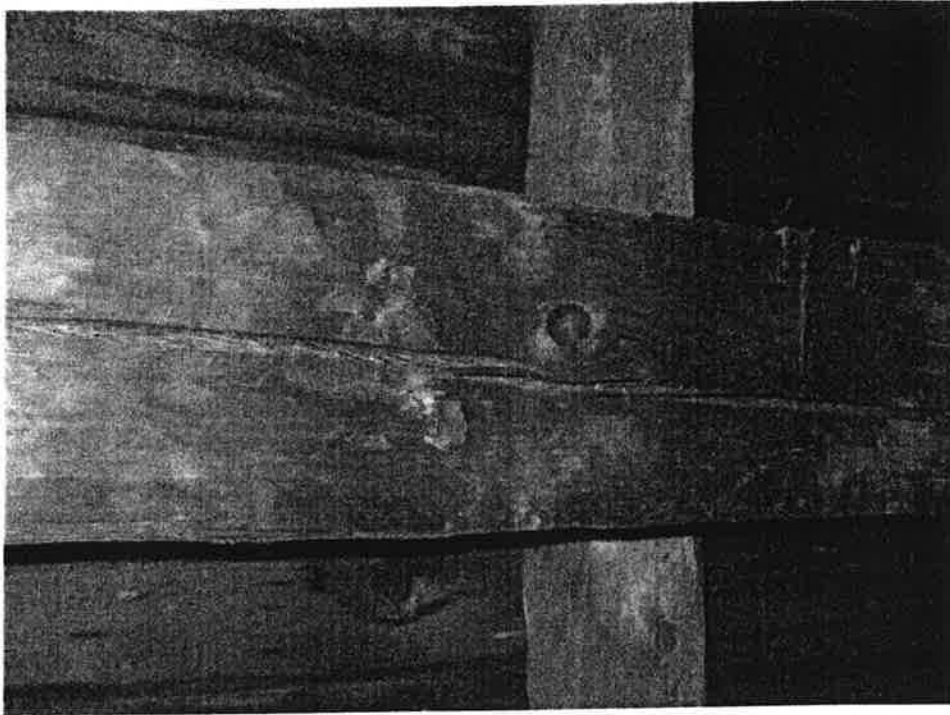
**Figure 11: Checking in Member**

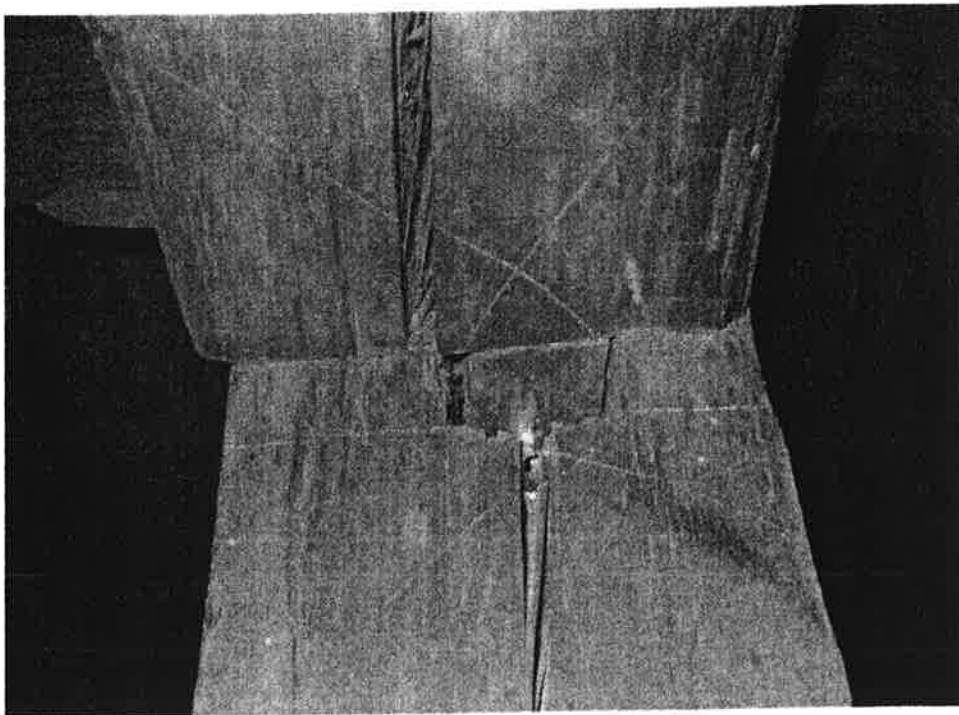
**Figure 12: Checking in Member**

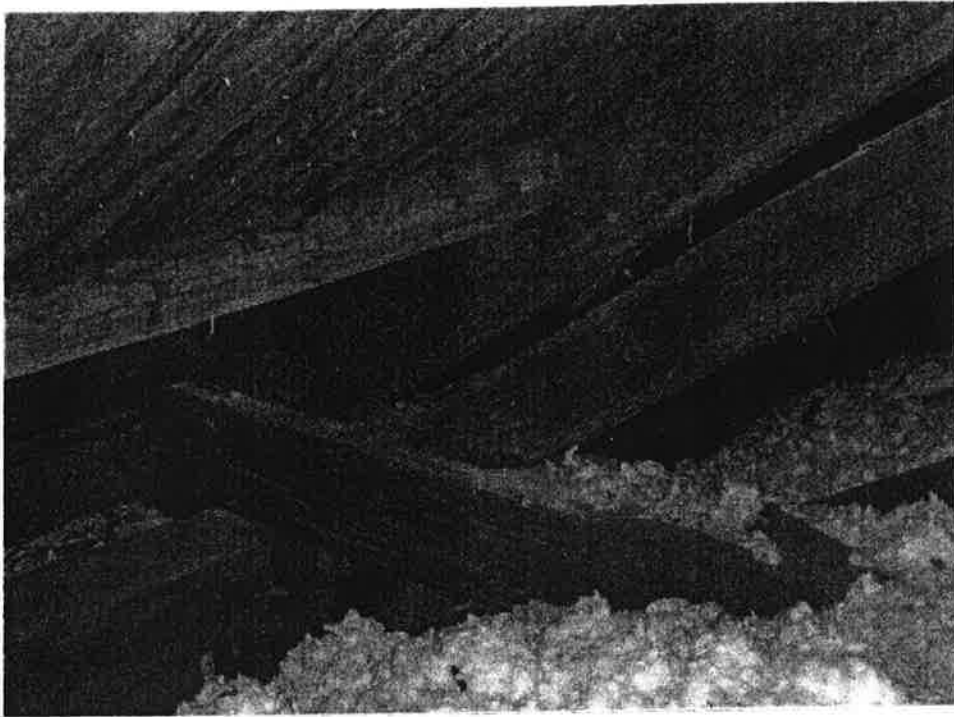
**Figure 13: Sawdust**

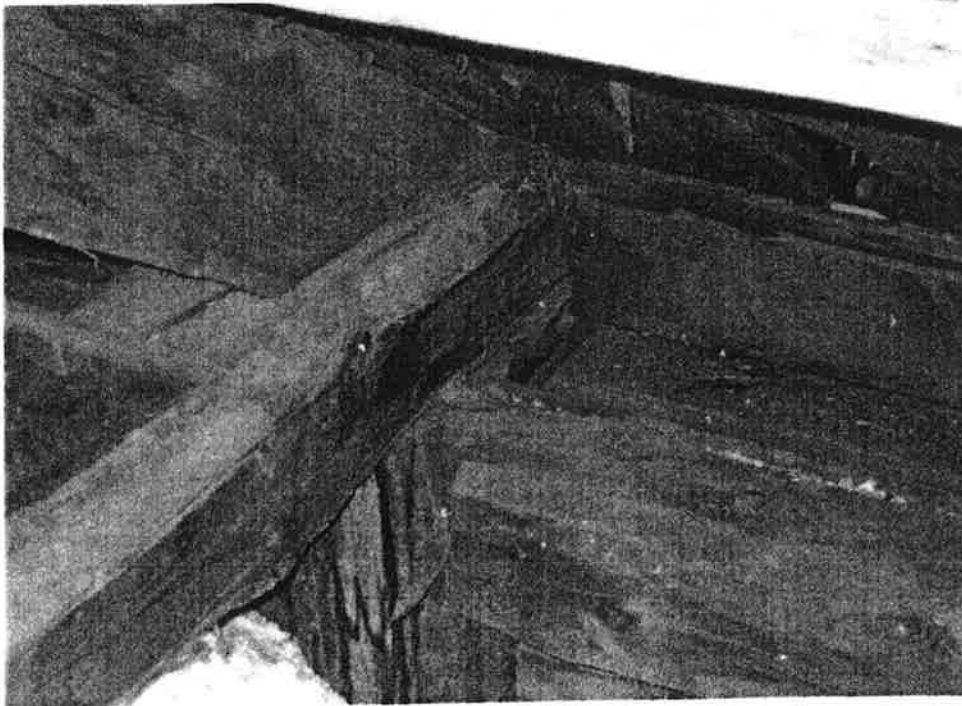
has cracked at the dowel connection to the perimeter beam (Figure 14). At Frame 3, the north end queen post has been removed and replaced with a smaller post and a support brace was added. It appears the original queen post had failed at some point in the past and was reinforced (Figures 15 and 16). At the south end queen posts of Frames 1 and 2, dowels are missing at the connections of the post to the tie beams.

**Figure 14: Column cracked at the dowel connection to perimeter beam**

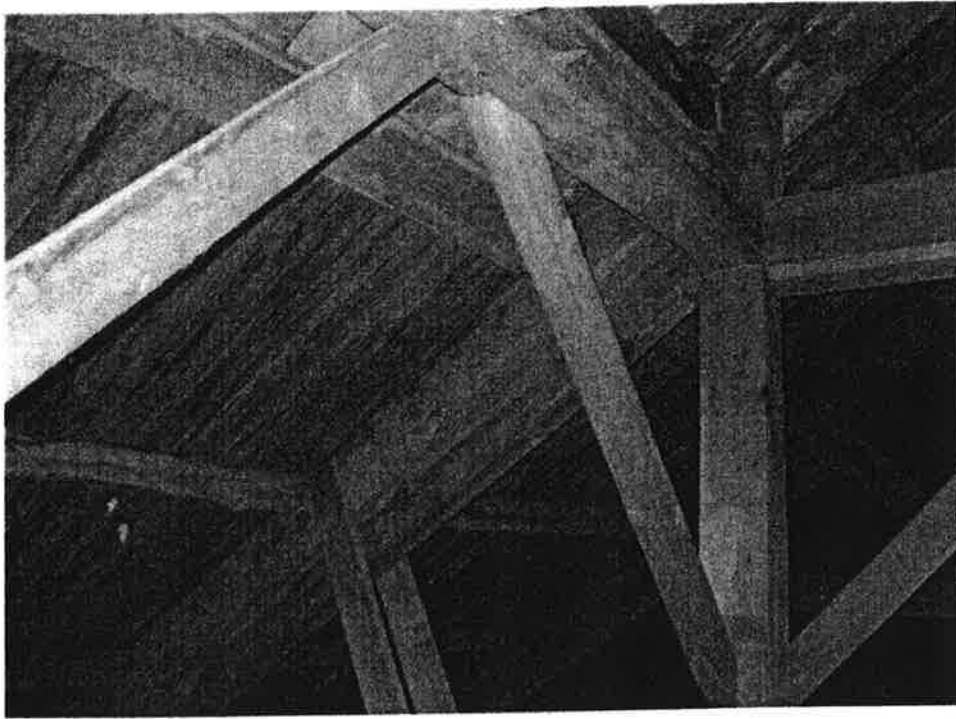
Although the roof trusses and purlins do not meet the current code requirements they appear to be in good condition. Minor deficiencies and deterioration were found, but nothing to suggest the structural integrity of the roof trusses or the purlins have been compromised except for the repaired truss on Truss Frame #3.

**Figure 15: Queen Post Column Replacement and added Brace**

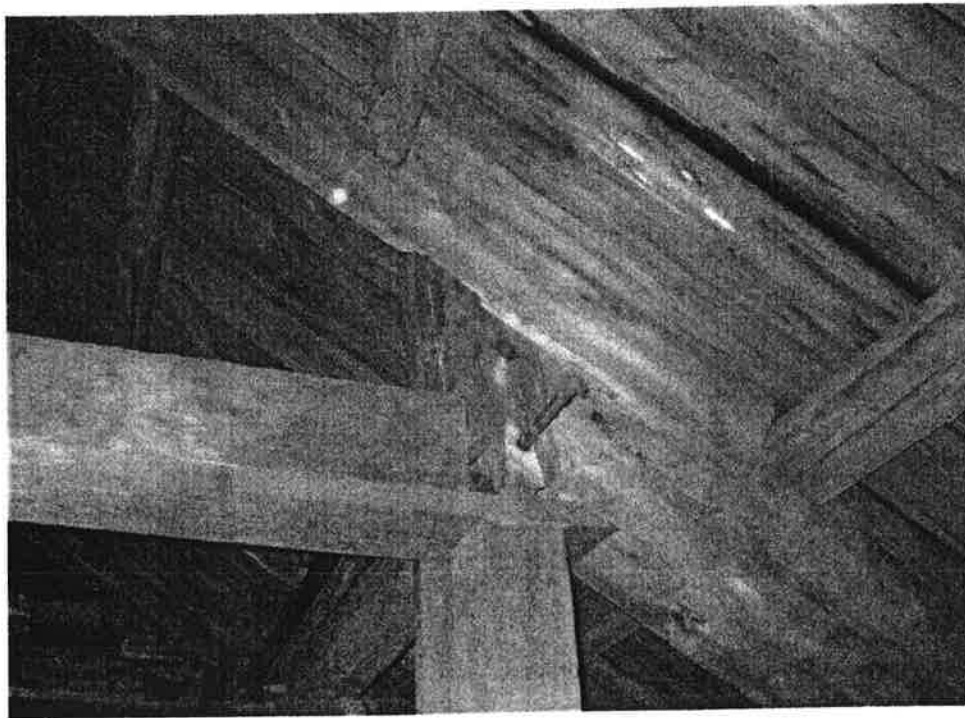
**Figure 16: Queen Post Column Replacement**
