**Annual Post-Closure Report 2023
Grove Road Municipal Landfill
Grove Road
Rye, NH 03870
NHDES Site #: 123456789
Project Type: LAND/UNLN
Project Number: 0002039**

ANNUAL POST-CLOSURE REPORT

Reporting Year 2023

FACILITY INSPECTION INFORMATION

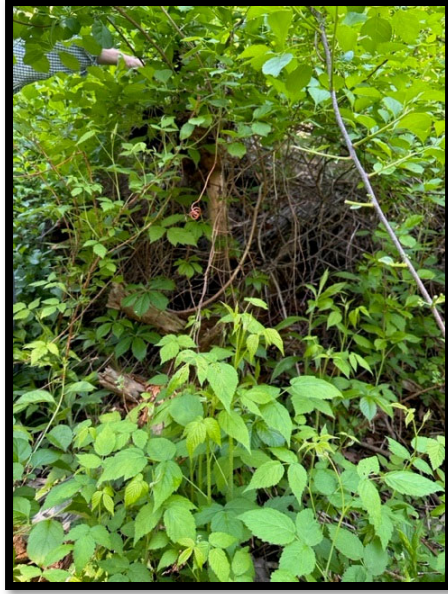
Supplemental Information
<p>There is brush at MW-2D that should be cut back (Photo #1).</p> <p>The brush on the locating bar for MW-4 should be removed (Photo #2).</p> <p>The tubing for MW-101 is above the casing so the cover to the well does not sit on it correctly (Photo #3). There is the possibility of introducing contamination into the well. To permanently fix it, the PVC should be cut down and the top of the well resurveyed. In the interim, an alternative temporary cover could be used.</p>

Photo 1: Overgrown brush at MW-2D

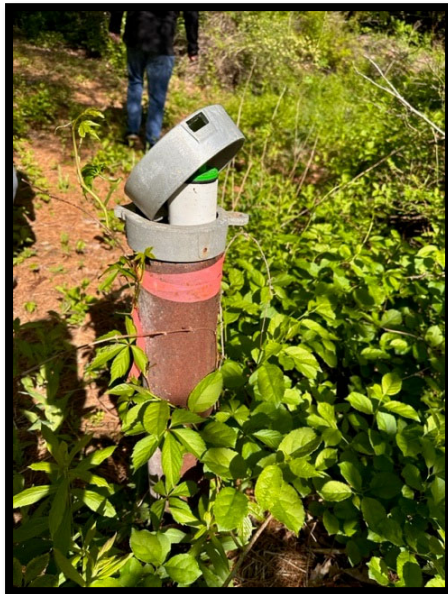
Action Item	Carried Forward from 2022?		Date Completed	Date to be Completed	Information Attached?
Tubing for MW-101 extends higher than the metal casing. Cut tubing and resurvey the top of the well.	<input type="checkbox"/> Yes	<input checked="" type="checkbox"/> No		2024	<input checked="" type="checkbox"/>
Brush at MW-2D and MW-4. Cut back brush.	<input type="checkbox"/> Yes	<input checked="" type="checkbox"/> No		2024	<input checked="" type="checkbox"/>
Remove fallen trees.	<input type="checkbox"/> Yes	<input checked="" type="checkbox"/> No		2024	<input checked="" type="checkbox"/>
	<input type="checkbox"/> Yes	<input type="checkbox"/> No			<input type="checkbox"/>
	<input type="checkbox"/> Yes	<input type="checkbox"/> No			<input type="checkbox"/>
	<input type="checkbox"/> Yes	<input type="checkbox"/> No			<input type="checkbox"/>
	<input type="checkbox"/> Yes	<input type="checkbox"/> No			<input type="checkbox"/>

Photo 2: PVC riser sticking out of casing MW-101

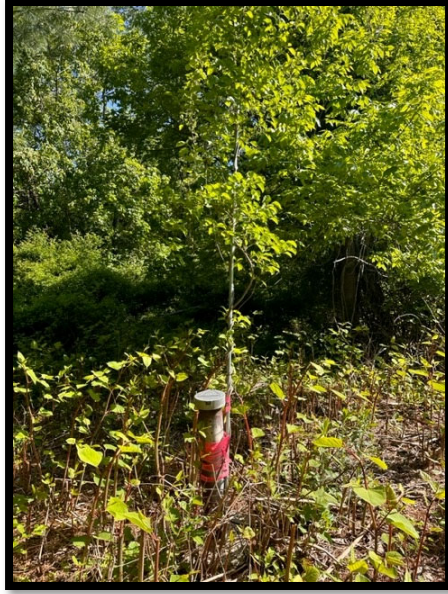
Photo 3: Growth on locator bar MW-4

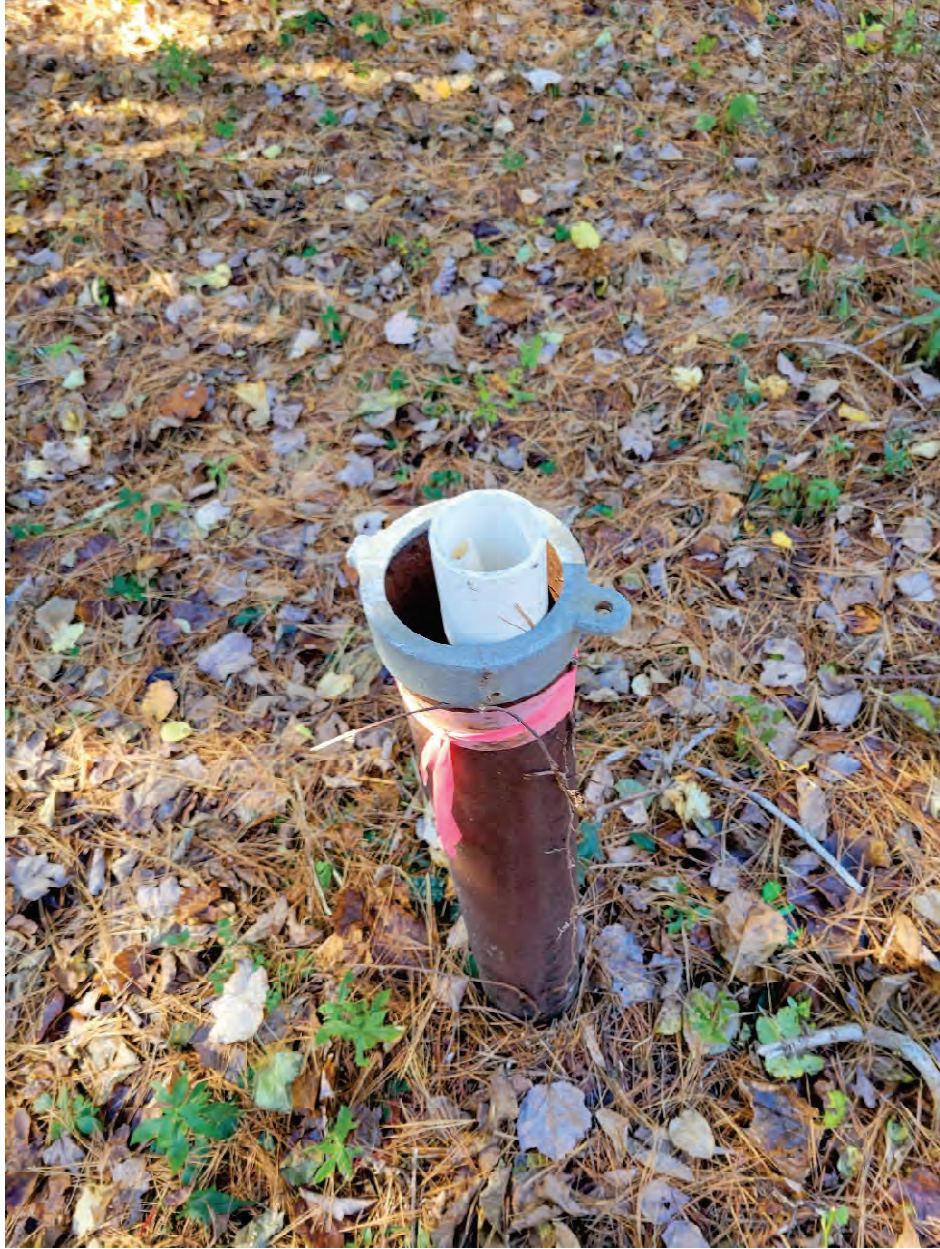
Supplemental Information
<p>MW-101's PVC tubing extends higher than the metal casing which makes the cap unable to be put on correctly. There is the possibility this can introduce contamination into the well. The PVC should be cut down and the top of the well resurveyed. In the interim, an alternative cover could be used.</p> <p>MW-2D is inaccessible due to brush from a fallen tree. This should be cut back.</p> <p>MW-4 is overgrown but accessible. The brush should be cut back.</p> <p>There were multiple downed trees over the landfill most noticeably around the access road leading to MW-1.</p>

Photo 1: PVC riser sticking out of casing MW-101

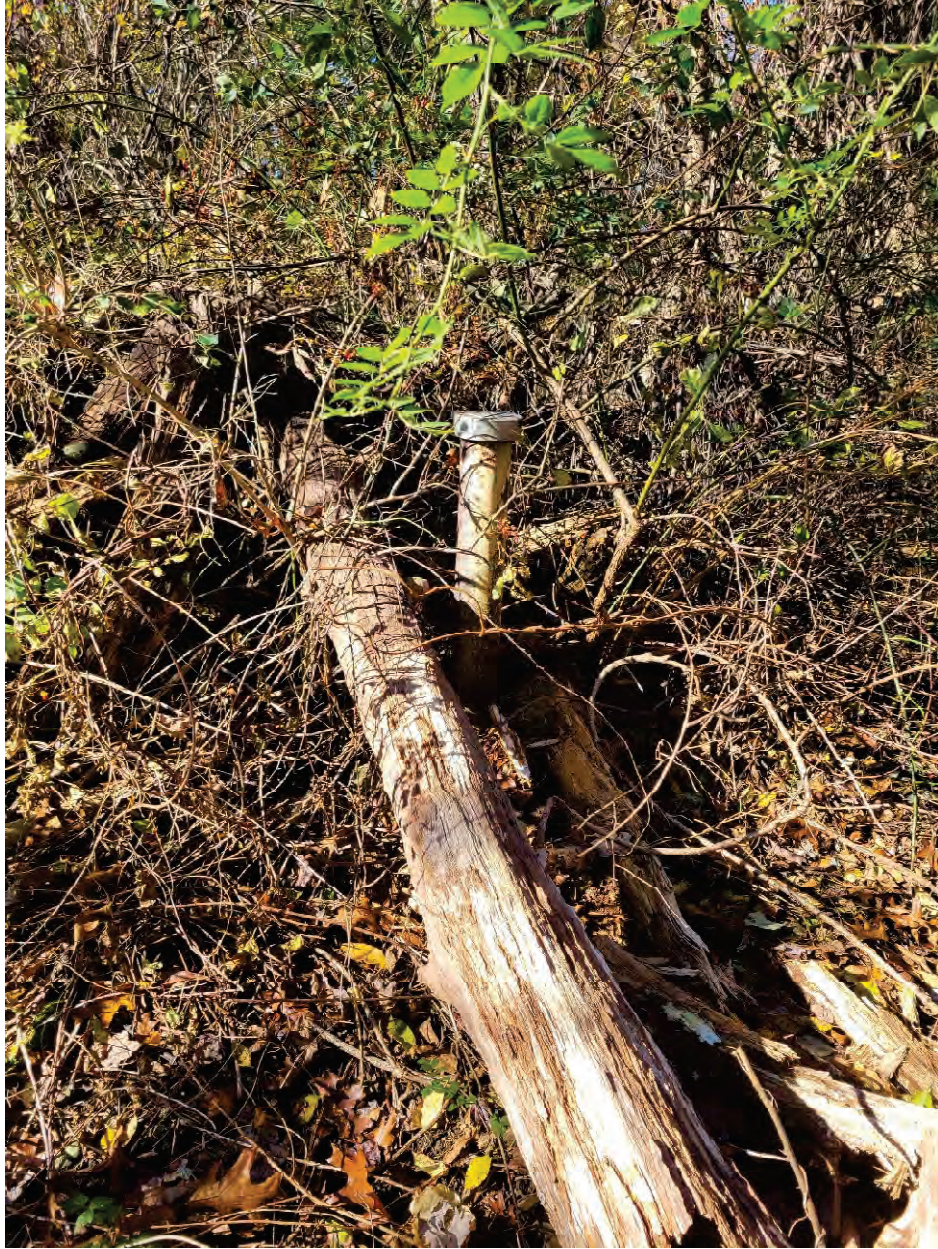
3. Does cap slope promote runoff?	<input type="checkbox"/>	<input checked="" type="checkbox"/>		
4. Is the cap mowed on a regular basis? NHDES recommends that landfills be mowed twice per year. Date(s) the landfill was mowed for this reporting year:	<input type="checkbox"/>	<input checked="" type="checkbox"/>		MW-101's PVC tubing extends higher than the metal casing which makes the cap unable to be put on correctly. There is the possibility this can introduce contamination into the well. The PVC should be cut down and the top of the well resurveyed. In the interim, an alternative cover could be used. MW-2D is inaccessible due to brush from a fallen tree. This should be cut back.

Photo 2: MW-2D is inaccessible due to a downed tree

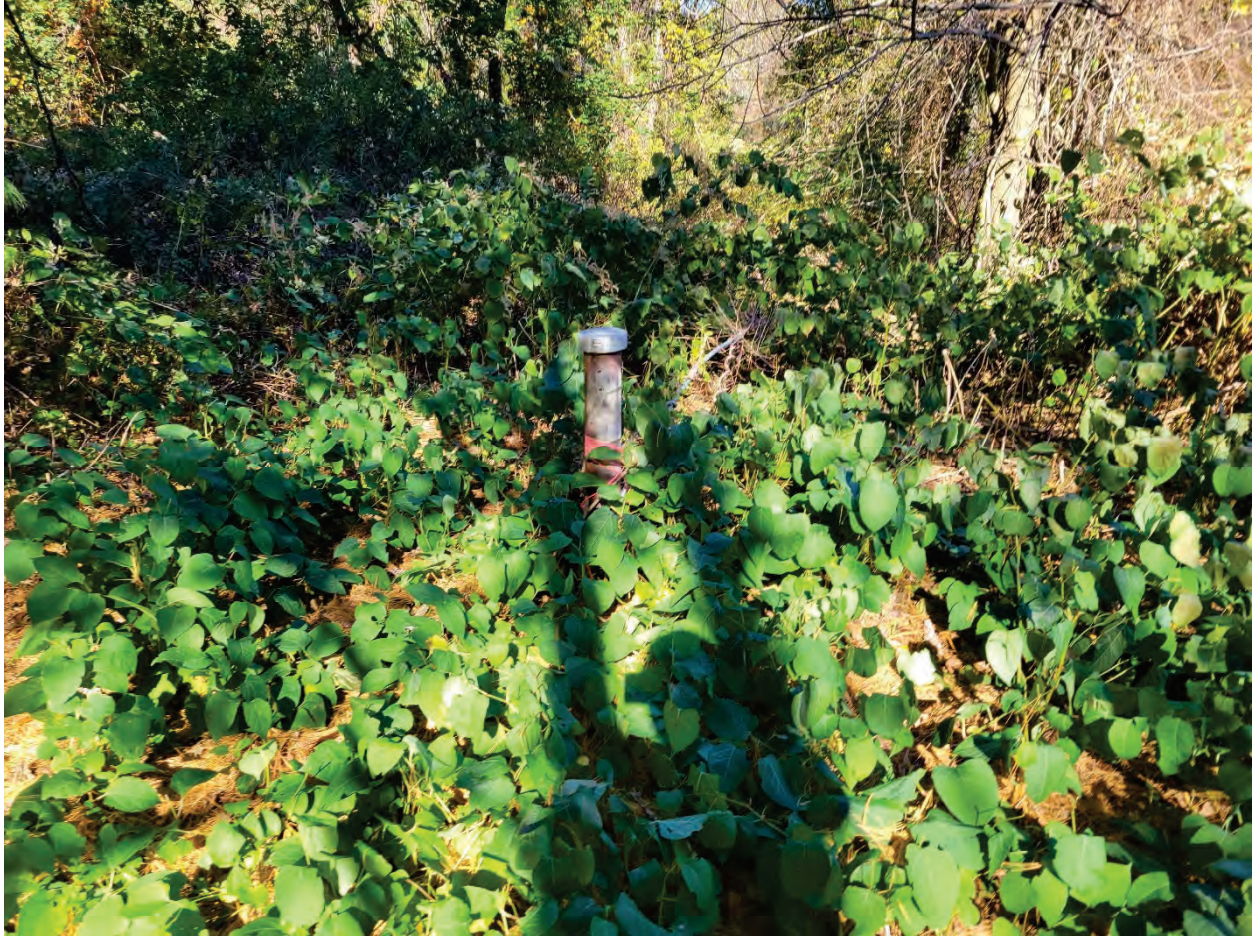
Photo 3: Growth on and around locator bar at MW-4

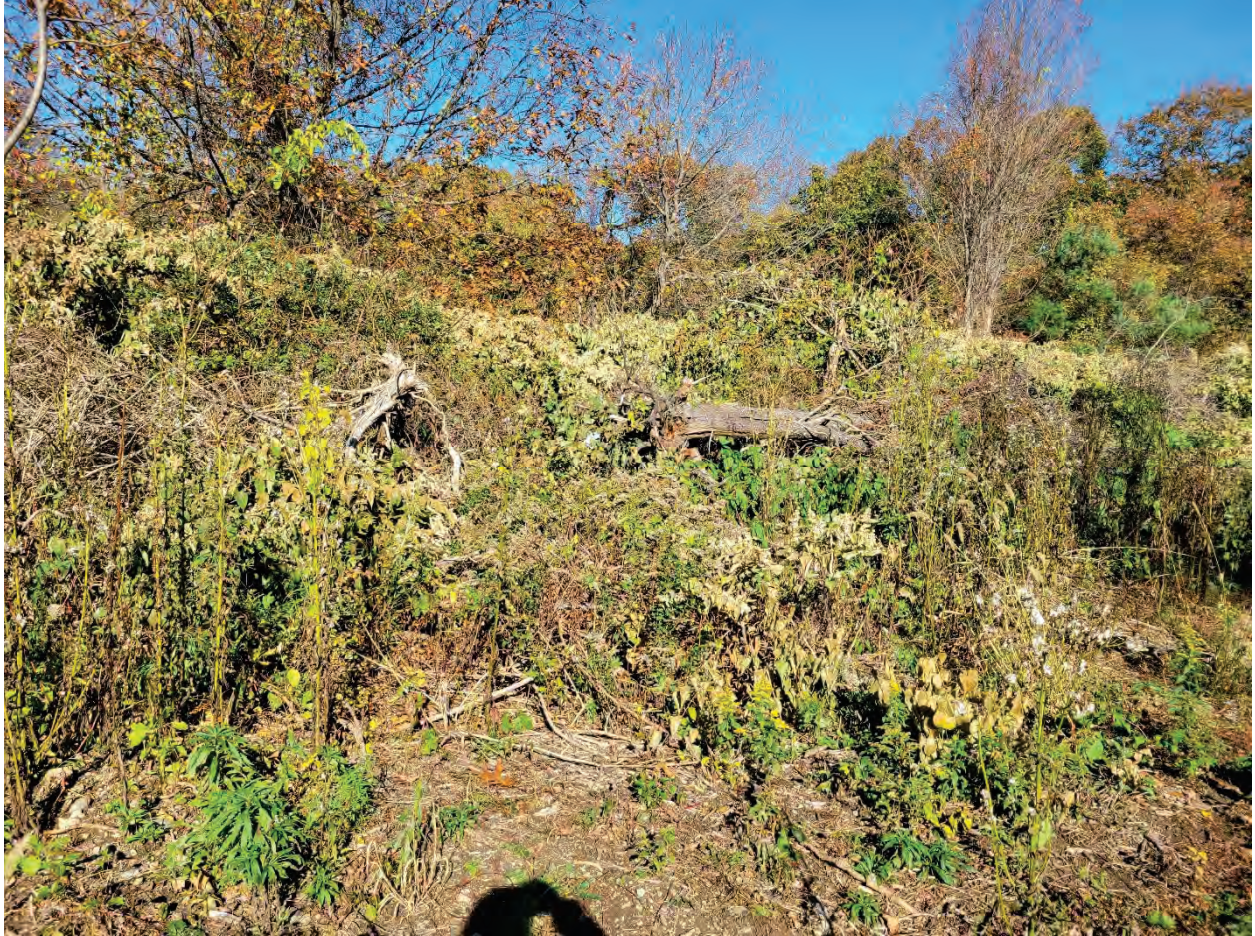
Photo 4: Downed tree near access road

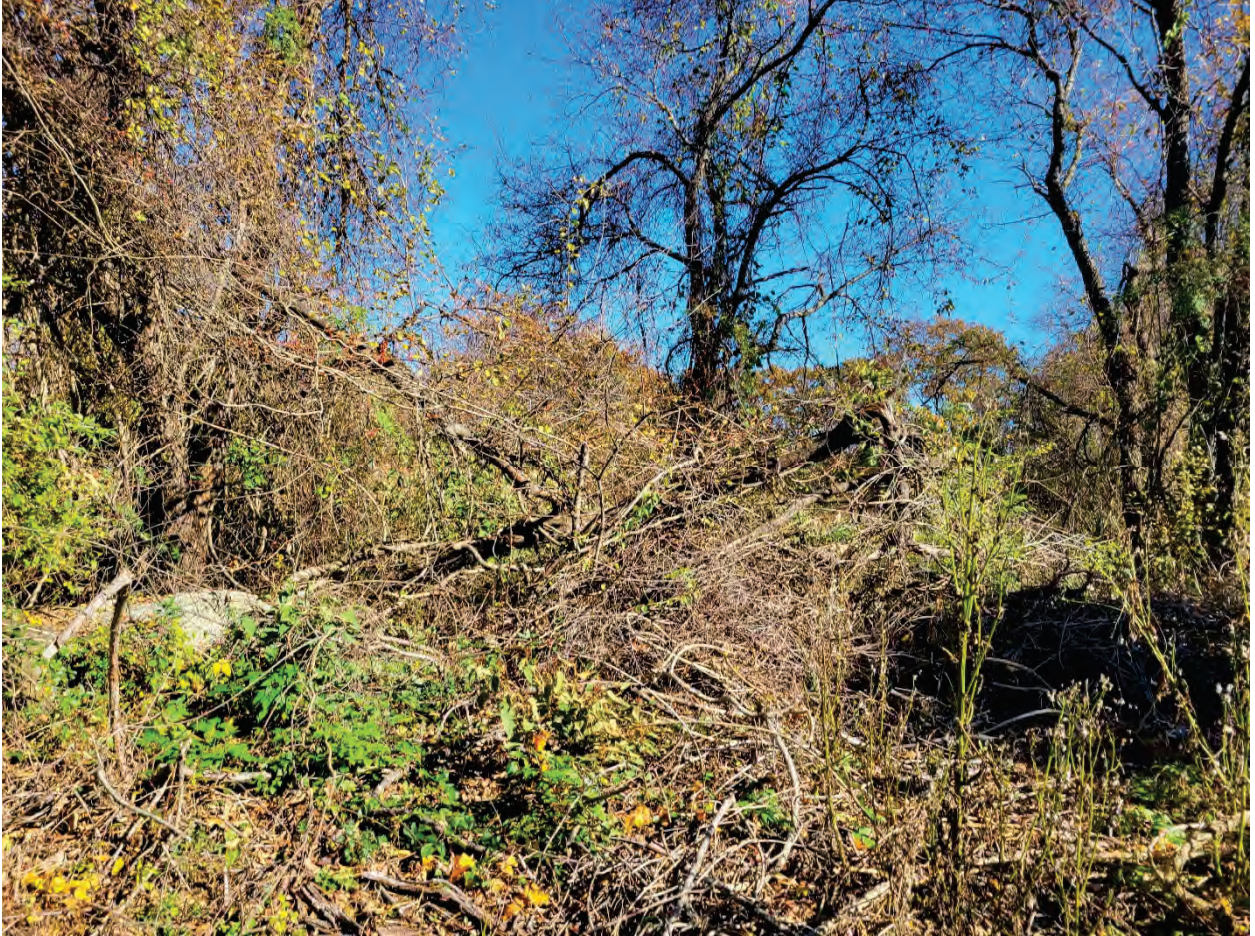
Photo 5: Downed tree near access road

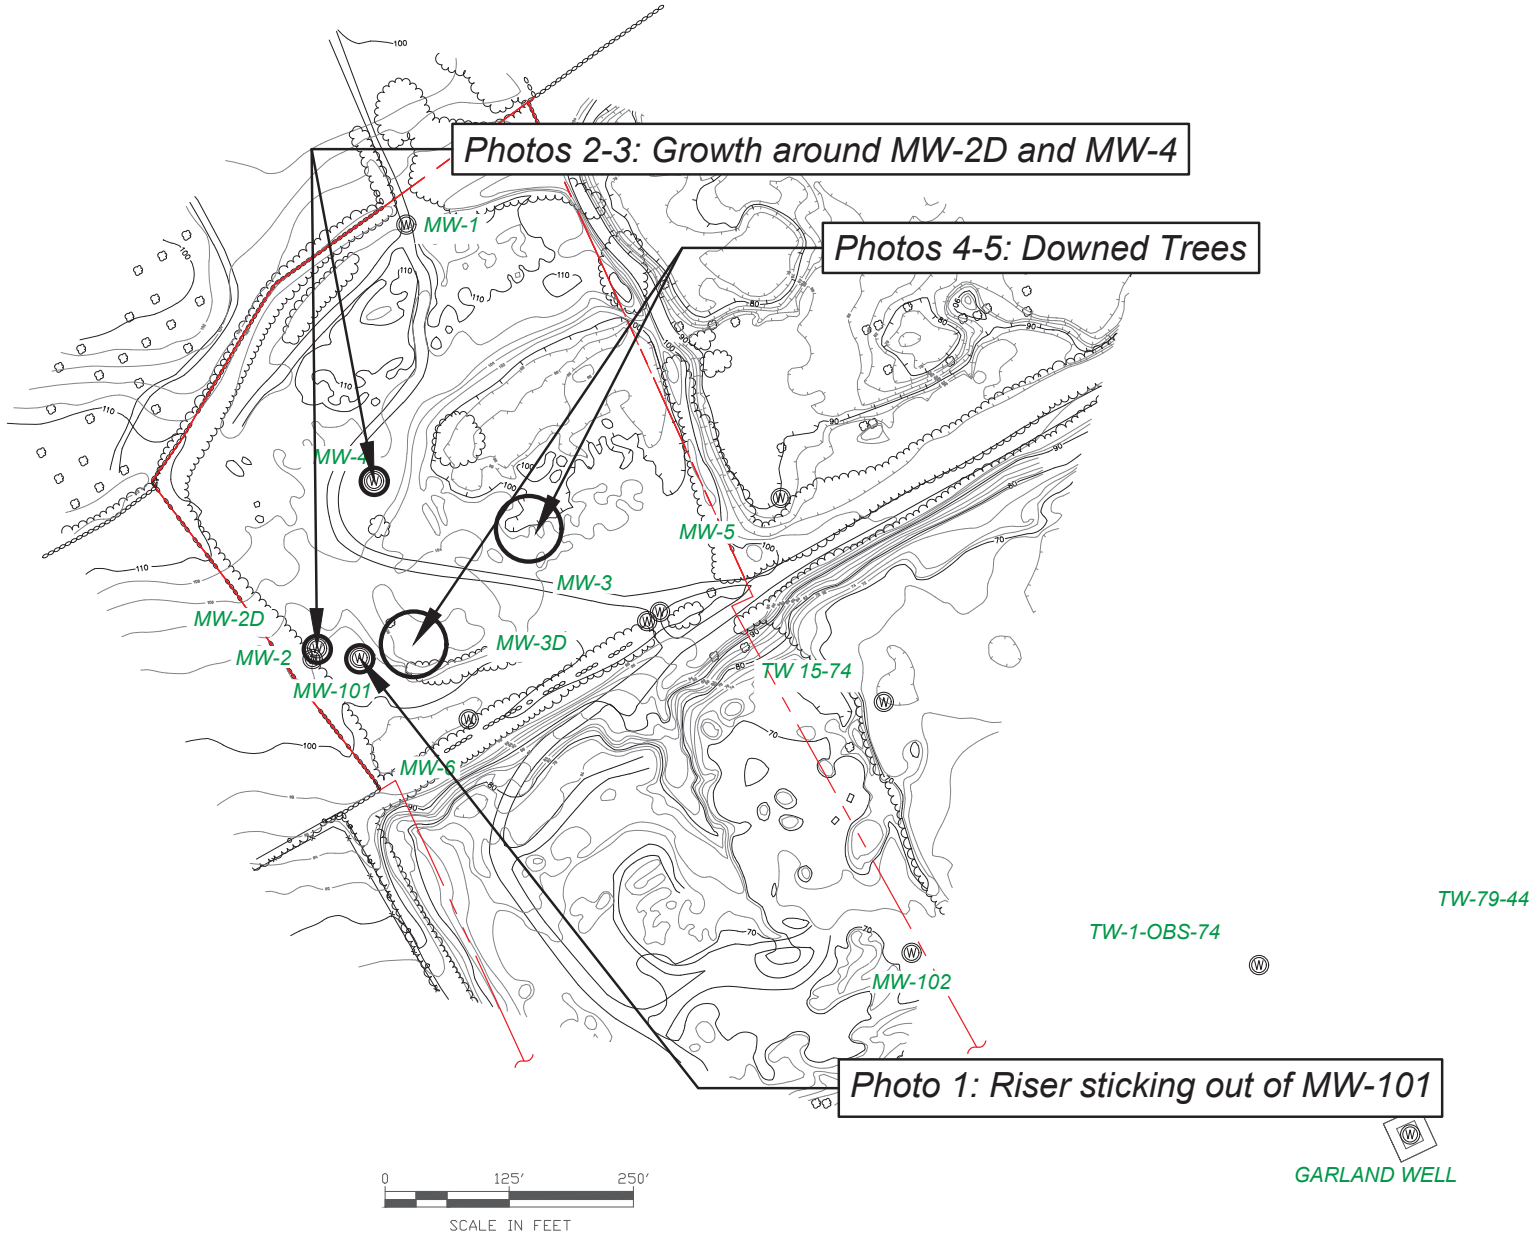
Photos 2-3: Growth around MW-2D and MW-4

Photos 4-5: Downed Trees
