## **Introduction**

The Town of Rye has in recent years been evaluating what improvements should be considered for the Town Hall building. An energy audit conducted in 2009 noted major issues with the condition and energy performance of the building. The report noted that exterior walls are mostly uninsulated, there is no attic ventilation, roof shingles are failing and there are leaks requiring repair, water penetration is damaging the wooden eave molding and fascia boards, single-pane windows with sash cords and weights are drafty and inefficient, mechanical systems are old and inefficient, the fuel storage tank is buried on the North side of the building, and the electric service for the building is inadequate at 200 amps. A structural study completed in early 2011 evaluated foundation and roof structure concerns, and included recommendations for reinforcing the existing roof trusses to meet current code load requirements. In 2011, a grant was obtained for replacing the mechanical system with a geothermal heat pump system; this work is still pending final approvals.

The Town is at a crossroads in its decision making process. In order to better understand the Town's needs, the

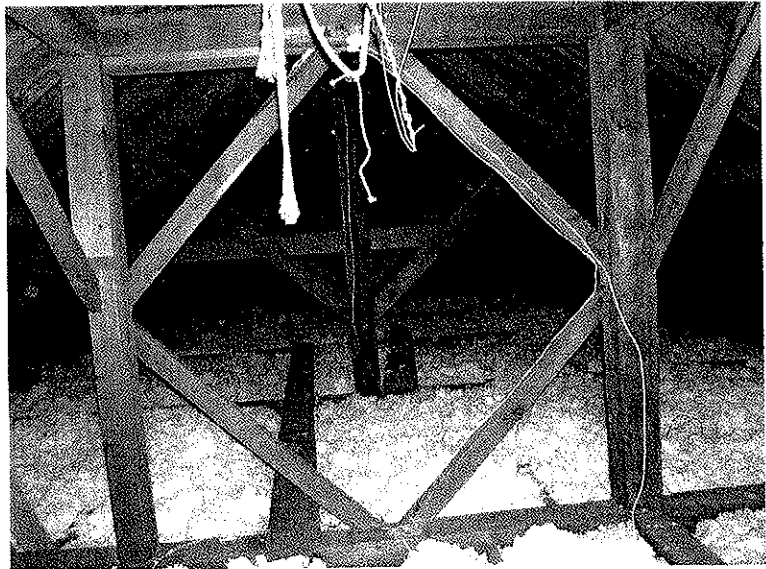
- The roof and building structure is a timber frame with purlins and 1x12 board decking for the roof. The timber frame is classic construction with a combination of king post trusses and queen post trusses. The belfry extends vertically above the queen post trusses.
