**Annual Post-Closure Report 2021  
Rye Municipal Landfill  
Breakfast Hill Road  
Rye, NH 03870**

**NHDES Site #: 123456789  
Project Type: LAND/UNLN  
Project Number: 0000225**

Date of Report: March 22, 2022

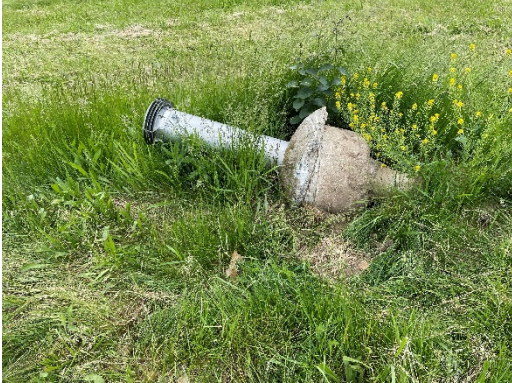
**Photos 1 & 2** - A gas vent was damaged. It was repaired later in the year.

Photo #1 - Damaged gas vent in May 2021.

All gas monitoring wells are in good condition and appear to be functional. There is one gas vent that has been damaged and needs to be repaired. There are no landfill odors or evidence of stressed vegetation.

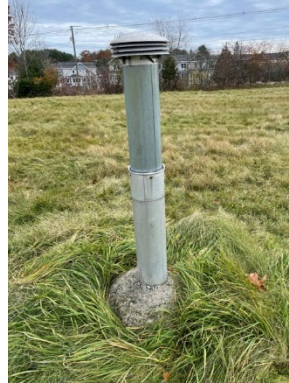
Photo #2 - Repaired gas vent in November 2021.

All gas probes and gas vents are in good condition and appear to be functional. The gas vent that was previously noted as damaged has been repaired. There are no landfill odors or evidence of stressed vegetation.
