COAKLEY LANDFILL COMMUNITY UPDATE

November 14, 2022

BEDROCK INVESTIGATION

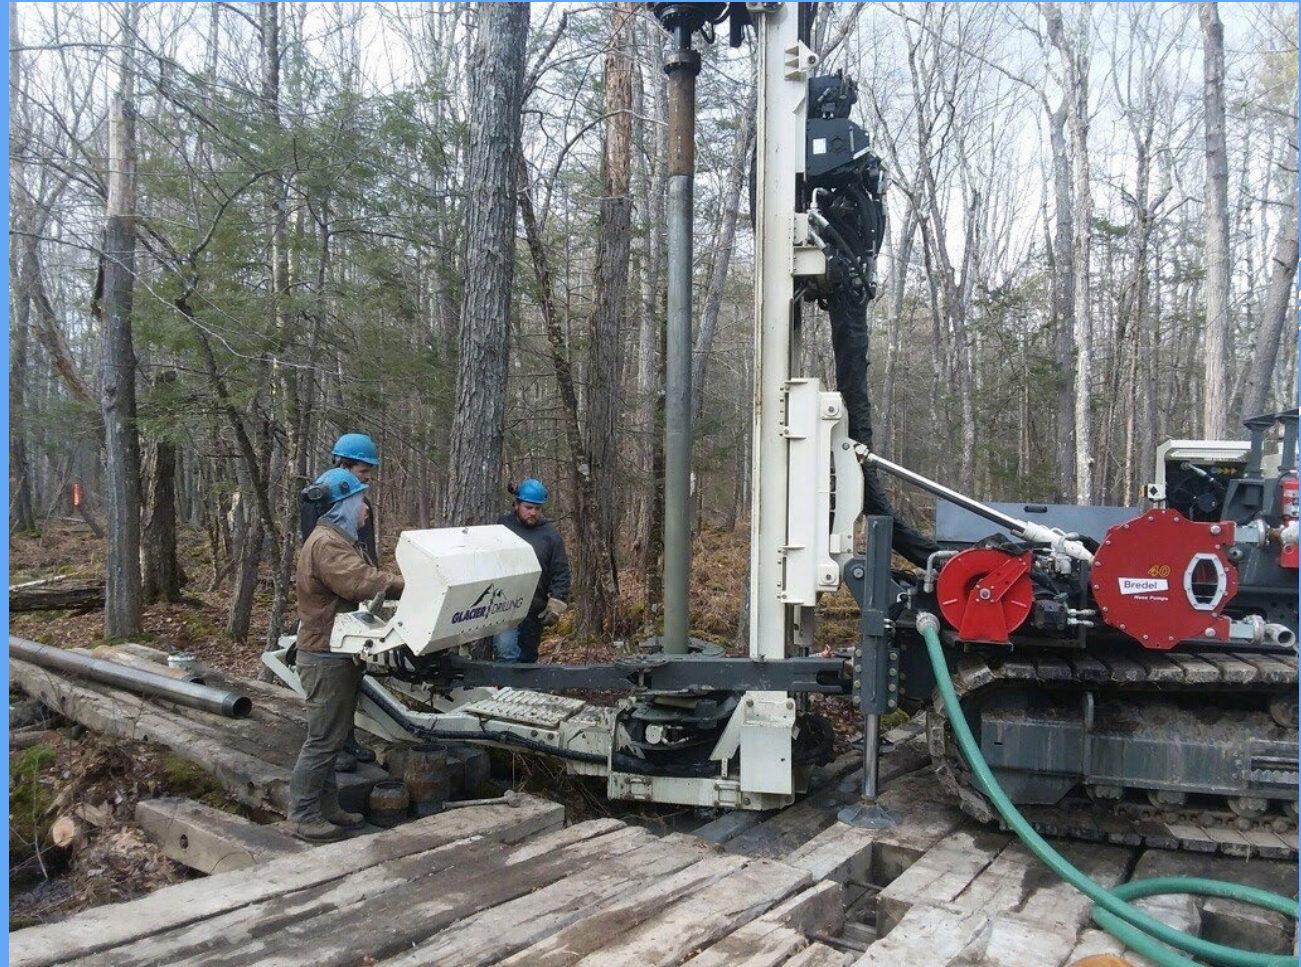
- Investigation activities conducted 2018-2021.
- Interim report submitted 2019.
- Final report submitted December 2021.
 - EPA disapproved final report and directed CLG to address concerns and resubmit.
 - Final report resubmitted September 2022.

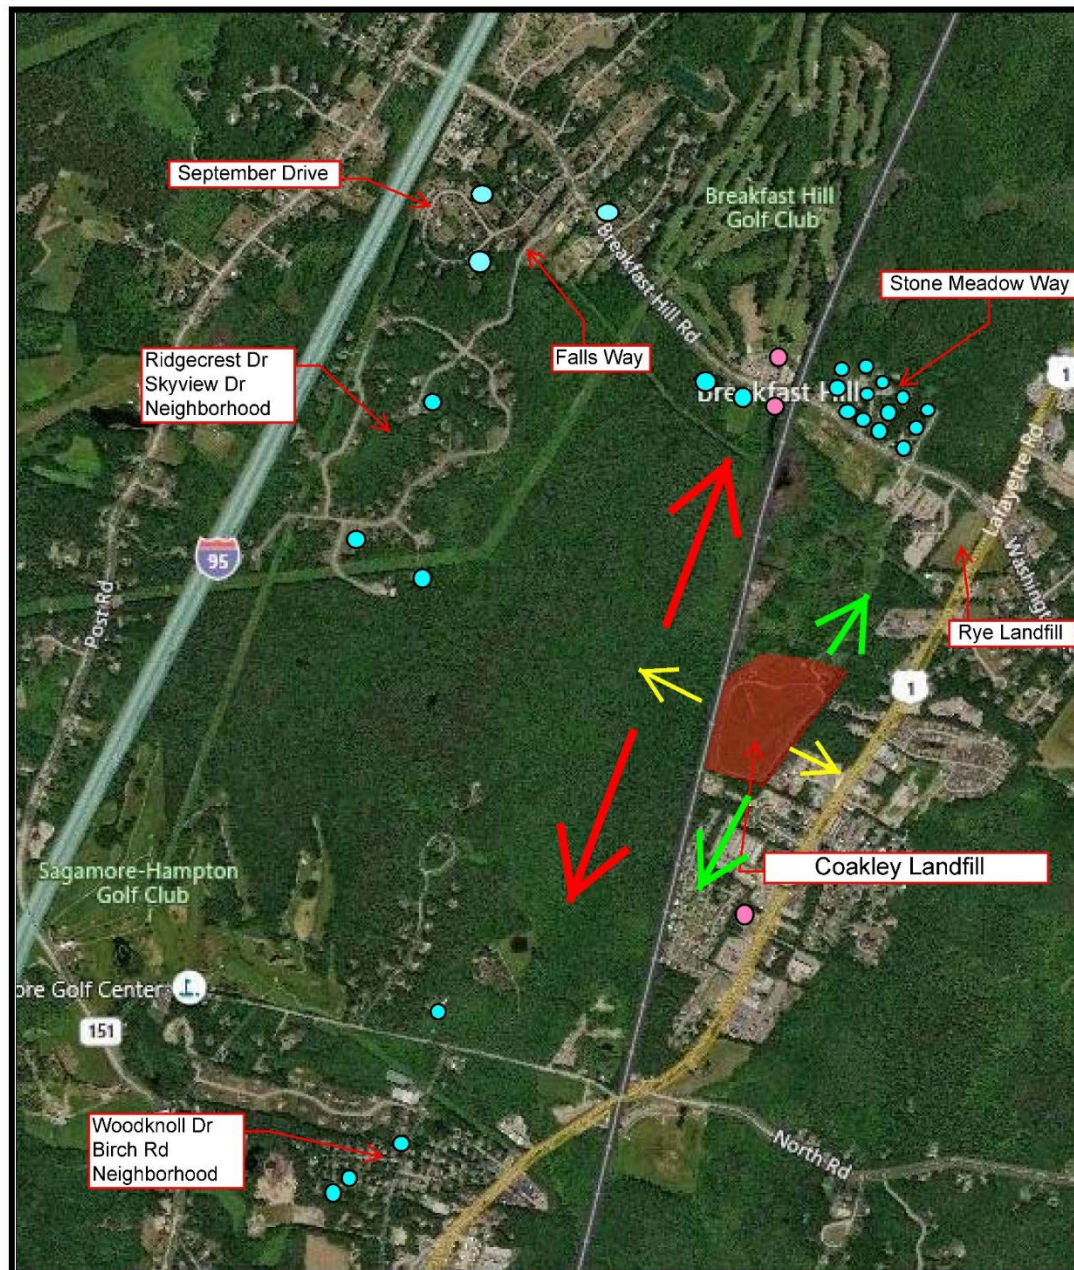
Figure 4 - Area Map with Flow Paths Coakley Landfill and Vicinity

- Flow in bedrock is not always direct but meandering through interconnected fractures.
- Complex interaction between groundwater, surface water and stormwater runoff.
- Migration of contaminants from the landfill via groundwater in bedrock pathways is occurring.
- Significant contaminant migration is west from the landfill, then turns north and south along primary bedrock fracture pathway.
- Some limited contaminant migration to the east.
- Stormwater runoff contributes to contaminant loading.
- Contaminants are reaching 3 private wells via groundwater pathways in bedrock.
- Current evidence does not indicate a direct flowpath from landfill to other private wells.
- Extent of flowpath in bedrock to the south is not defined.
- Continued private well and flowpath monitoring will track any changes.

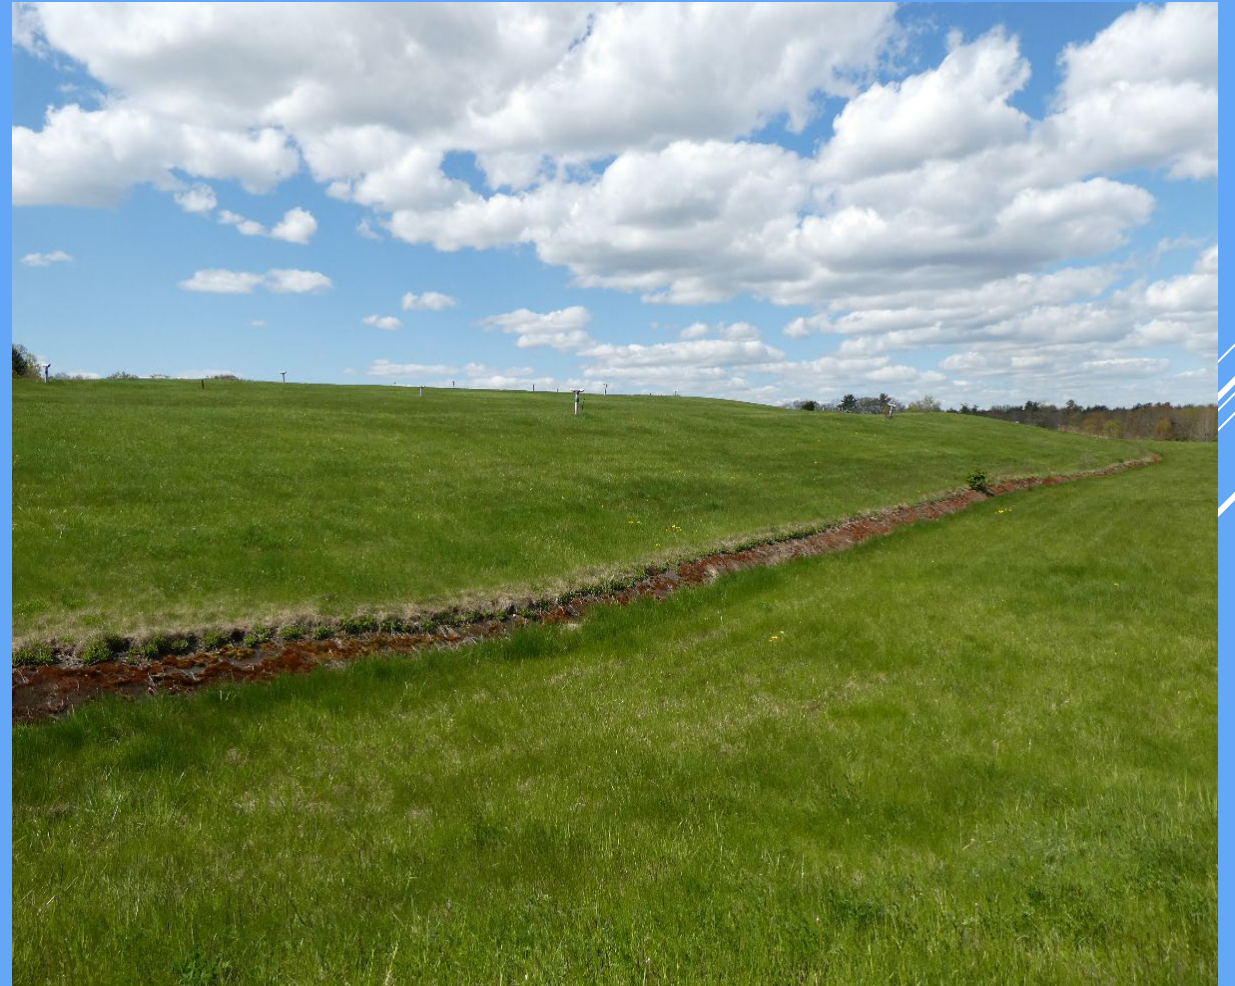
- Landfill cap stormwater runoff
 - Stormwater runoff from landfill cap sampled during storm events.
 - Landfill liner and cover material sampled.
 - PFAS detected in runoff, though runoff events are infrequent.
 - Landfill cap liner and cover material contain PFAS compounds.
