Building Performance Evaluation and Sustainability Assessment

Rye Town Hall

Rye, New Hampshire

June 2009

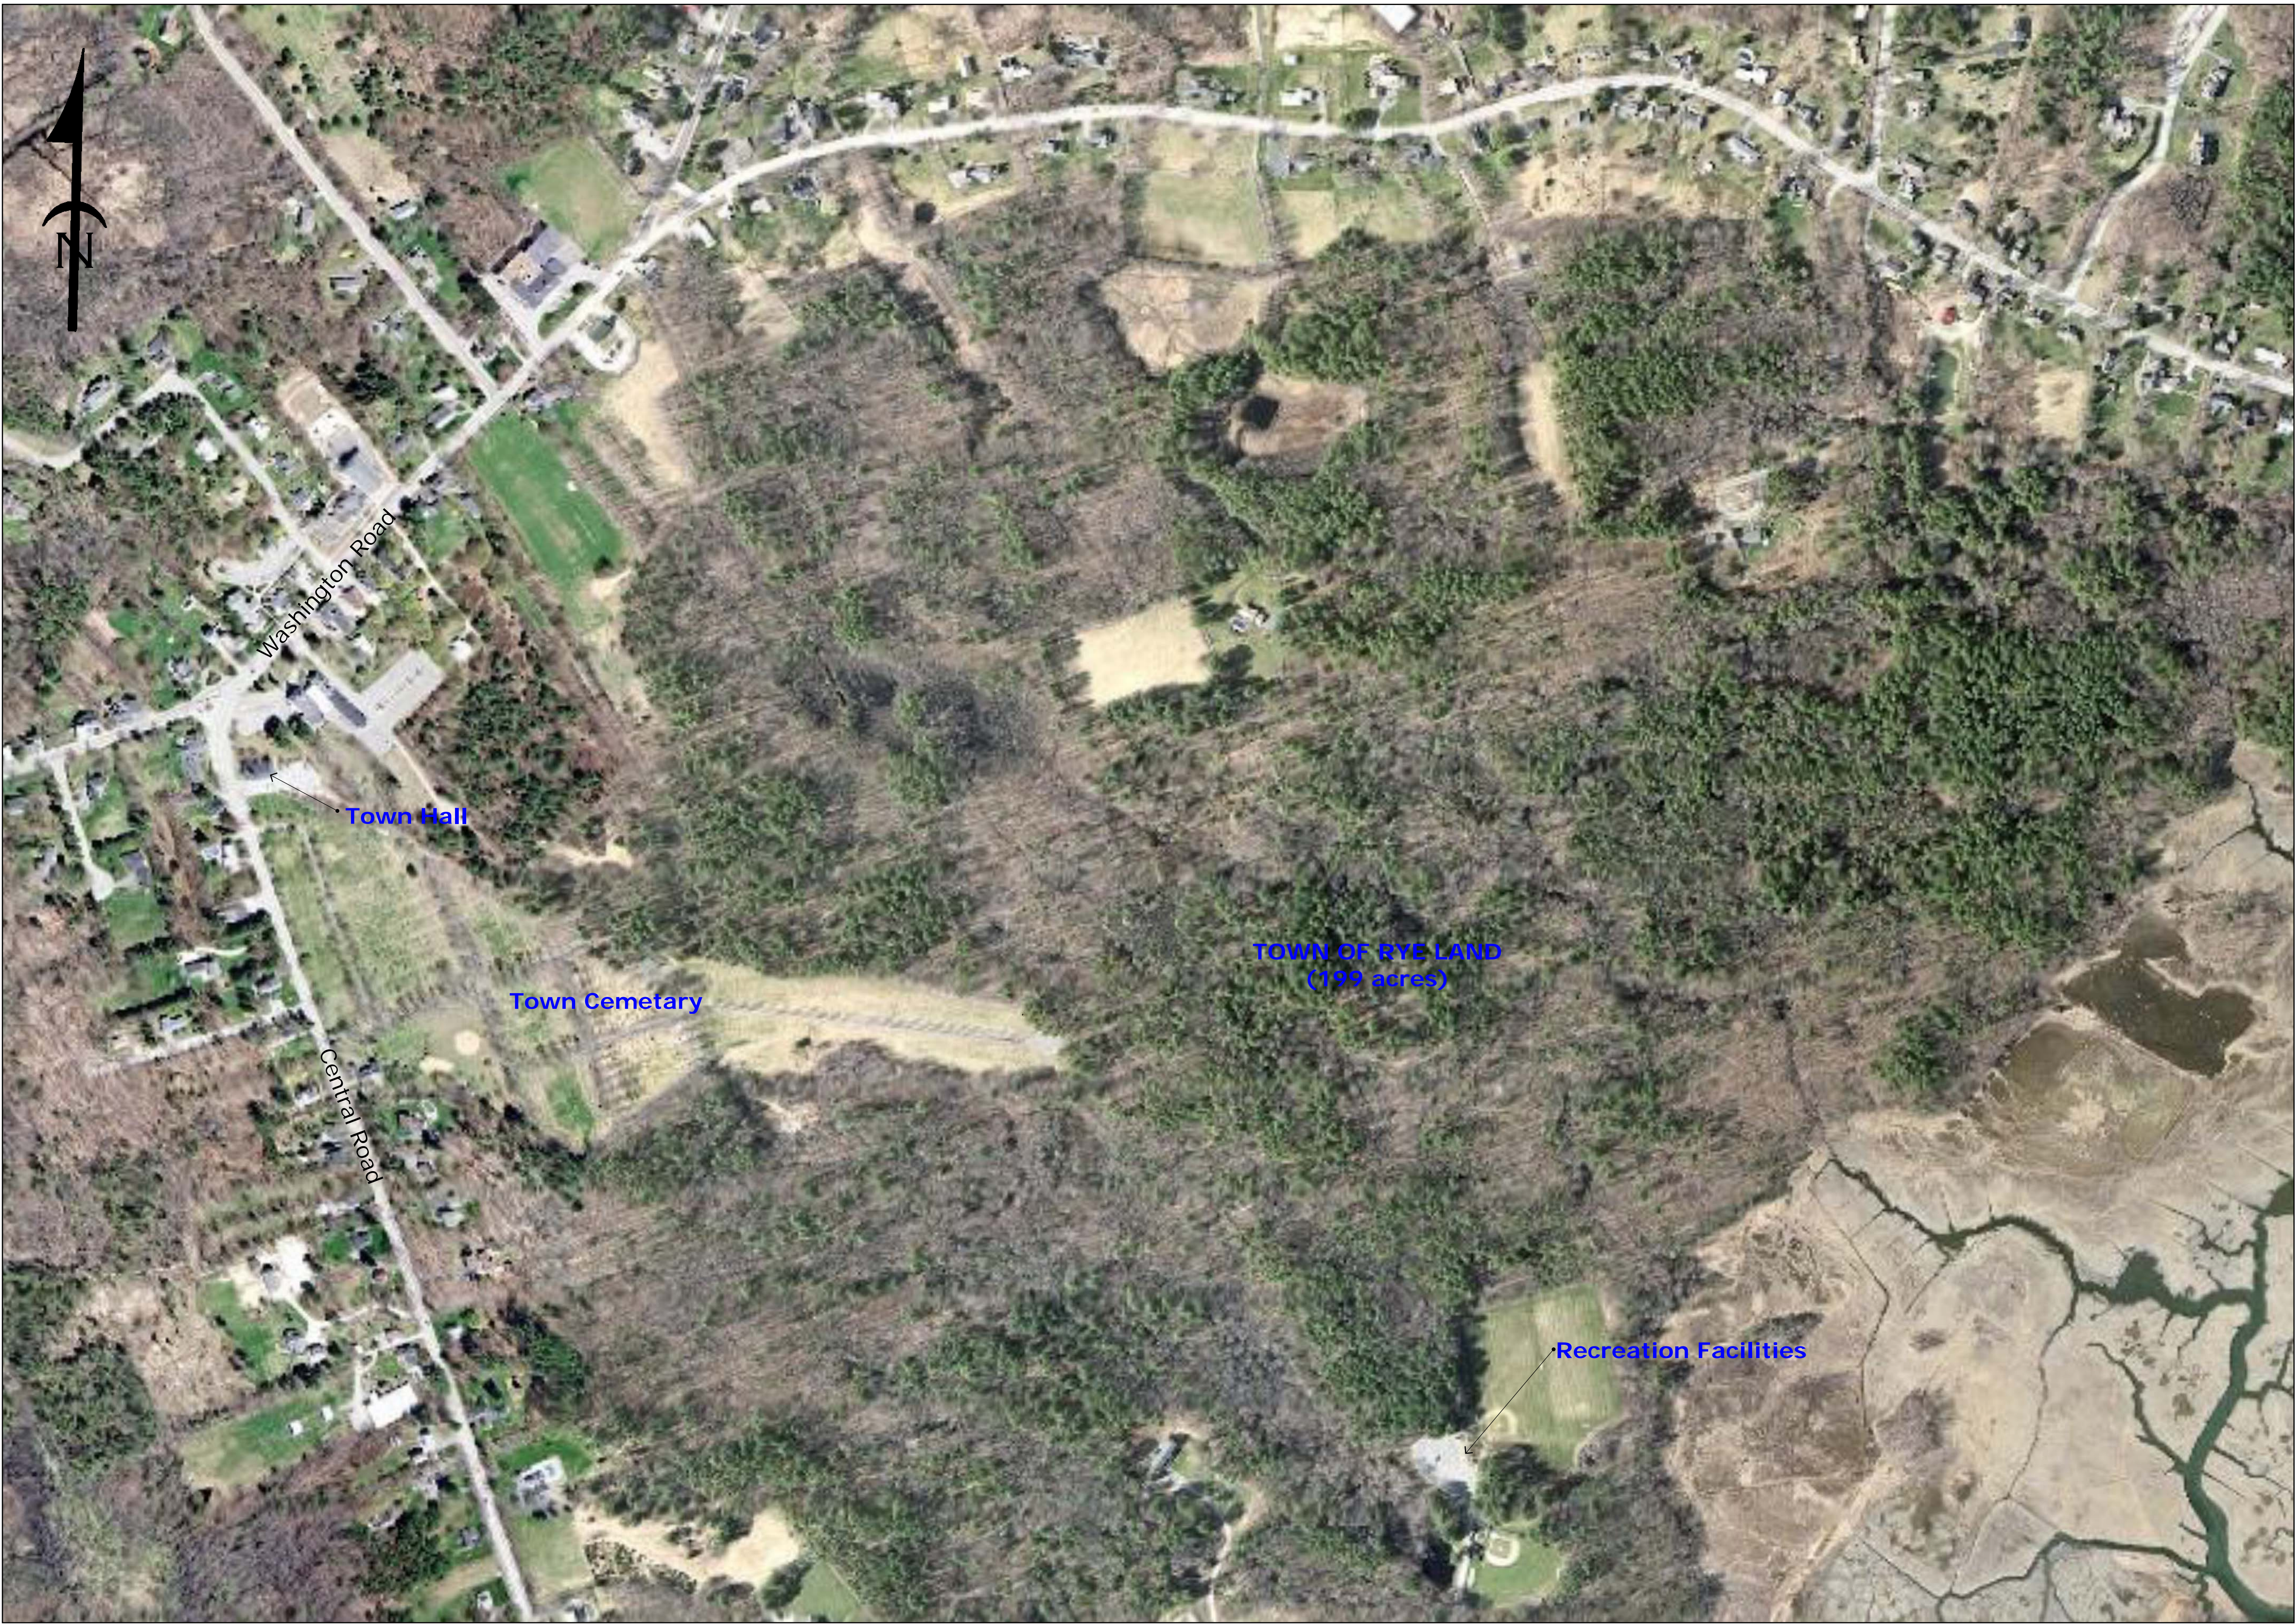
FIGURE 1

The Town Hall building and associated infrastructure are located within a 200-acre parcel of Town owned land. Aside from the Town Hall facilities, current land use designations include a Town cemetery, deeded conservation lands, protected wetlands, and Town recreation facilities (Figure 1).

Storm water within the Town Hall site generally flows northwest to southeast eventually draining to wetlands and estuaries at the southernmost edge of the Town parcel (Figure 1). Runoff controls are limited to some catch basins and piping located on the west and east sides of the building. Inspection of the catch basins revealed a substantial amount of sediment (Photographs 158, 160, and 161) and cleaning of the catch basins is recommended. Landscaped areas are covered with native grasses, groundcover,

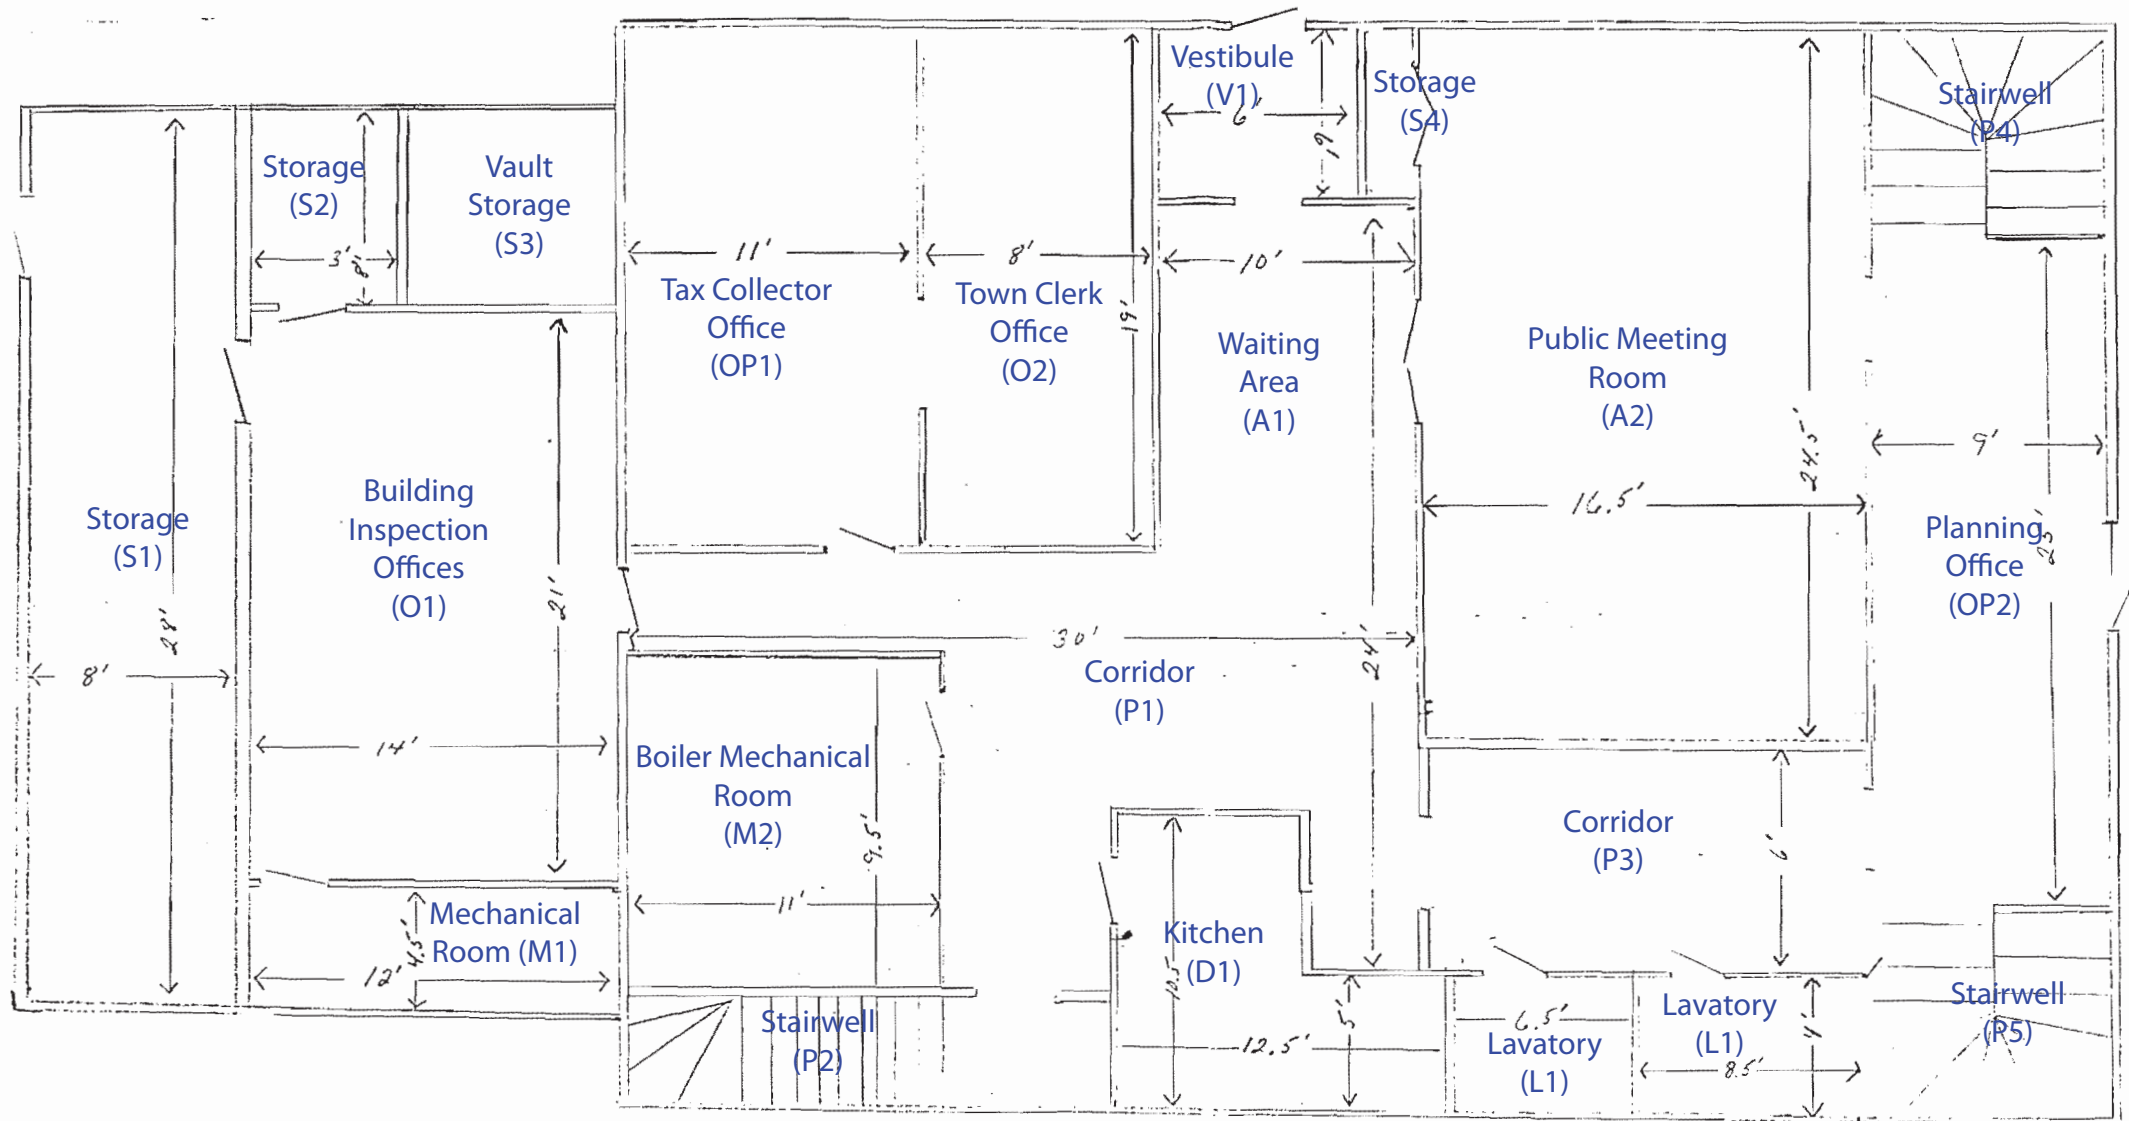
FIGURE 2

The net conditioned area of the Town Hall building is approximately 5,642 square feet including all first and second spaces and the storage room located on the third floor. This area does not account for the unfinished attic spaces. Primary designated use spaces within the Town Hall include public assembly areas and office spaces for Town employees (open and private). Table 1.2 presents the estimated area based on the designated use for the Town Hall. Figures 2 and 3 present a building floor plan and use designation map of the Town Hall for the lower and upper floors respectively.

The current building configuration and space use does not appear to support the needs of the Town Hall users. More than 18% of the building is designated for passage suggesting inefficient layout and configuration – in general, passage space in office buildings should represent 5% to 10% of total conditioned area. Other concerns include corridors within office space such as the recreation office, the Town Engineer Office, and the office in the southwest stairwell. Although storage space represents a sizeable portion of the building area, the storage spaces are not easily accessible and are not efficiently organized resulting in less usable storage space. Respective areas for office and assembly space are 43% and 16% of the net conditioned area representing a total primary space allocation of 59%. Primary spaces

should represent at least 75% of the total conditioned space to provide the most efficient utilization of space.

It is recommended that a space planning study be completed to define the functional needs for existing and potential future Town operations 🚩.
