Energy Audit, Level 3

9 November, 2011

Prepared For: Town of Rye

Property Address: **10 Central Street
Rye, New Hampshire 03870**

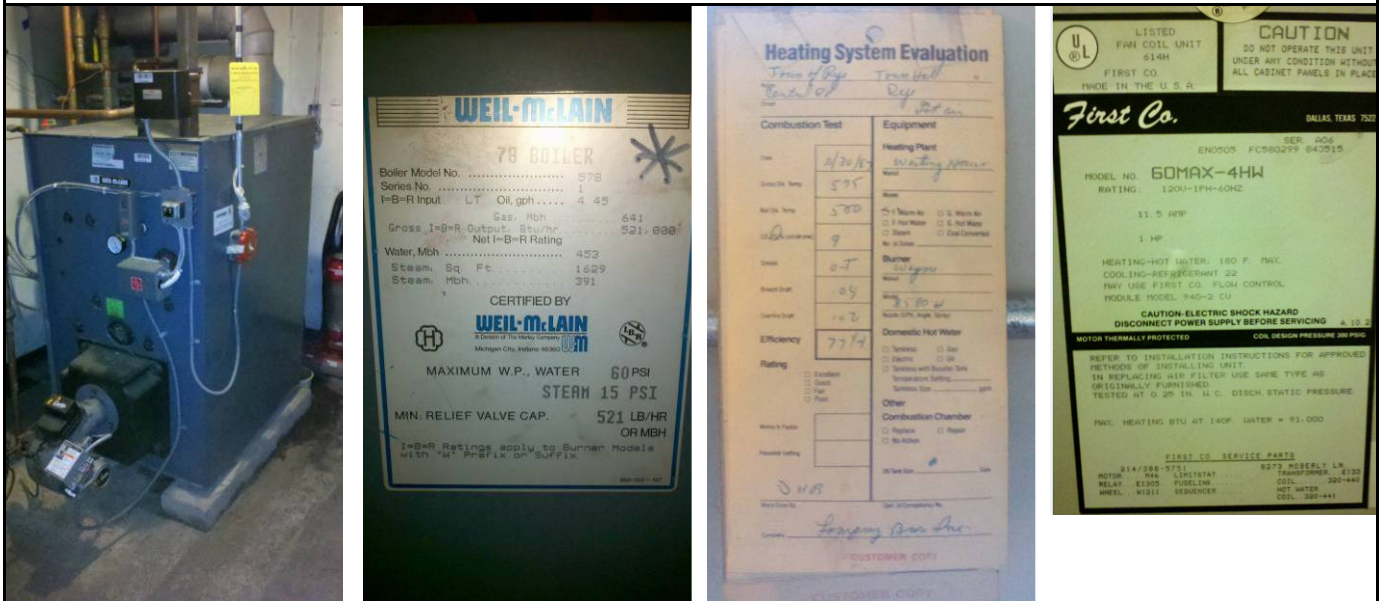
Heating System Assessment									
Type of System	<input type="checkbox"/> Forced Hot Air <input checked="" type="checkbox"/> Forced Hot Water <input checked="" type="checkbox"/> Hydro / Air <input type="checkbox"/> Electric Baseboard <input type="checkbox"/> Steam <input type="checkbox"/> Geothermal <input type="checkbox"/> Air Source Heat Pump <input type="checkbox"/> Other								
Fuel Type	Oil	Propane	Kerosene	Electric	Nat. Gas	Cord wood	Wood Pellets	Wood Chips	Other
	<input checked="" type="checkbox"/>	<input type="checkbox"/>	<input type="checkbox"/>	<input type="checkbox"/>	<input type="checkbox"/>	<input type="checkbox"/>	<input type="checkbox"/>	<input type="checkbox"/>	
Estimated System Efficiency	78% AFUE			Manufacturer			Model Number		
Estimated Age	16-18 Years			Weil-McLain			578		
Programmable Thermostats	Yes								
Note: Refer to "Health & Safety" Section for Results of Combustion Safety Testing Refer to "Other Improvements Recommendations" For Hydronic Pipe Insulation Recommendations

<input type="checkbox"/> System should be serviced <input type="checkbox"/> Additional Inspection is recommended by a HVAC technician <input checked="" type="checkbox"/> Consider replacement with a high efficiency system <input type="checkbox"/> Replace with high efficiency system at end of current system's useful life <input type="checkbox"/>									
Comments: Detailed inspection of the existing heating systems was not accomplished due to previous contractor evaluating the building's systems and plan to enstall new geothermal system.

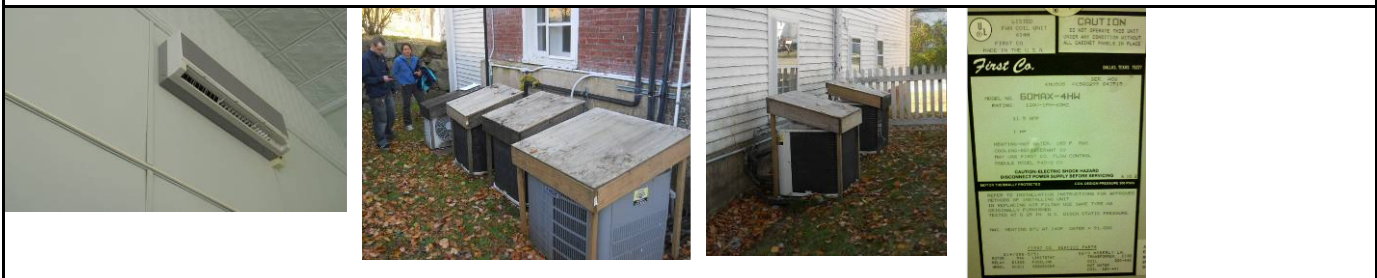
Comments: Systems 1-5 are ductless mini-splits. All systems are low efficiency compared to current systems available. Due to plans to have systems replaced with geothermal system, no recommendations are made for the air conditioning systems.
