Facility and Space Needs Assessment Rye Recreation Facilities Rye (and New Castle) New Hampshire July 21, 2016 - revised

Norman E. Larson, AIA, LEED AP Christopher P. Williams, Architects

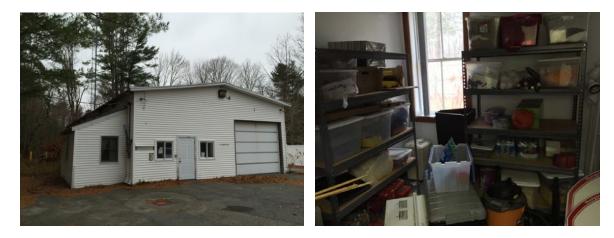
Soccer Snack Shop. (Dedicated facility, Town owned)

Single story wood frame on timbers laid on grade - vinyl siding on 2x4s, asphalt shingle roof Overhead power with Meter on building No H/C access

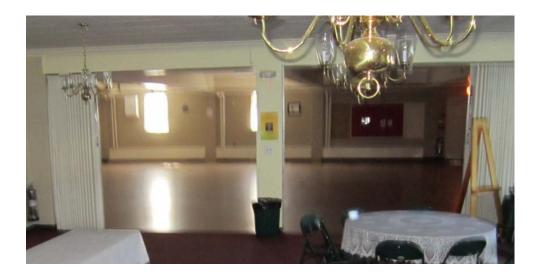
Fellowship Hall Storage (Rye Congregational Church, borrowed space)

Shared linear closet / storage space with large accordion door.

Closet built into original Fellowship Hall space is in similar condition to larger space.

Assessment: Storage is conditioned but unsecured and shared which limits what can be stored safely here.

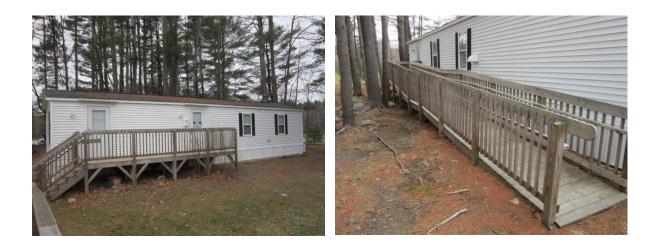
Staff Work Area (Recreation Modular, controlled space)

Open space behind reception counter in reception area of office trailer (parked with skirt) at Recreation Road facility. Rye Recreation staff work at desk oriented to service counter.

Finishes and environment in this building are in fair to good condition and are better than in any other Rye Recreation controlled building
