923.86.01

January 31, 2011

SUBJECT: Town Hall Structural Investigation Services  
Rye, New Hampshire

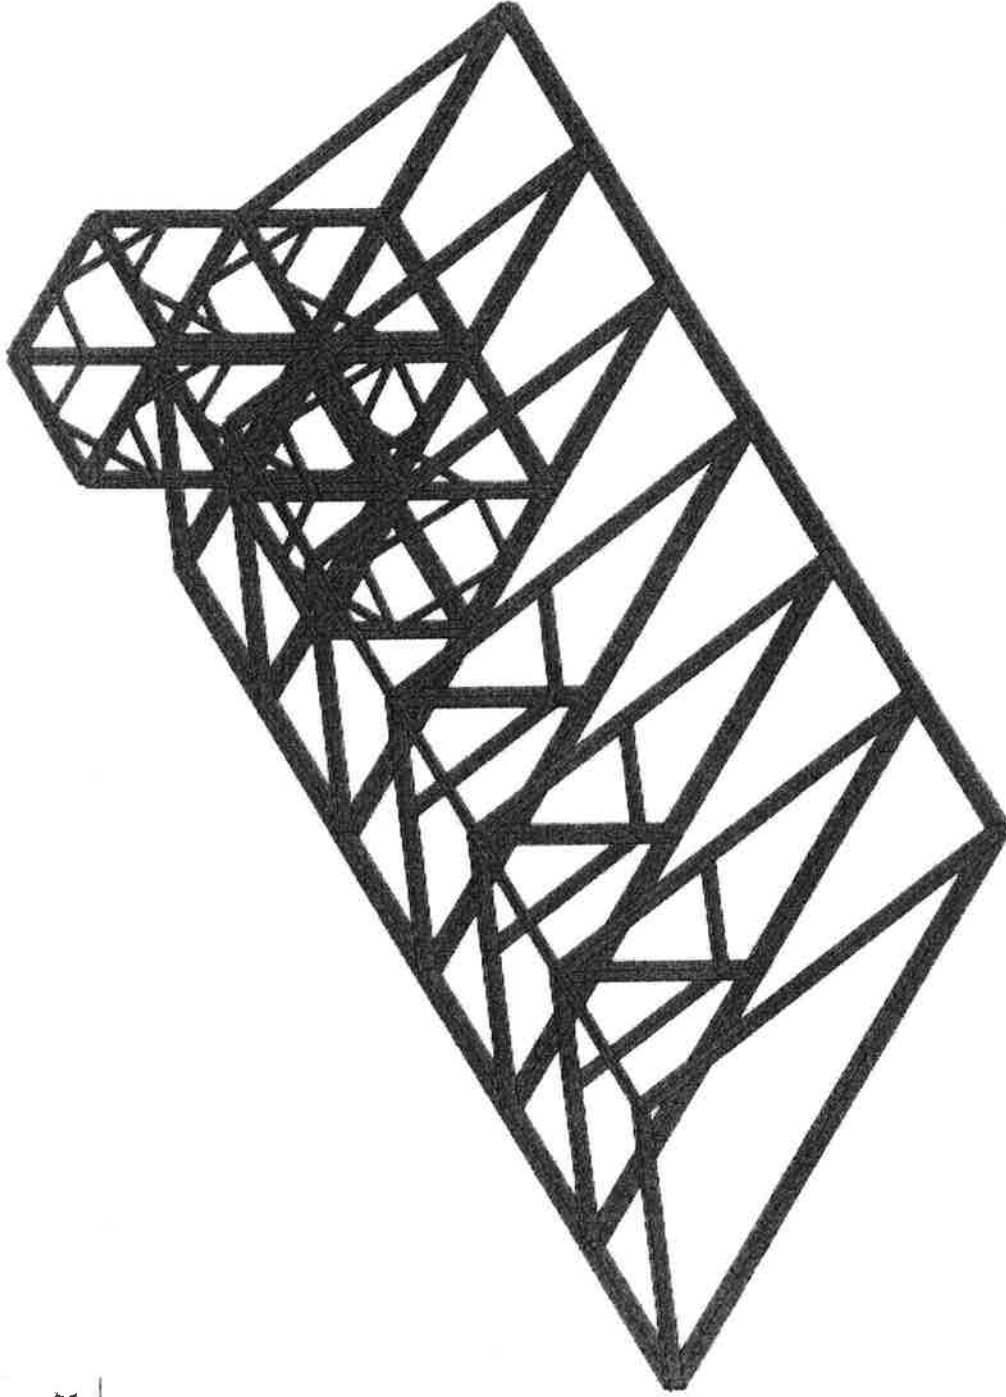
SK1

AMEC performed a structural analysis on the timber framing members using field measurements, existing conditions, and information provided to us by the current owner. We calculated dead loads, live loads, snow loads, and wind loads based on the current code (ASCE 7-05 and IBC 2006). We created a computer model of the roof structure to determine how the structure will act under current loading requirements. The results of this analysis indicate the existing roof structure is inadequate to support the current code required loads.
