# Performance Evaluation and Sustainability Assessment

## Rye Public Works Building

Rye, New Hampshire

June 2009

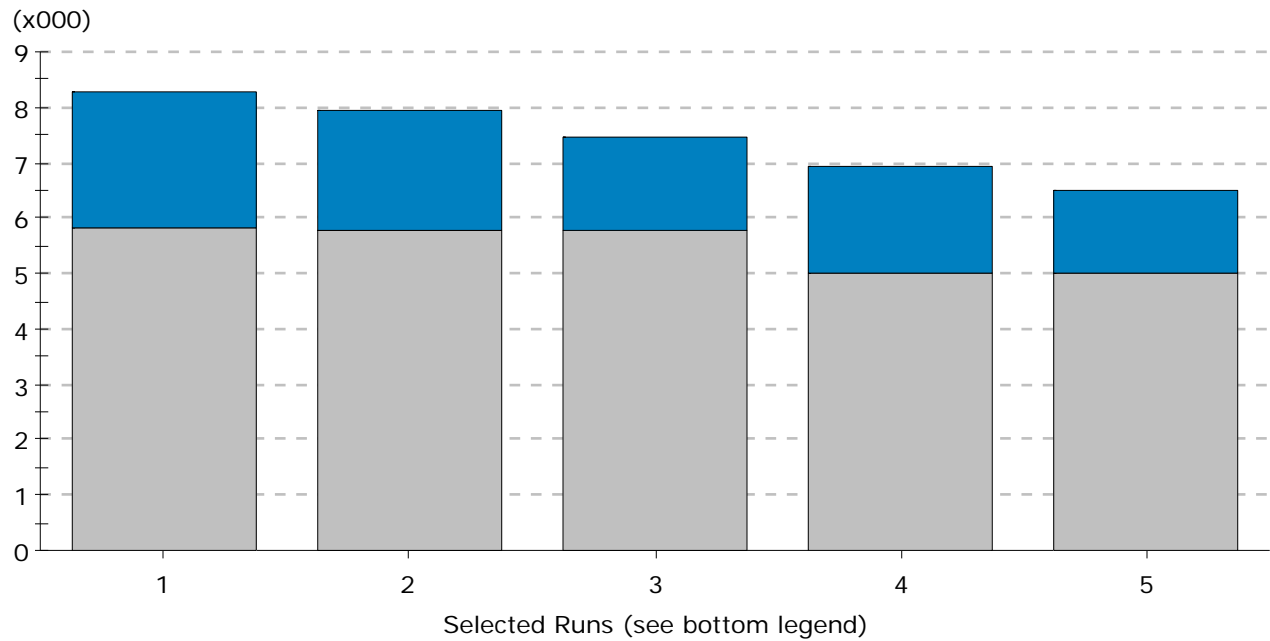
### Annual Utility Bills (\$)

Custom Elec Rate
  Custom Gas Rate

1. Rye Public Works Bldg - Baseline Design (07/27/09 @ 10:24) (annual bill: \$ 8,264)
2. Rye Public Works Bldg - Roof Insul EEM (07/27/09 @ 10:24) (annual bill: \$ 7,920)
3. Rye Public Works Bldg - Ext Wall Insul EEM (07/27/09 @ 10:24) (annual bill: \$ 7,483)
4. Rye Public Works Bldg - Lighting Power EEM (07/27/09 @ 10:24) (annual bill: \$ 6,953)
5. Rye Public Works Bldg - Pkg HVAC Eff EEM (07/27/09 @ 10:24) (annual bill: \$ 6,475)
