Performance Evaluation and Sustainability Assessment

Rye Recreation Facilities

Rye, New Hampshire

June 2009

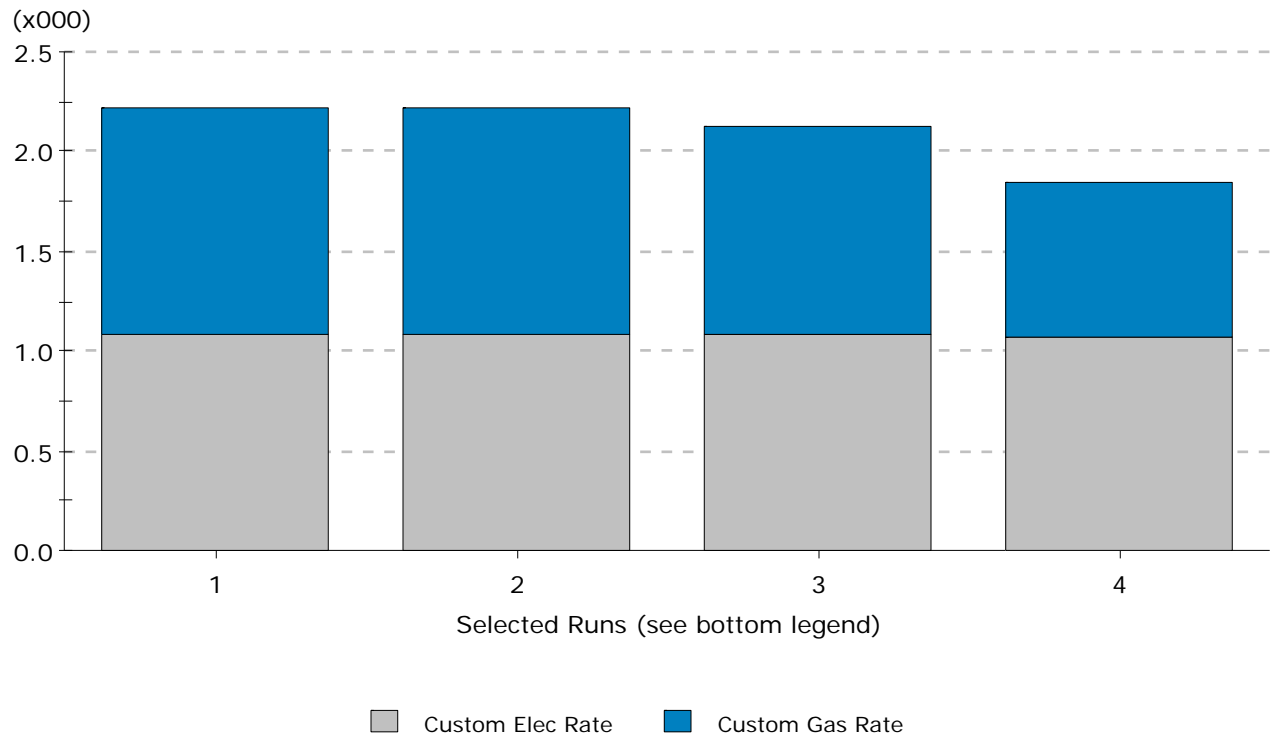
Annual Utility Bills (\$)

1. Town of Rye - Recreation Bldg - Baseline Design (07/17/09 @ 19:35) (annual bill: \$ 2,213)
2. Town of Rye - Recreation Bldg - Roof Insul EEM (07/17/09 @ 19:35) (annual bill: \$ 2,218)
3. Town of Rye - Recreation Bldg - Ext Wall Insul EEM (07/17/09 @ 19:35) (annual bill: \$ 2,130)
4. Town of Rye - Recreation Bldg - Grnd Floor Insul EEM (07/17/09 @ 19:35) (annual bill: \$ 1,849)
